Study

**on Aeroplane State Awareness
during Go-Around**

BEA

Bureau d'Enquêtes et d'Analyses
pour la sécurité de l'aviation civile

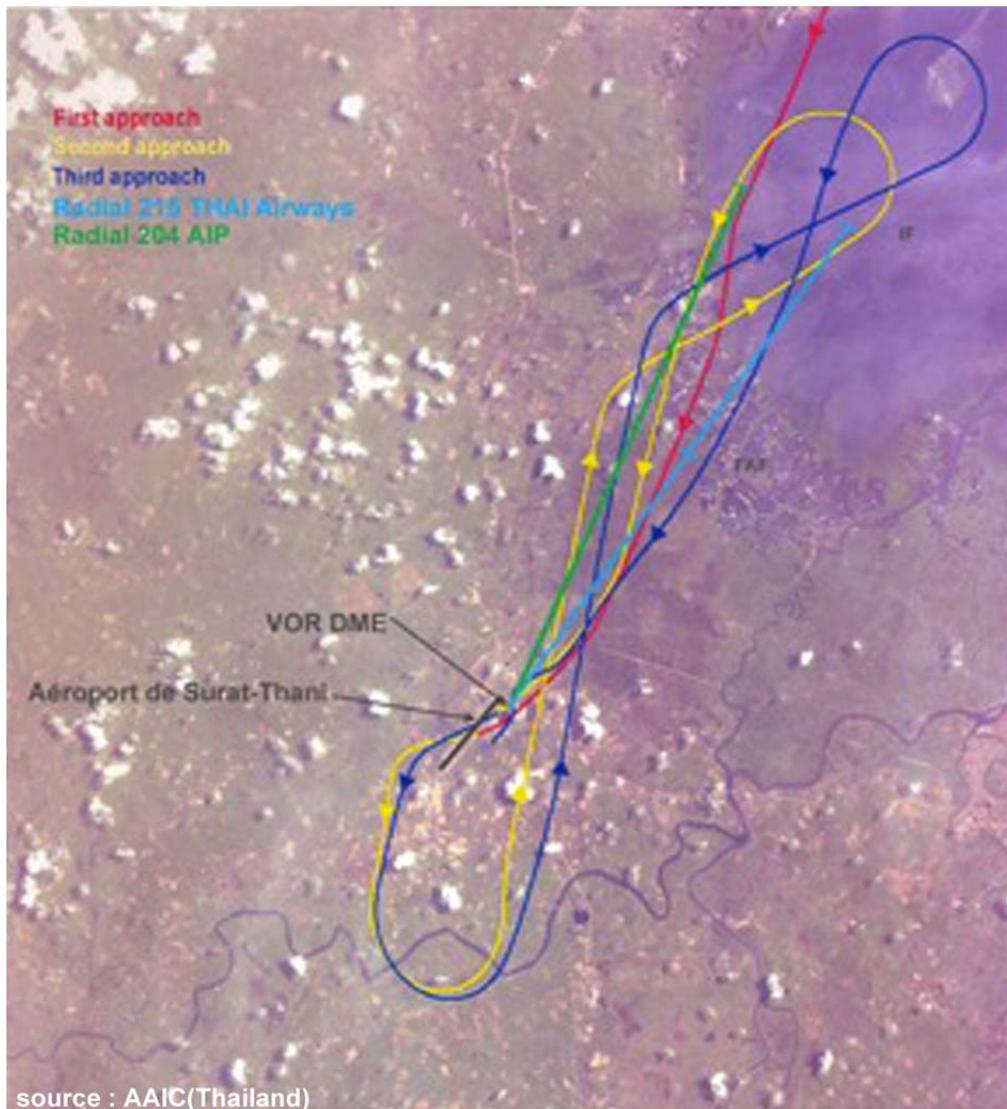
Figure 1 : Approach from 11.37.33 UTC to 12.07.35 UTC

The PF made his first pitch input on the sidestick when the pitch attitude reached 36 degrees. The FCOM recommends a maximum pitch attitude of 18 degrees. During the stall, nose-up inputs on the sidestick were recorded. Similarly, the first input to counter the roll was taken when the roll angle was 50 degrees.

During all three approaches, the PF flew too far to the left of the radial of the final approach segment and did not correct this deviation. Moreover, his last skills checks revealed that he was not very familiar with non-precision approaches.

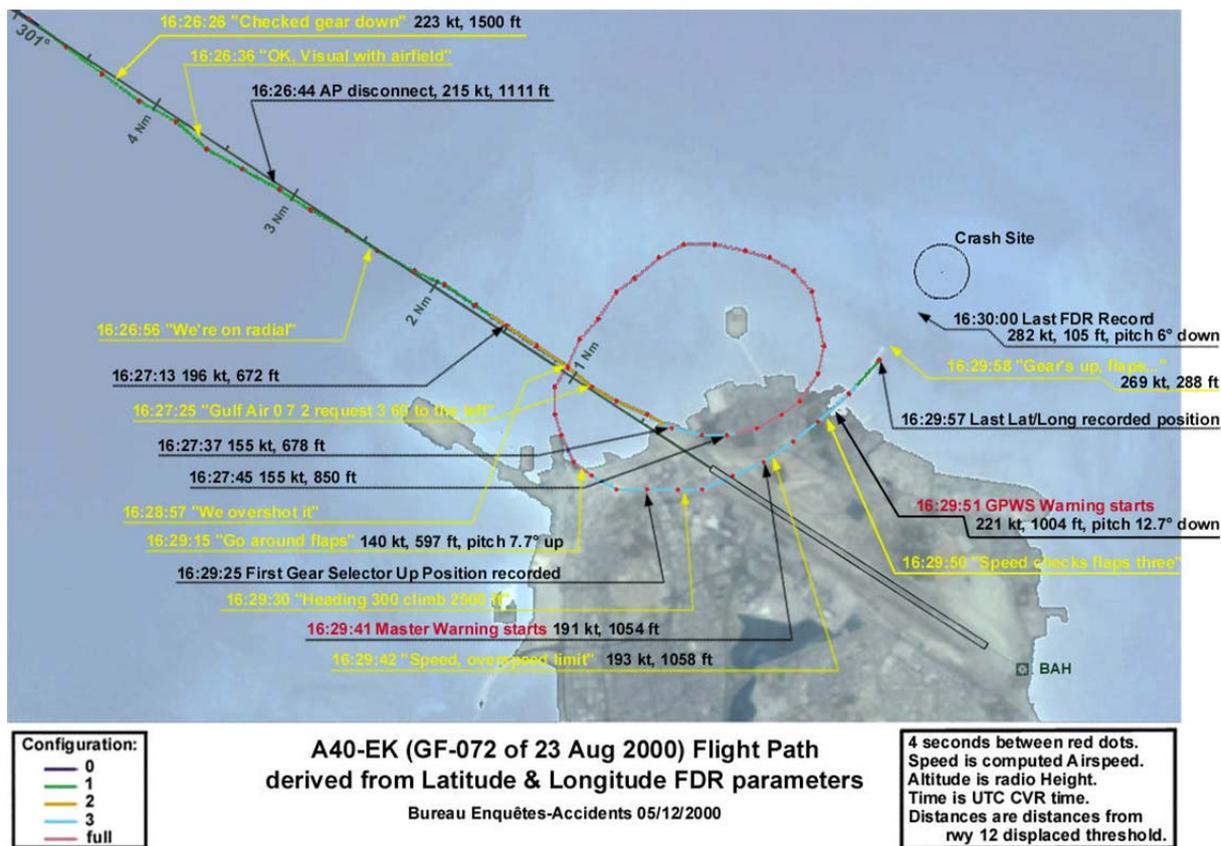
Figure 2

Just as the controller offered new radar vectoring which was accepted by the crew, the master warning associated with VFE overspeed condition sounded. The latter was called out by the PNF/PM. The Captain asked the co-pilot to retract the flaps, without specifying a position. The Captain then held the sidestick forward of the neutral position for 11 seconds, even though the aeroplane's height was 1,050 ft. The investigation considered that the most likely explanation for this nose-down input at night was a somatogravic illusion. The PFD was nonetheless correctly displaying the aircraft's true pitch attitude. The report indicates that this pitch attitude information was not used by the Captain since he was mentally overloaded, while his attention was monopolized by monitoring the airspeed.

The pitch attitude reduced rapidly due to the nose-down input, reaching 12° nose-down. The "sink rate" aural warning from the GPWS sounded and the Captain pushed the sidestick forward. The "pull-up" warning then sounded and continued until the aircraft's impact with the sea. There was no verbal communication between the flight crew members after the activation of the GPWS warning. A few seconds before the impact, the Captain pulled back on the sidestick. The last recording obtained from the FDR indicated airspeed of 282 kt and a pitch attitude of 6° nose-down.

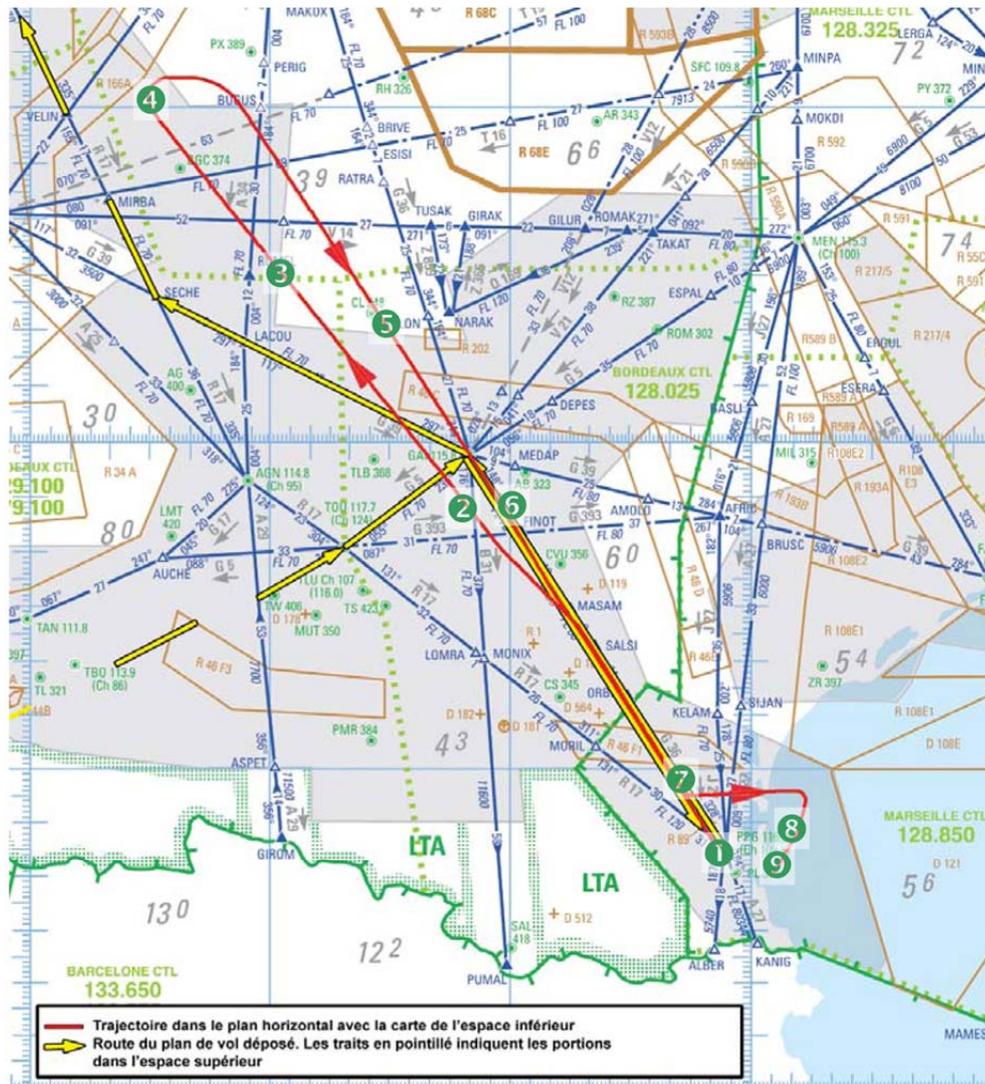
- ① 14 h 44
Takeoff from Perpignan aerodrome
- ② 14 h 52
The controller told the crew that they could not perform a "360"
- ③ Between 15 h 04 et 15 h 06
Blockage of angle of attack sensors 1 and 2
- ④ 15 h 12
Turn back
- ⑤ 15 h 22
Arrival at FL 390
- ⑥ 15 h 26
Beginning of descent
- ⑦ 15 h 34 min 34 s
Co-pilot: "(...) we'll appreciate a radar vector the approach"
- ⑧ 15 h 43 min 41 s
Thrust levers on IDLE
Beginning of the check on the low speed angle of attack protections
- ⑨ 15 h 45 min 05 s
Stall warning

- **that EASA undertake a safety study with a view to improving the certification standards of warning systems for crews during reconfigurations of flight control systems or the training of crews in identifying these reconfigurations and determining the immediate operational consequences**
- **that EASA, in cooperation with manufacturers, improve training exercises and techniques relating to approach-to-stall to ensure control of the aeroplane in the pitch axis.**

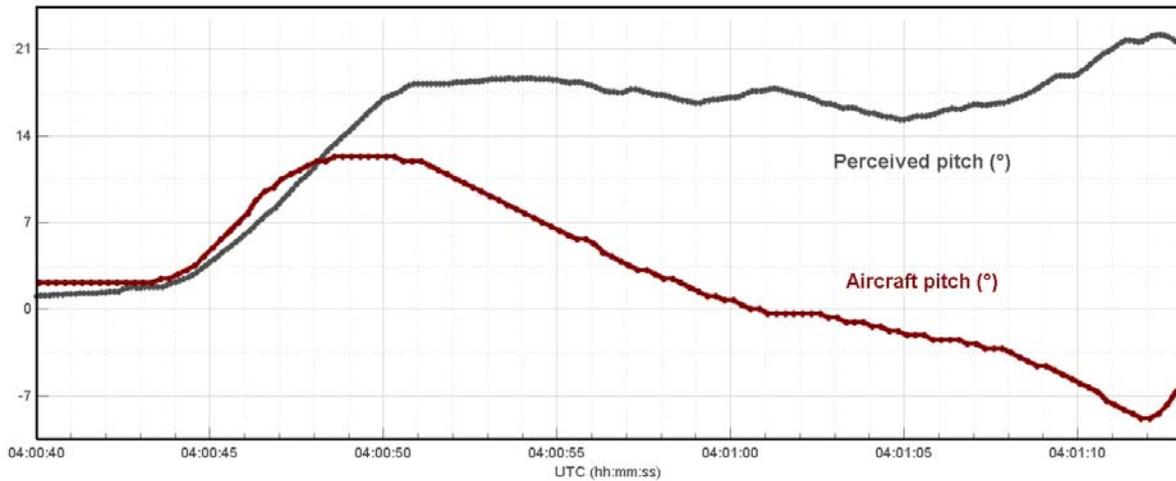
Figure 37 : Real and perceived pitch attitudes during a missed approach

When a somatogravic illusion is present, there is therefore a difference between the attitude experienced and the real pitch attitude. This difference may be as much as 25 degrees.
