INCIDENT INVESTIGATION REPORT

**McDonnell Douglas DC-9-31 Aircraft,
VH-TJP at Melbourne Airport, Victoria
on 29 November 1978**

September 1979

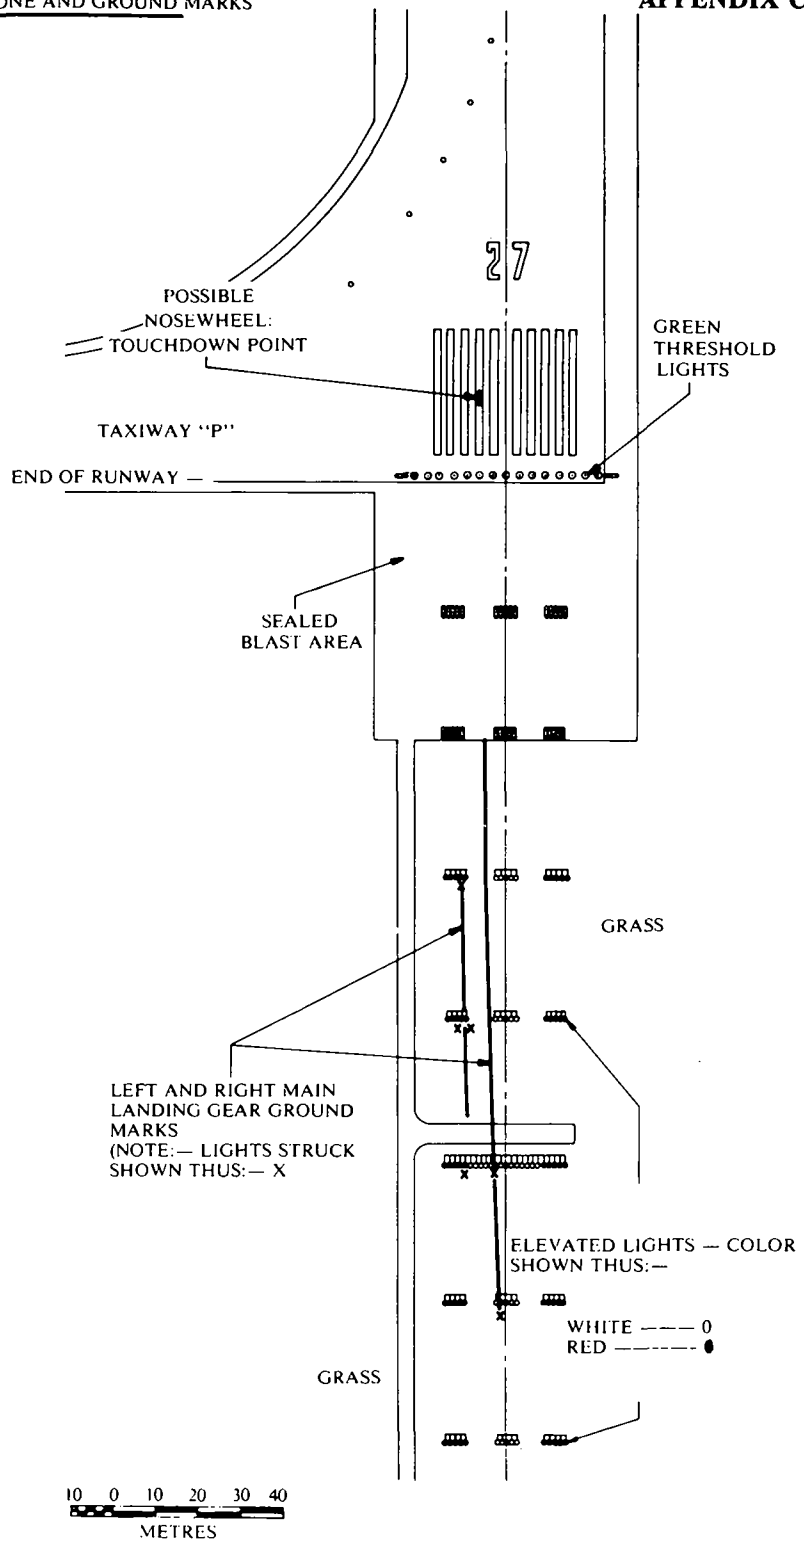
TOUCHDOWN ZONE AND GROUND MARKS

Touchdown was in a near normal landing attitude, 192 metres short of the runway threshold. A total of six approach lights, in the last four rows leading to the threshold, were struck by the main wheels as the aircraft rolled across the grassed area. The nose wheel probably touched down on the runway just beyond the threshold (see Appendix C) The aircraft remained within the confines of the runway as it slowed down. It was then taxied to the terminal under its own power and the passengers disembarked by normal means.

Six lights in the Runway 27 approach lighting system were destroyed by the landing gear of the DC-9 during the aircraft's ground roll. The lights were mounted on frangible supports about one metre high, set in concrete bases flush with the ground. The supports were designed to break off at the base under impact forces and, in all cases, they failed as intended.

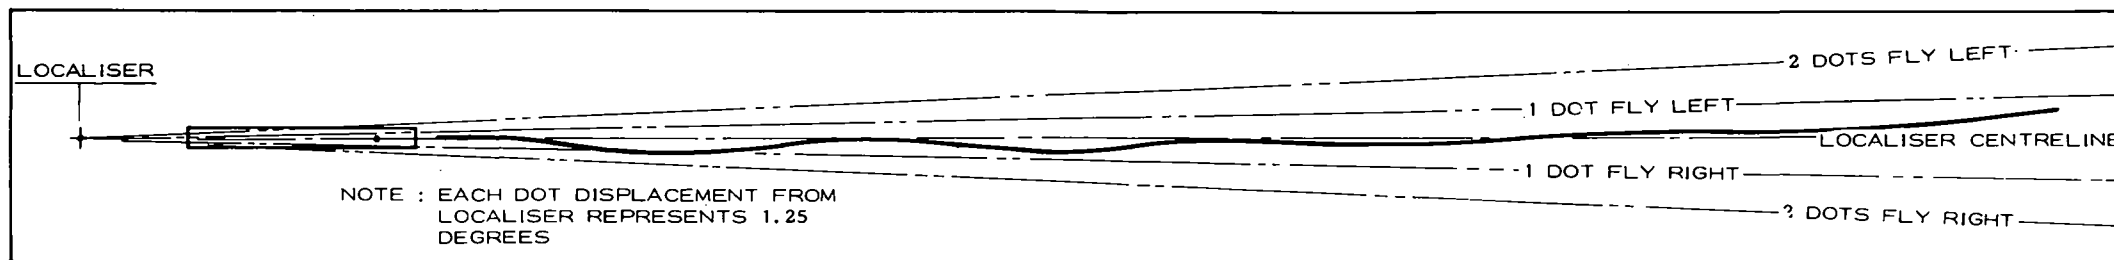
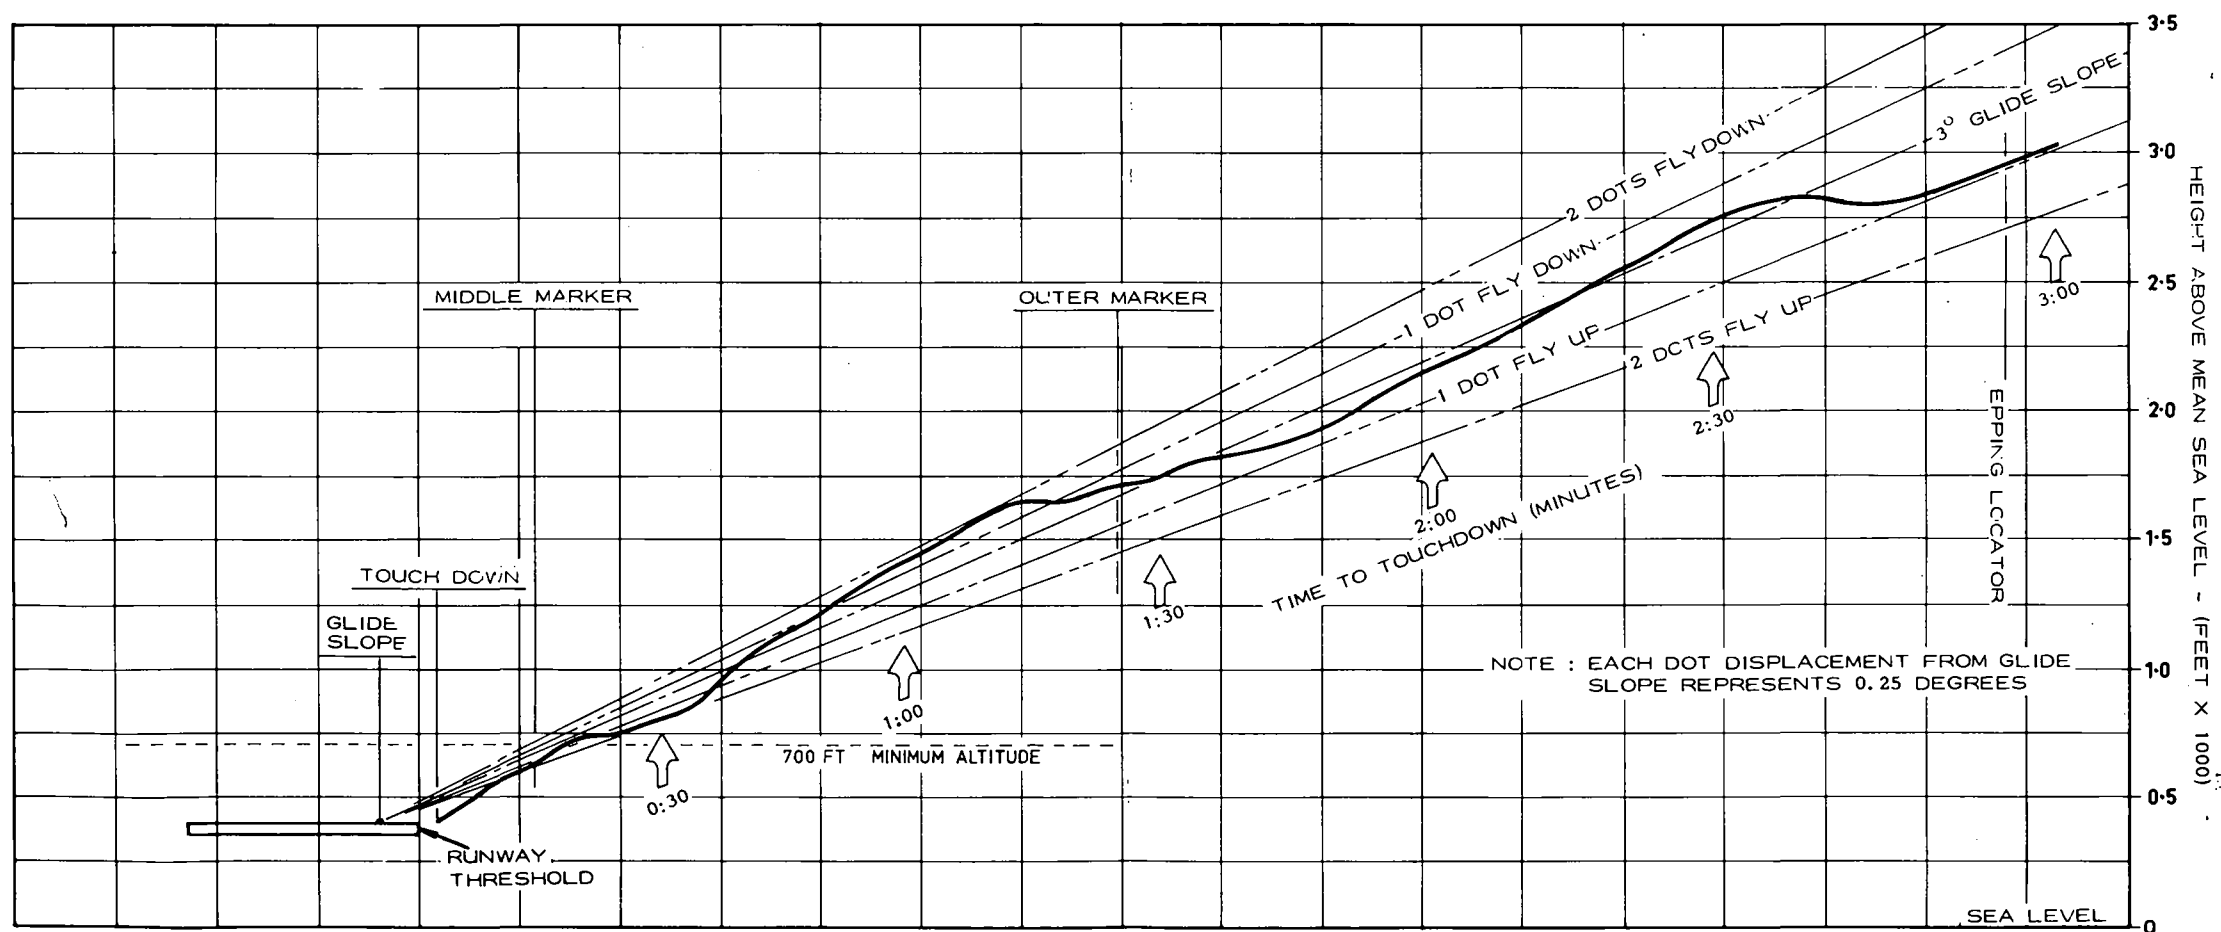
FLIGHT PATH DERIVED FROM RECORDED FLIGHT DATA

From inspection of the FDR traces, a marked increase in total energy was noted, primarily in the airspeed record, over the period 65-75 seconds before touchdown. On the assumption that this was indicative of frontal passage, pre- and post-frontal atmospheric conditions were appropriately applied to the FDR information to derive an approach flight path. This is at Appendix E.

The rate of descent was then reduced and the aircraft began to deviate above the glideslope. At the same time a left turn of approximately five degrees was made and the aircraft also began to deviate left of the localiser. The Outer Marker was crossed at 83 seconds. At 75 seconds the aircraft encountered wind shear associated with the passage of the front. The IAS increased approximately 15 knots, to 195 knots, over a 10 second period. This was accompanied by a brief pause in descent which caused the aircraft to be displaced some two dots above glideslope.

The aircraft then entered a descent at about 1200 feet per minute. At the same time the aircraft began to turn to the left but, because of the cessation of left drift, the localiser was still closed at approximately 60 seconds. A more rapid left turn onto 255 degrees magnetic was then made, and this caused the aircraft to again deviate left of the localiser by about one dot on the course deviation indicator (each dot equals 1.25 degrees of localiser deviation). Immediately following this turn the rate of descent increased to about 1500 feet per minute, and this expedited closure of the glideslope. However, as the high rate of descent was as maintained the aircraft passed through the glideslope at approximately 38 seconds. It was at this time that a right turn to a heading of about 267 degrees magnetic was commenced.
