Crash During a Nighttime Nonprecision Instrument
Approach to Landing
UPS Flight 1354
Airbus A300-600, N155UP
Birmingham, Alabama
August 14, 2013

NTSB/AAR-14/02
PB2014-107898

Aircraft Accident Report

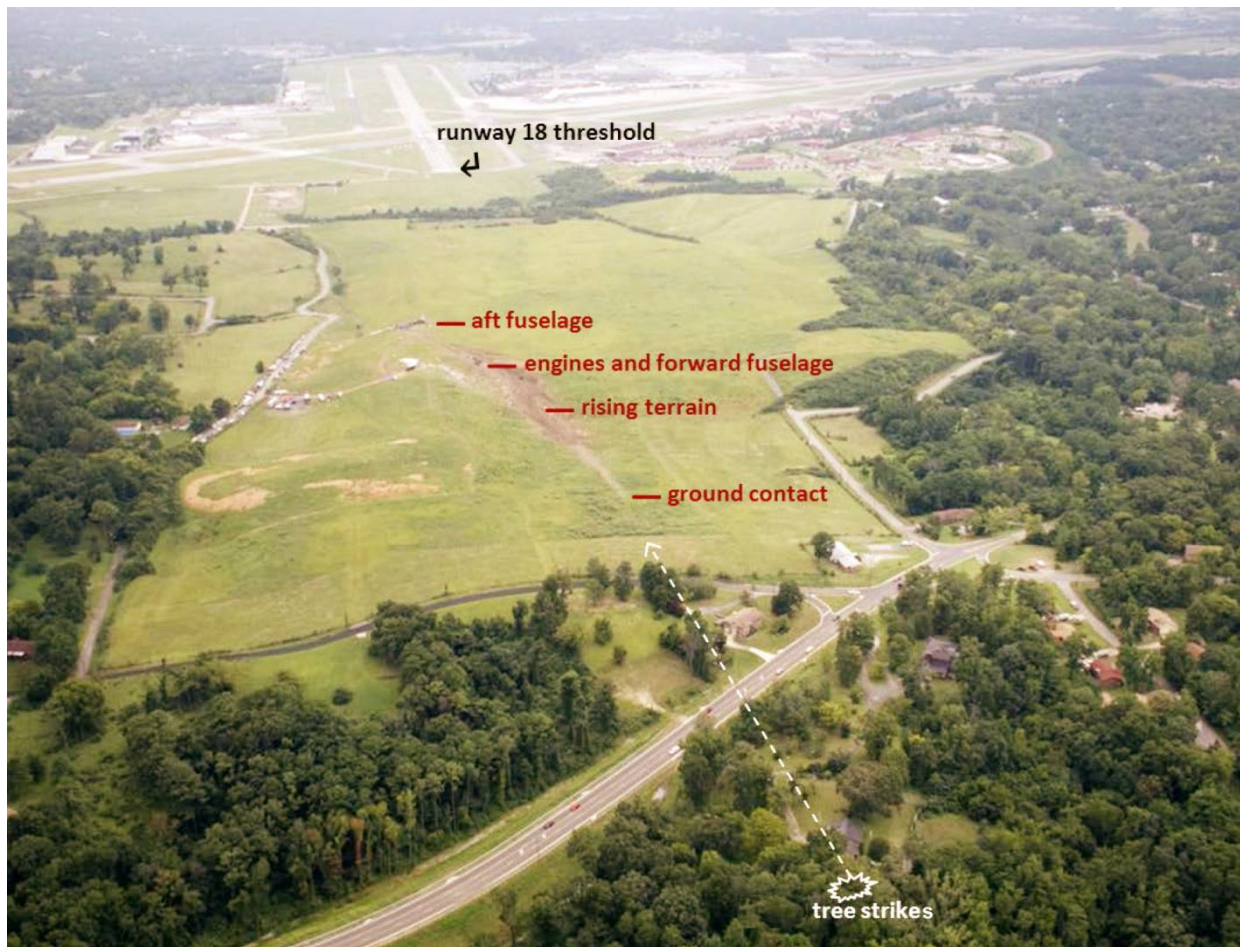
Postaccident examination revealed that the airplane struck several trees and ingested tree debris into both engines during its descent toward runway 18. Pieces of airplane wreckage associated with the initial impacts were found about 1 1/4 miles (mi) north of the runway threshold and consisted mostly of small fragments of left wing, engine nacelle, and engine inlet material. The airplane struck more trees, a power pole, and power lines before it impacted downsloping terrain in a large gulley north of the runway 18 threshold. The debris path continued to the bottom of the gulley and up the adjacent side. Figure 4 is an overhead photograph of the wreckage path.

Figure 4. Overhead photograph of the wreckage path.

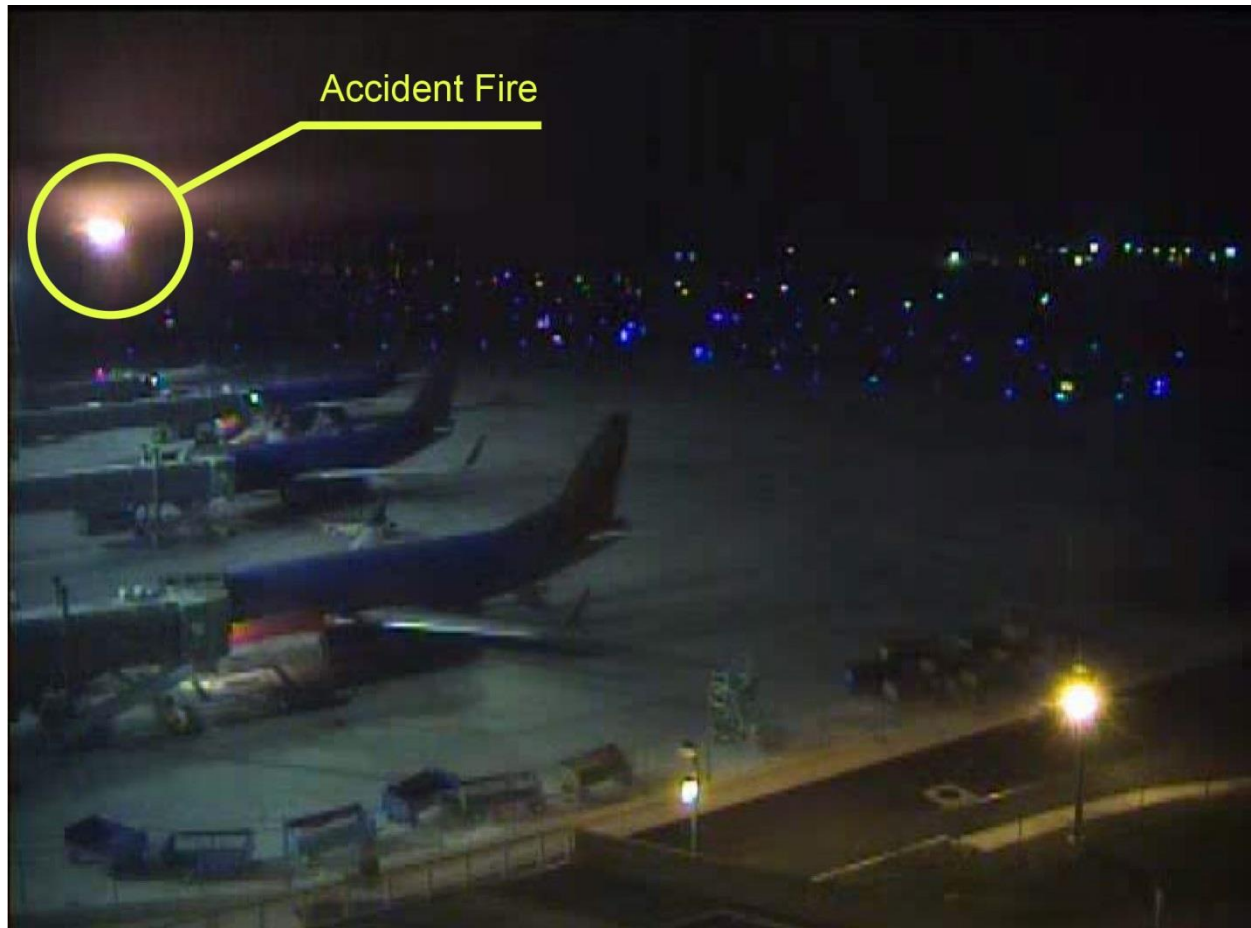
The airplane was destroyed by impact forces and postcrash fire. Images recorded by several surveillance video cameras based at the airport showed the fire associated with the airplane's ground impact and the presence of low clouds above the impact area (see figure 5). The forward fuselage was largely intact; however, the lower portion of the fuselage, especially under the cockpit, sustained severe impact damage. The left wing was highly fragmented. The right wing, aft fuselage, and tail sustained significant fire damage. For additional wreckage information, see section 1.12.

Figure 5. Still-frame photograph from an airport surveillance video camera showing the fire.

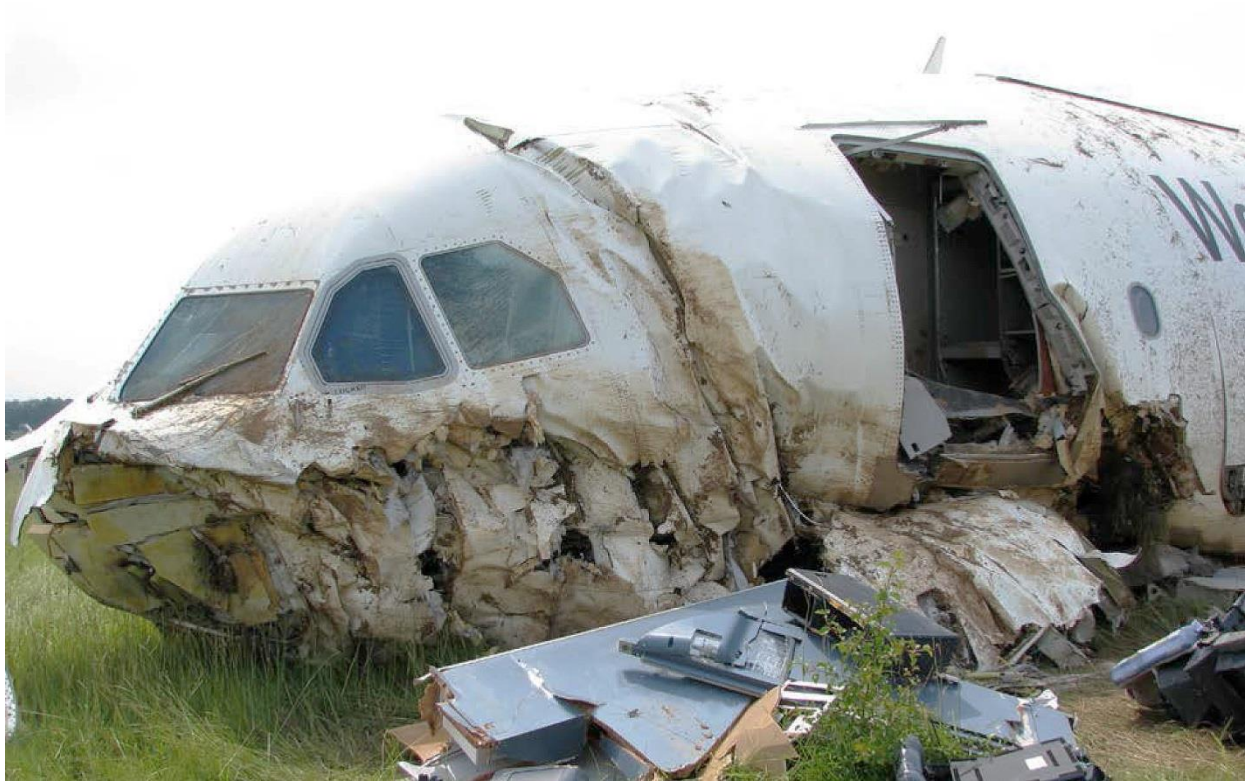
along the intended flightpath to the runway (see figures 13 and 14). The aft fuselage, including the tail section, right wing, and inboard portions of the left wing, were located farther forward, about 3,629 ft from the runway 18 threshold on the downsloping terrain to the runway. The two engines were located within 25 ft of each other about 171 ft west-northwest of the forward fuselage.

Figure 13. Photograph of the left side of the forward fuselage.

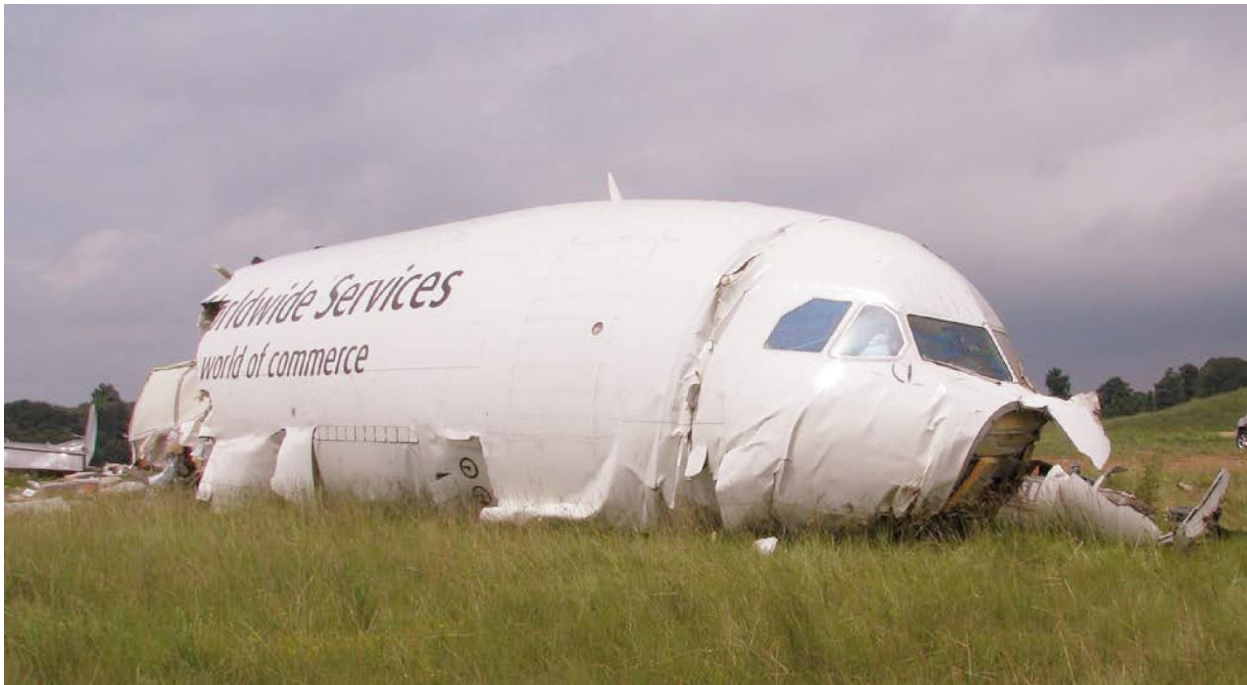
Figure 14. Photograph of the right side of the forward fuselage.

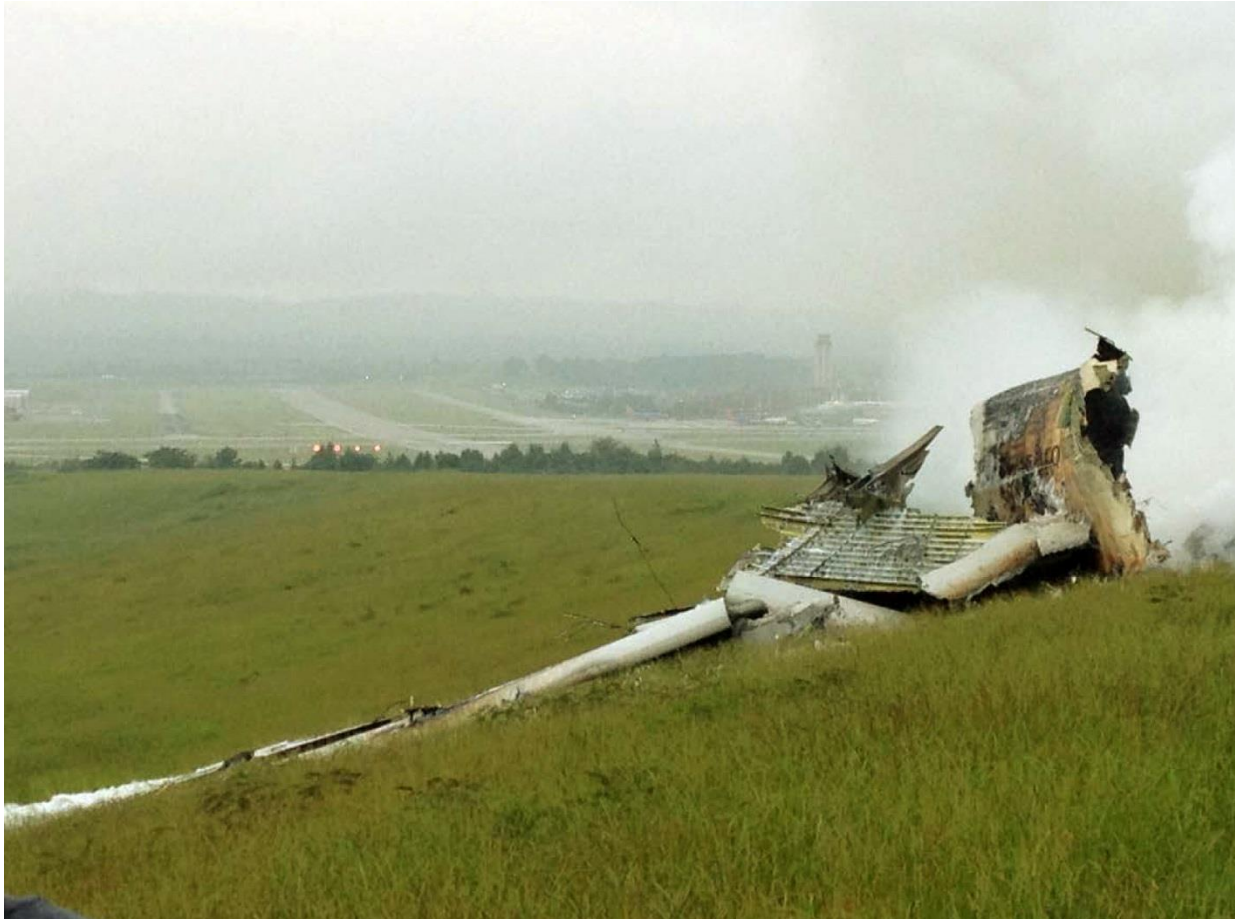
Postaccident examination of the wreckage path revealed extensive ground scarring and a distinct fuel odor from the initial ground impact throughout the debris field. Several pieces of left wing structure were embedded in the dirt starting at the initial ground impact. The first evidence of fire began about 4,636 ft from the runway threshold and continued all the way to the aft fuselage section. An extensive postcrash fire consumed most of the aft fuselage of the airplane (see figure 15 for a photograph of the aft fuselage and the right wing wreckage). No evidence of fire was found on the forward fuselage section. The entire airplane was accounted for at the accident site. Postaccident examination of both engines revealed no evidence of uncontainment or preimpact fire.

Figure 15. Photograph of the aft fuselage and the right wing wreckage, with runway 18 in the distance.

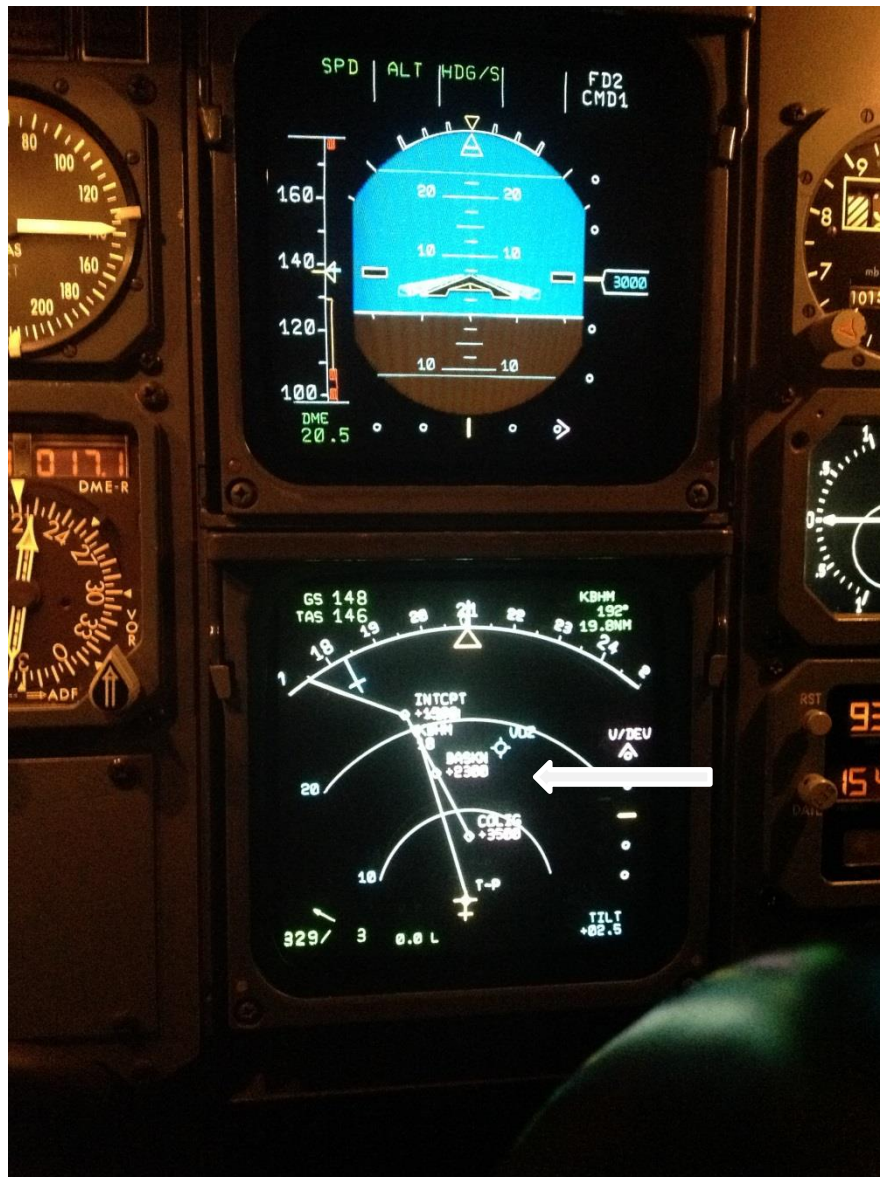
The NTSB conducted simulator testing in an A300 simulator at the UPS training facility on December 4, 2013. During the testing, NTSB investigators entered the accident airplane's decoded flight plan data and the BHM localizer 18 approach into the simulator FMC. The accident flight was simulated from 280 nm north of BHM to the point of impact. The flight plan was consistent with the flight crew navigating directly to KBHM. The localizer 18 approach did not have a feeder route from KBHM; the last waypoint in the active flight plan that the airplane flew while navigating directly to BHM was KBHM. As a result, a F-PLN DISCONTINUITY was created before the first waypoint (COLIG) of the approach and was visible on each of the simulators CDUs (see figure 16). The ND also showed the active routing (directly to KBHM) and the approach routing, as entered in the FMC, with the F-PLN DISCONTINUITY still in the active flight plan (see figure 17).

Figure 17. Photograph of the A300 simulator PFD and ND with the flight plan discontinuity (direct to KBHM) in the active flight plan indicated by white arrow.

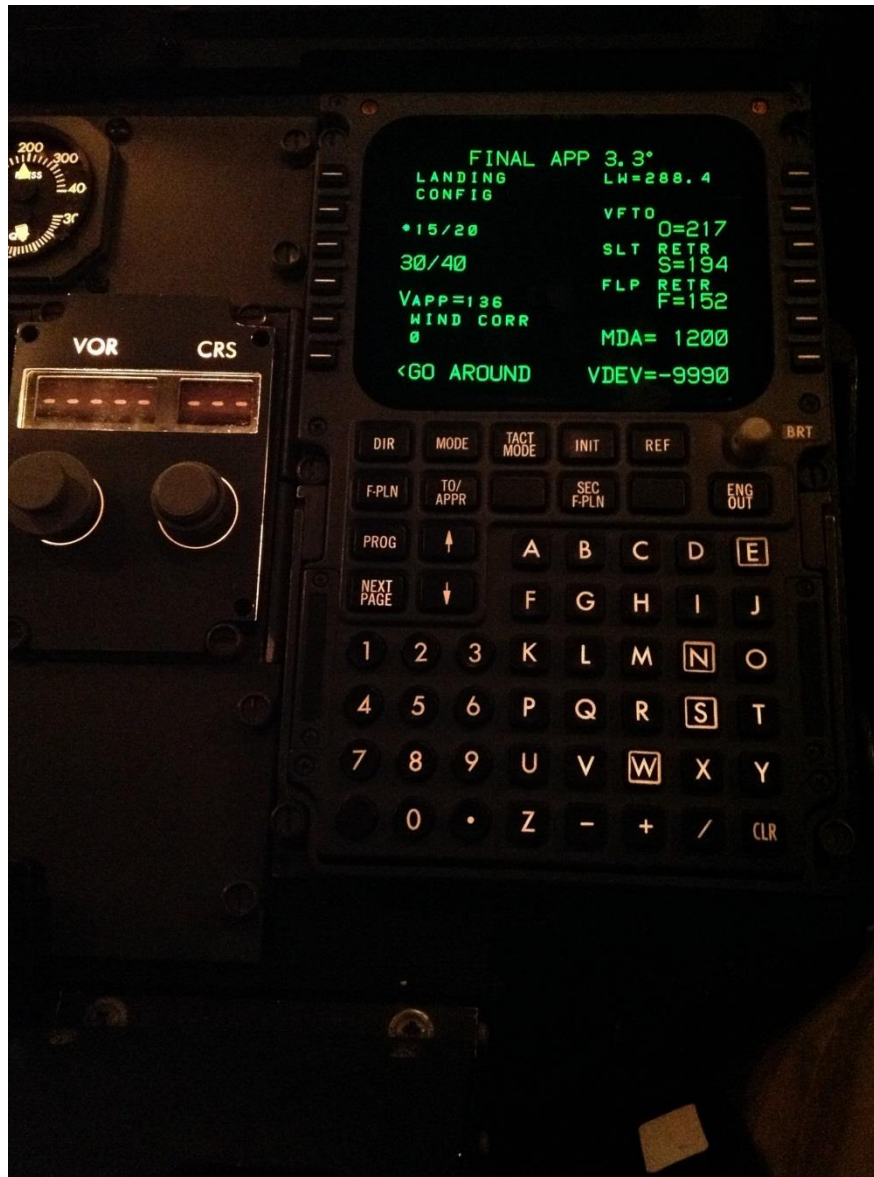
Figure 18. Photograph of the CDU FINAL APP page with the flight plan not verified.
