# CIVIL AIRCRAFT ACCIDENT

Caravelle III HS-TGI

near Hong Kong International Airport

30th June, 1967

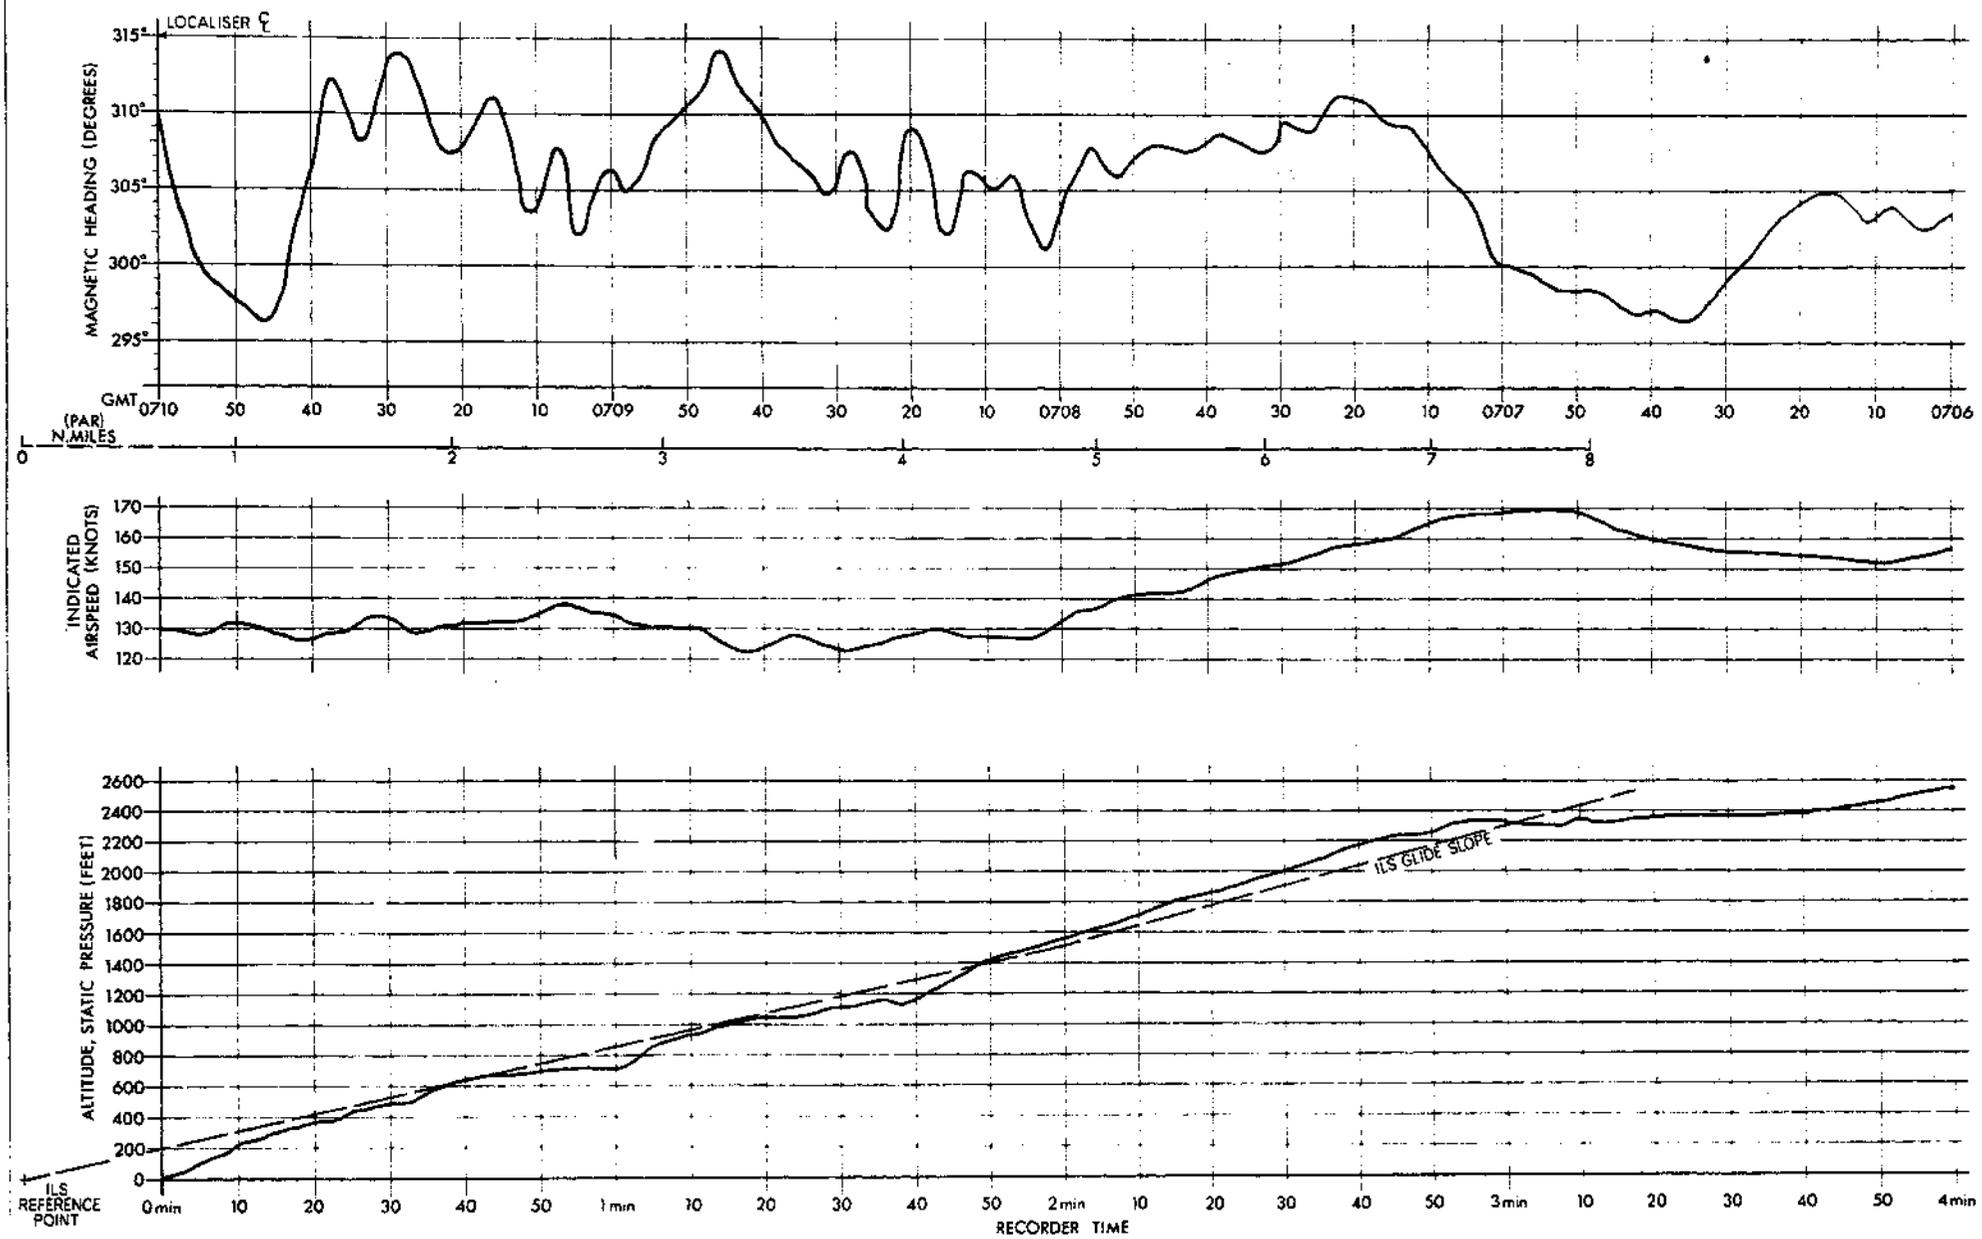
# FLIGHT RECORDER READOUT HS-TGI 30th JUNE, 1967 APPENDIX B1

The flight recorder shows that there was a rapidly increasing rate of descent during the final 15 second period before impact with the sea but

no equivalent increase in airspeed is recorded. Performance calculations indicate that the recorded rates of descent are compatible with those which would have resulted from the final turn if it had been made without fully co-ordinated elevator control. Meteorological evidence suggests that there may have been downdraughts present in the final approach area.
