## Air Canada Flight 624 Accident, Halifax Nova Scotia, 29 March 2015.

### Accident report critique by Capt. Steve Last

## Air Canada 624 Halifax Accident Report Critique - introduction.

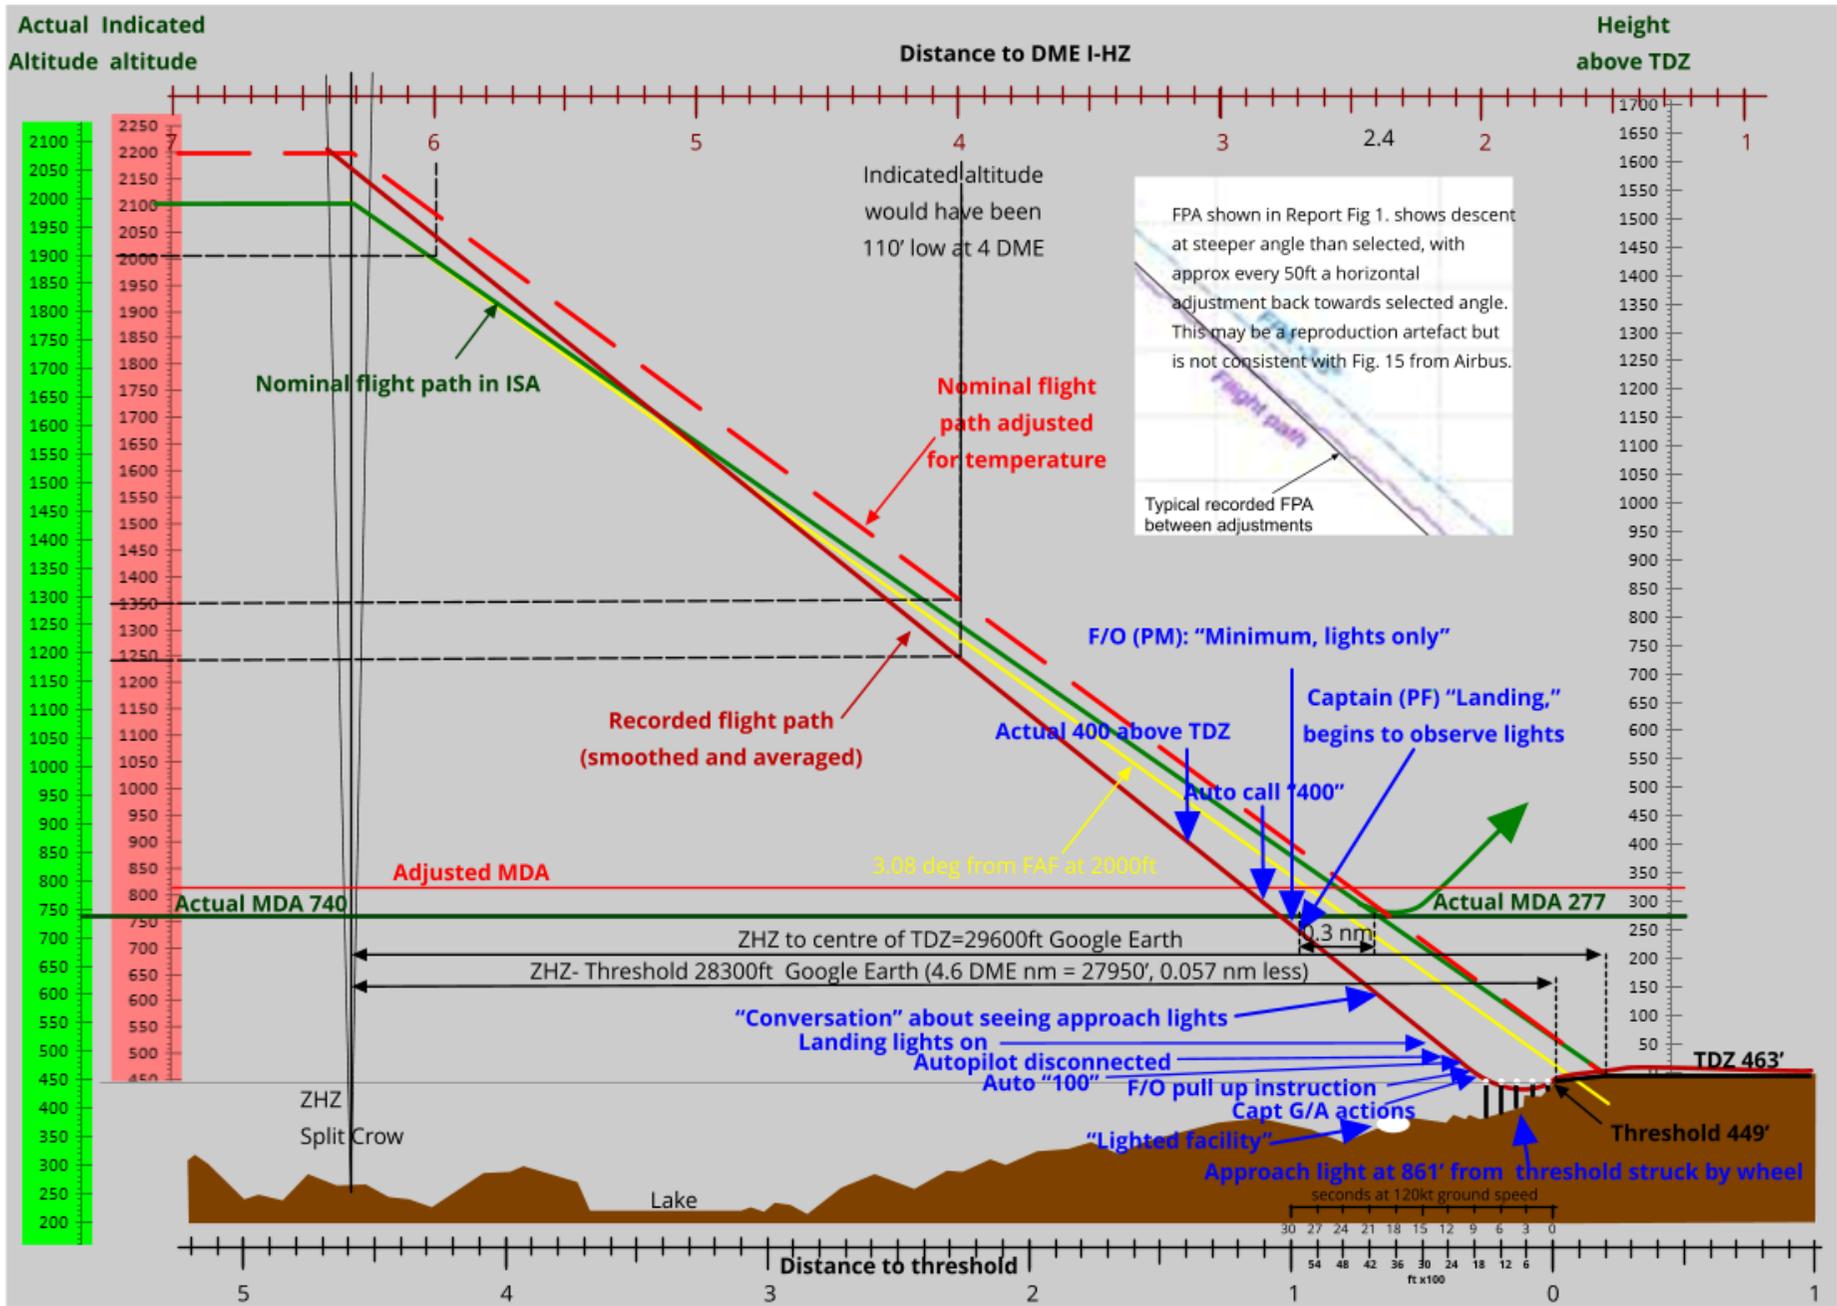
In this accident, none of the pilots' instruments were showing the altitude above the TDZ, which makes it hard to make sense of some of the reported events, so Fig. 1 shows 3 altitude scales.

The Green scale is the ACTUAL height above mean sea level (AMSL). Pink shows what the main altimeters were INDICATING as the height AMSL. The scale on the right shows the actual height above the TDZ, which should have been zero when the aircraft touched down, but was not displayed on any altimeters.

A number of events are shown in blue, the positions are estimates from distances, altitudes or time information in the text or footnotes. The terrain information is obtained from the TSB's press conference presentation correlated with data from Google Earth.

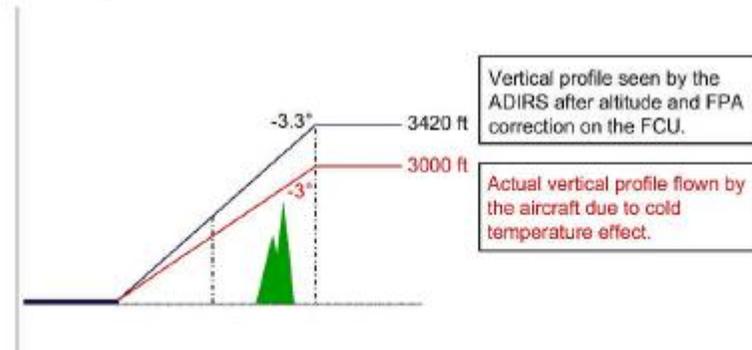
Example

**EXAMPLE** Airport outside temperature -20 °C ; Delta ISA = -35 °C.  
 Approach: FAF at 3 000 ft ; Final descent slope 3 °.

The process reported seems valid BUT the FCTM illustration of this for ISA-35 shows an altitude correction of 420 ft at 3000ft (equivalent to the 160ft calculated above), and the associated FPA change shown is from 3° to 3.3°. (i.e. **-0.3°**). For AC624, at ISA-20 the cold temp correction would be expected to be significantly LESS than for ISA-35, but is calculated here at 0.42° degrees to give a FPA of -3.5°. Thus, the angle in the Airbus drawing appears to be wrong, the horizontal distance for 3000ft at 3.0° is 57,234'. 3420ft altitude produces an apparent VDA of angle of 3.42° degrees not 3.3° as shown, i.e. **-0.42°** correction.

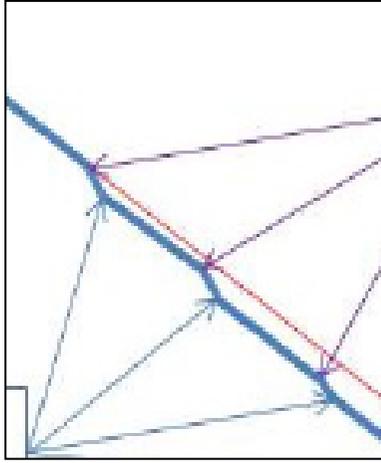
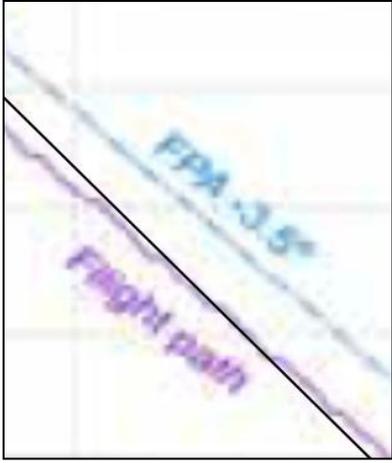
52.	<b>I.18</b>	<b>Additional information</b>	
53.	1.18.2	<p>Flight Path Angle guidance mode</p> <p>When flying with the FPA guidance mode, external perturbations, such as wind variations or turbulence, can cause the aircraft to move away from the selected FPA initial approach path. If these perturbations result in momentary changes to the aircraft's vertical trajectory, then the autopilot will recover the selected FPA, effectively paralleling the initial trajectory</p>	<p>It is understood that Airbus uses the calculation <math>FPA = \arctan(V_{zbi}/GS)</math>, where <math>V_{zbi}</math> = baro-inertial Vertical Speed (inertial for accuracy in dynamic manoeuvres &amp; barometric for stability in time) and <math>GS</math> = Groundspeed. <math>V_{zbi}</math> is computed from <math>V_{acc}</math> (Vertical acceleration from IR), <math>H_i</math> (Inertial altitude from IR) and <math>H_b</math> (Baro altitude from ADR).</p> <p>Report Fig.15 (below left) illustrates the "perturbations" as described by Airbus, showing downward steps away from the initial selected FPA, followed by longer sections returning parallel to it. The printed trace in report Fig 1 (below right) is poor quality but shows the perturbations recorded, which has long sections where the "best fit" lines for the actual flight consistently DIVERGE from the selected FPA, with short horizontal steps back towards it. Without a full FDR readout and knowledge of the FPA algorithm which includes both barometric and inertial inputs, it is impossible to tell what was happening. However, given that no information whatever is provided on the winds experienced during the descent, "external perturbations such as wind variations or turbulence" does not explain the actual</p>

<p>flight path.</p> <div style="display: flex; justify-content: space-around;">
