Australian Government
Australian Transport Safety Bureau

Flight path management and ground proximity warning involving Airbus A330-202 VH-EBV

15 km NNE of Melbourne Airport, Victoria, | 8 March 2013

ATSB Transport Safety Report
Aviation Occurrence Investigation
AO-2013-047
Final – 9 July 2015

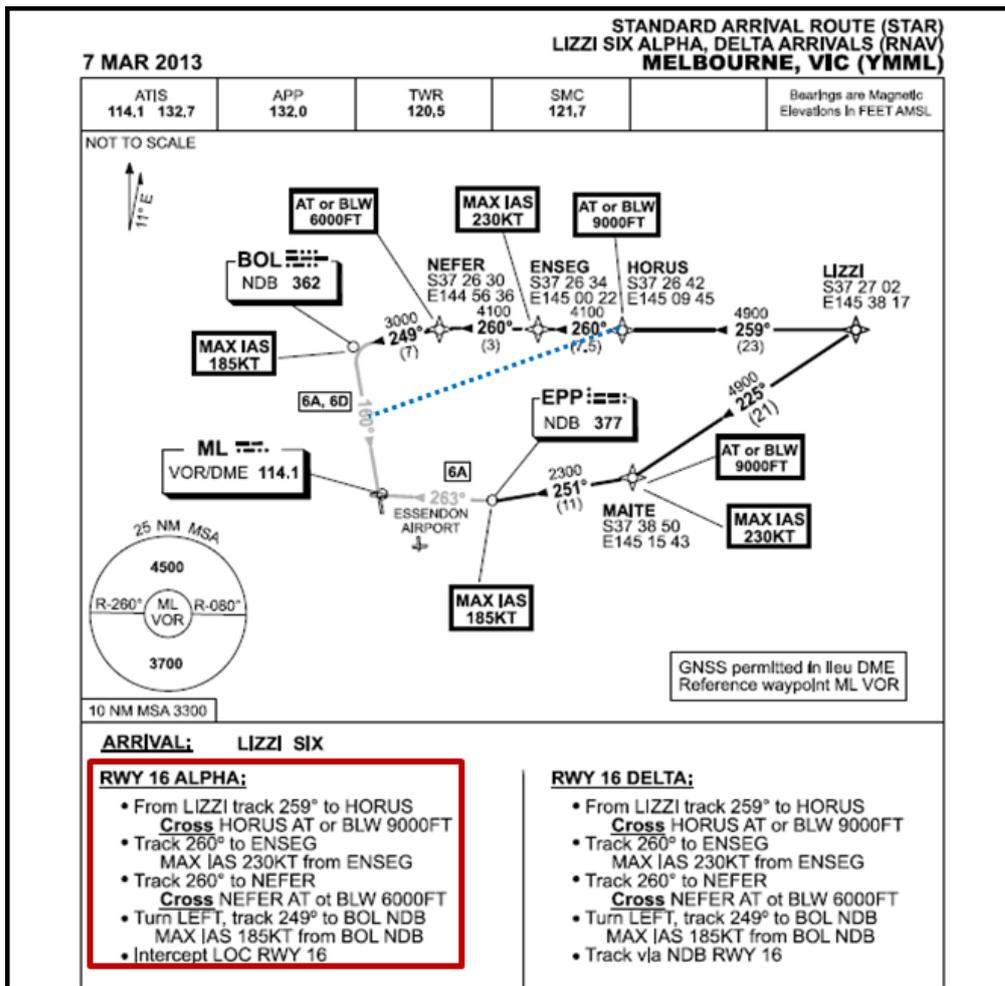
Figure 1: LIZZI SIX STAR chart with anticipated track shortening (blue dotted line)

Prior to top of descent, air traffic control (ATC) cleared the crew to track via the LIZZI SIX ALPHA standard arrival route (STAR) for a landing on runway 16 (Figure 1). The crew programmed the STAR as the active flight plan in the aircraft's auto-flight system. However, based on their previous experience operating into Melbourne Airport, and in anticipation of possible track shortening, they also programmed a secondary flight plan that would track the aircraft from waypoint HORUS to intercept the runway centre-line at the final approach fix (FAF), about 6 NM (11 km) from touchdown (Figures 1 and 2). The crew conducted an arrival briefing that included the potential track shortening, and relevant speed and airspace restrictions.

At 1844, with the aircraft approaching 9,000 ft, ATC cleared the crew to descend to 5,000 ft and offered track shortening from HORUS (Figure 1). The crew accepted an amended track from HORUS to the FAF and activated the secondary flight plan.

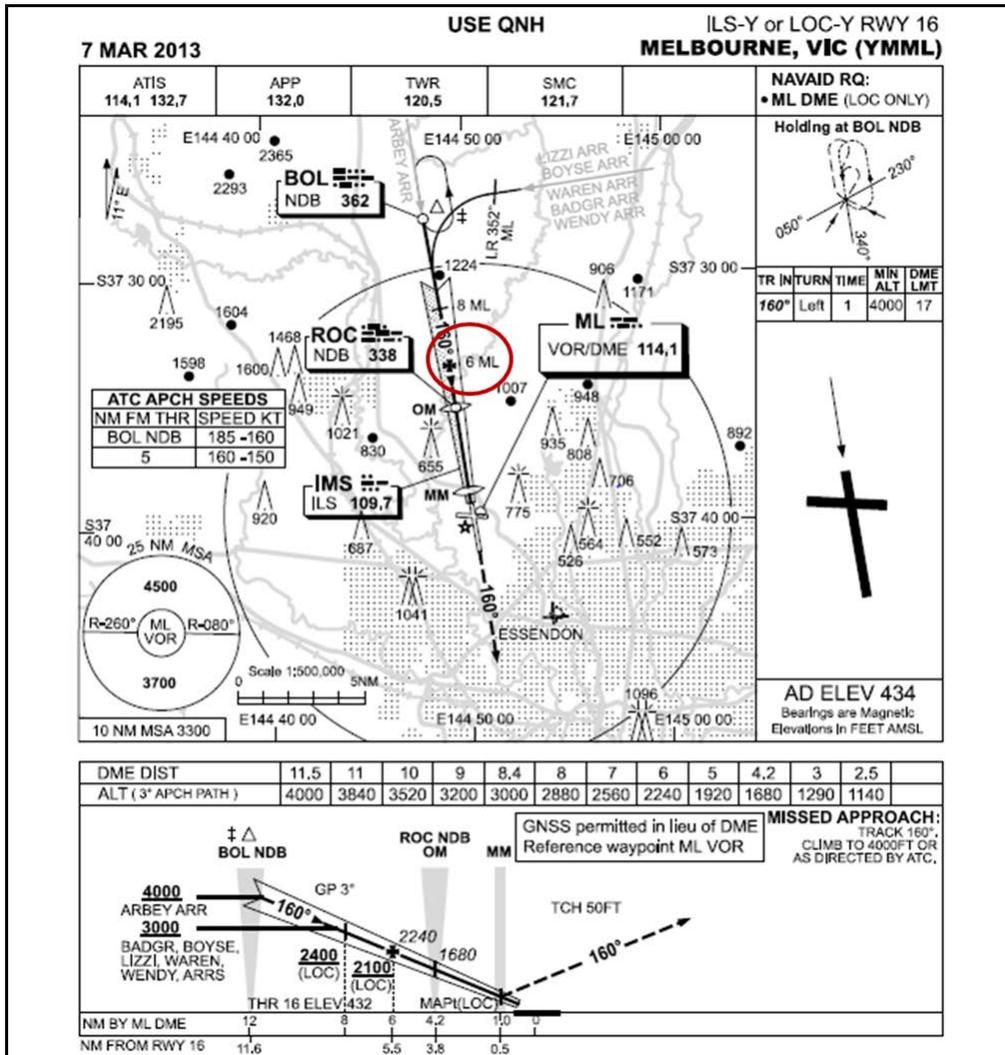
Figure 2: Melbourne instrument landing system chart showing the location of the final approach fix (circled)

At 1848:21, ATC asked the crew if they could accept an additional 2 NM (4 km) of track shortening direct to the Rockdale non-directional beacon (Figure 2). The crew declined that request.

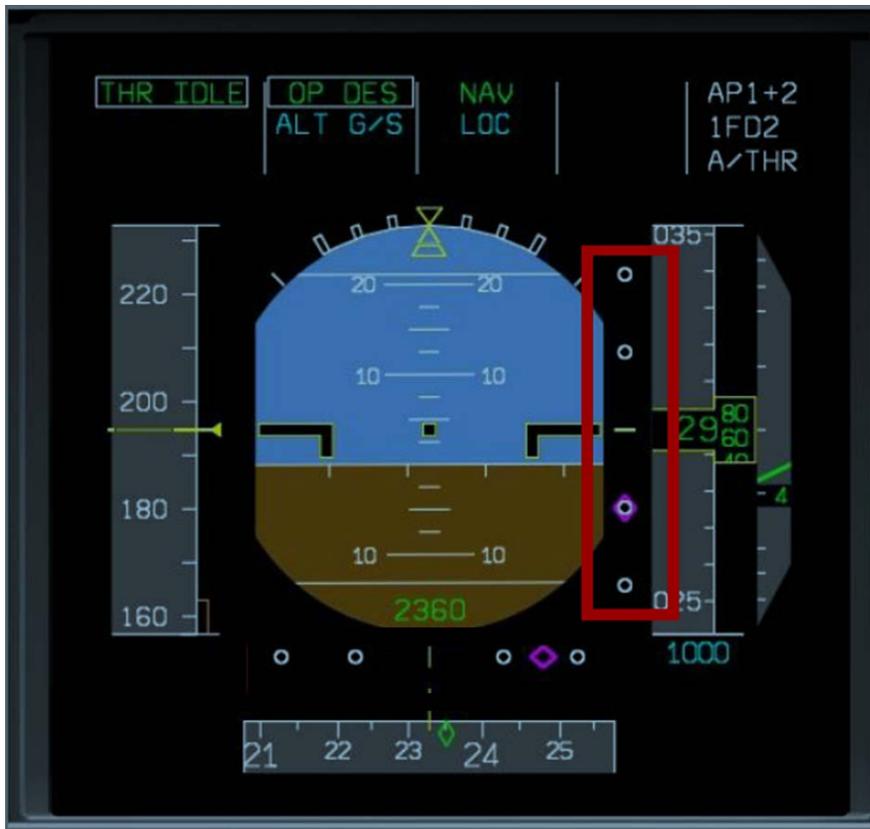
Figure 3: A330 primary flight display with the glide slope indication scale highlighted in red

The captain reported observing the aircraft's instrument landing system (ILS)⁶ glide slope deviation indicator on the primary flight display and that it was indicating the aircraft was above the glide slope. This appeared valid to the captain and was consistent with his earlier assessment of the aircraft being high relative to the track-shortened computed profile. Although other information about the aircraft's flight path was available and the aircraft was not established on the ILS localiser, the captain used the glide slope deviation indicator as the primary vertical flight path guidance.

The A330 is equipped to receive and process the radio signals transmitted from a ground-based ILS facility. When these signals are available, the position of the aircraft relative to a lateral path (localiser) and vertical path (glide slope) to the runway are represented by symbols on deviation scales on each primary flight display (Figure 3).

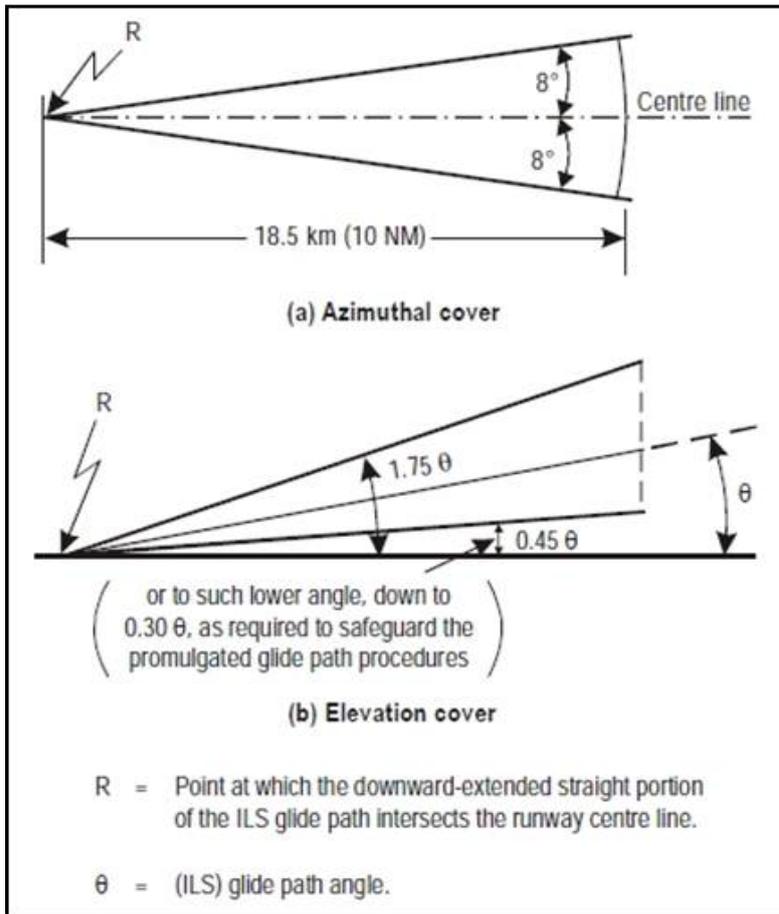
Figure 4: ILS glide slope coverage

The use of ILS glide slope indications when an aircraft was displaced from the approach centre-line was not specifically addressed in the Qantas procedures. However, a note in the standard operating procedures for conducting an ILS approach highlighted the International Civil Aviation Organization (ICAO)-defined envelope where the quality of the glide slope signal ensured a normal capture. This envelope was within 10 NM (18.5 km) and 8° either side of the glide path centre-line, and within a small range of elevation (Figure 4 – diagram not included in the Qantas procedures). The note indicated that when arming the approach well outside of the normal glide slope capture envelope, a spurious glide slope engagement may occur due to a wrong glide slope deviation signal. Whenever a pilot noticed any spurious indications, it was stipulated that the auto-flight system and approach mode be disengaged and recommended that any subsequent rearming of the approach mode occur within the normal capture zone.

The captain observed that the ILS glide slope indications were active and indicating that the aircraft was above the glide slope, which was consistent with his expectation. As a result, the captain considered the glide slope indications to be valid and useful for flight path guidance. Subsequently, the captain focussed on the glide slope without any apparent reference to the other available flight path or profile information.

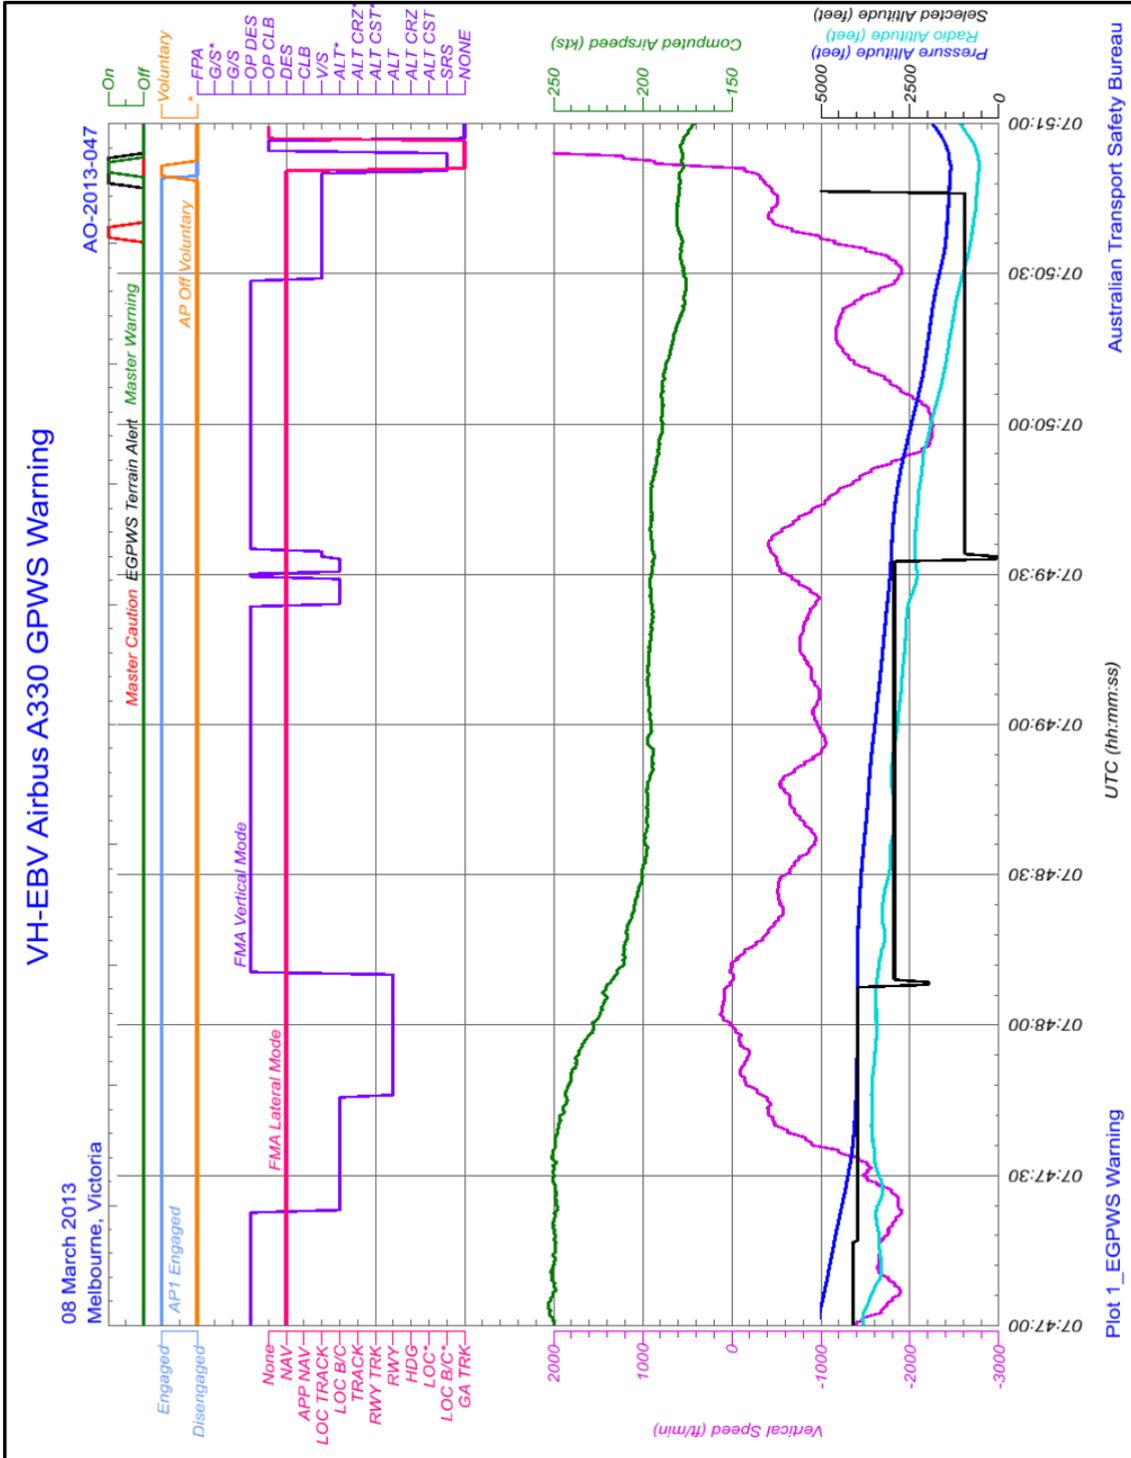
Appendix A –VH-EBV flight data recorder and enhanced ground proximity cautions, alerts and warnings

⁵ The recorded flight data is represented at appendix A.
