**AVIATION INVESTIGATION REPORT
A11H0002**

CONTROLLED FLIGHT INTO TERRAIN

**BRADLEY AIR SERVICES LIMITED (FIRST AIR)
BOEING 737-210C, C-GNWN
RESOLUTE BAY, NUNAVUT
20 AUGUST 2011**

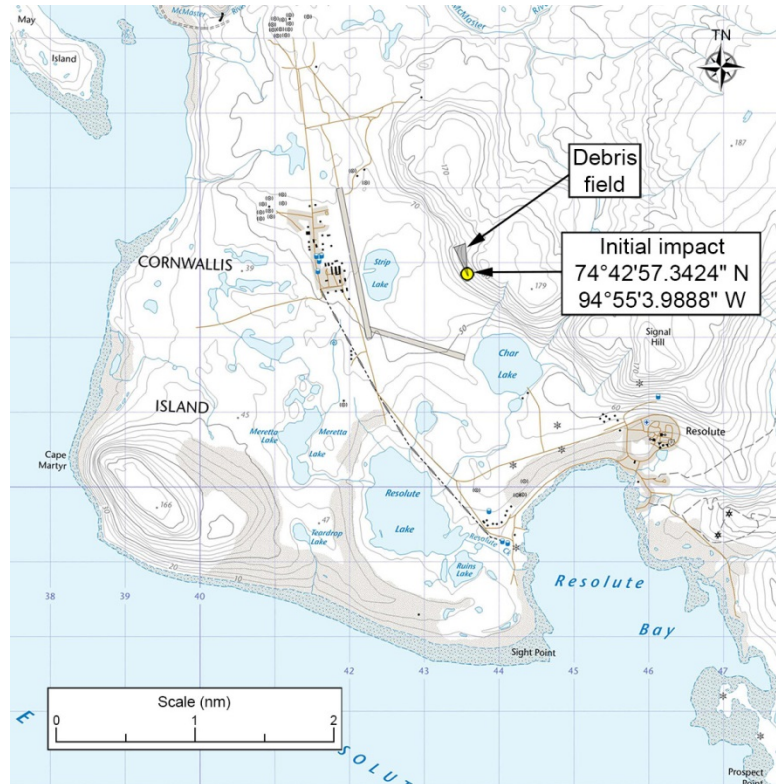
Figure 4. Accident site

The debris trail developed in a NNW direction, following a bearing of approximately 344°T. The debris trail had an overall length of 1400 feet from the point of initial impact to the cockpit. The widest section of the debris trail was about 320 feet. One wheel came to rest at the bottom of the hill east of Strip Lake.

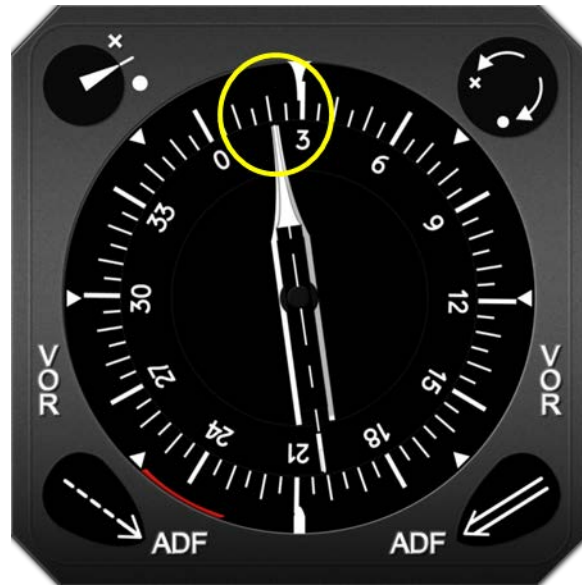
Figure 13. 1625:07: FO RMI (no. 2 compass) showing presumed indications with -8° heading error

On completion of the heading setting procedure, the heading should have been 037°T . The recorded heading was 029° , an error of -8° . At least 2 reasons for this error were possible. First, it is possible that the pilots incorrectly executed the final step in the procedure, setting the bearing to RB NDB, 029° , under the lubber line rather than the head of the ADF pointer. Second, it is possible that the heading setting was affected by inaccuracies inherent to the ADF/NDB system. Either scenario is considered equally likely.

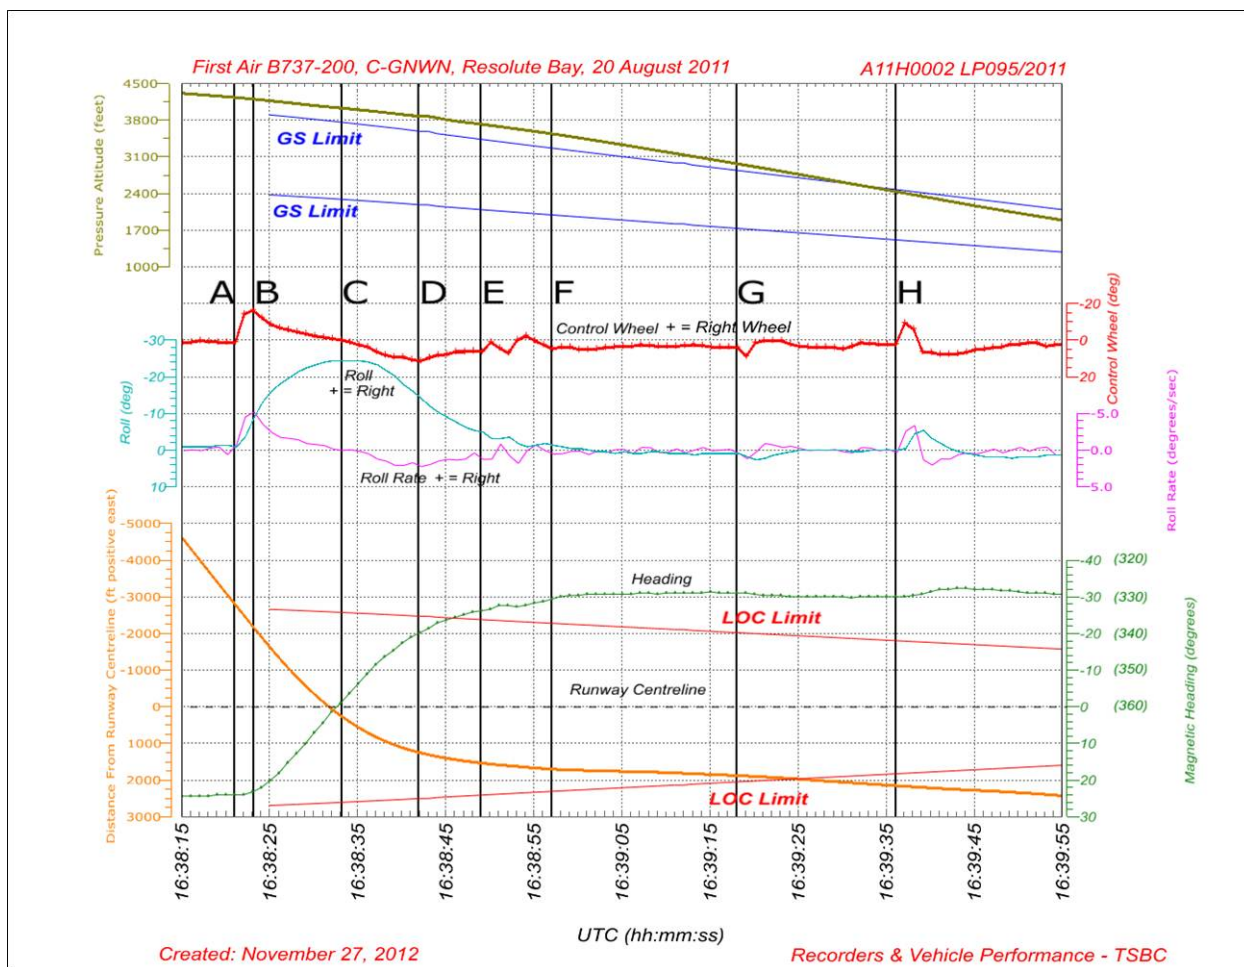
Figure 14. Flight data recorder (FDR) plot showing overview of turn at MUSAT

The curve smoothness of the roll angle plot between points A and E in Figure 14 is consistent with a turn initiated and executed by the autopilot. Control wheel movements made by the pilot would result in a jagged curve for the roll angle plot.

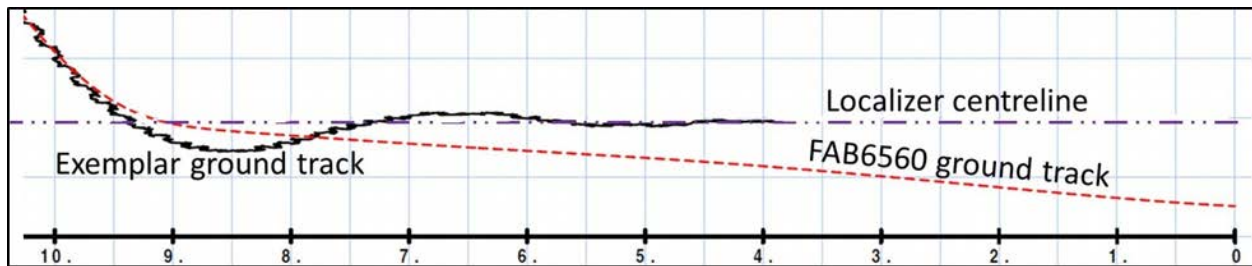
Figure 15. Example of VOR/LOC localizer capture (scale represents miles from the threshold)

At F, the aircraft was approximately 1.5 dots right of the localizer. Had the autopilot remained in VOR/LOC in localizer capture submode, the aircraft should have continued rolling further to the left, to a heading that would provide a suitable intercept angle back to the localizer from the right side. Once the aircraft returned to the localizer, the aircraft should then have turned slightly back to the right, to a heading that would maintain the localizer centreline (Figure 15).

The FDR data show that the CWS roll inputs ceased at 1638:53. At this time, the roll attitude was 1° left bank, and recorded heading was 332°. The aircraft continued rolling, and stabilized at 1° right bank at 1639:05, with the recorded heading of 330°. The compass error was -16°; therefore, the true heading was 346°. During final approach, the wind would have resulted in 3° of right drift. With the wind drift, the resultant radar track of FAB6560 diverged progressively further to the right of the localizer, as shown in Figure 15.

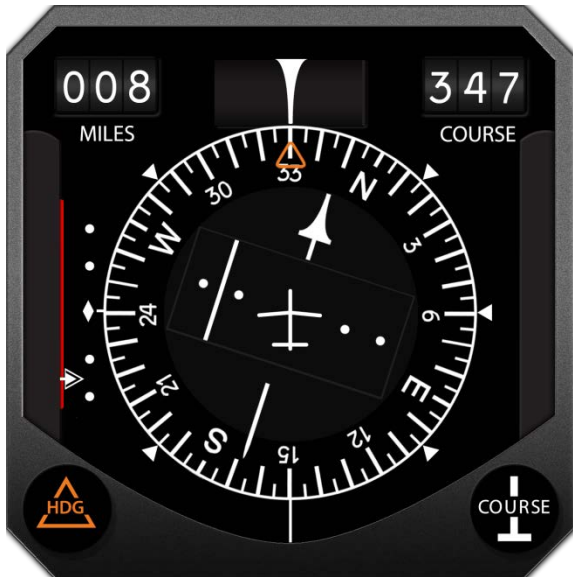
Figure 16. 1639:10: Captain's horizontal situation indicator (HSI), indicating 17° intercept angle (no. 2 compass with -16° heading error)

As shown in Figure 16, the indicated heading of 330° would have given the captain the perception that he had a 17° intercept angle to return to the localizer centreline track of 347°.

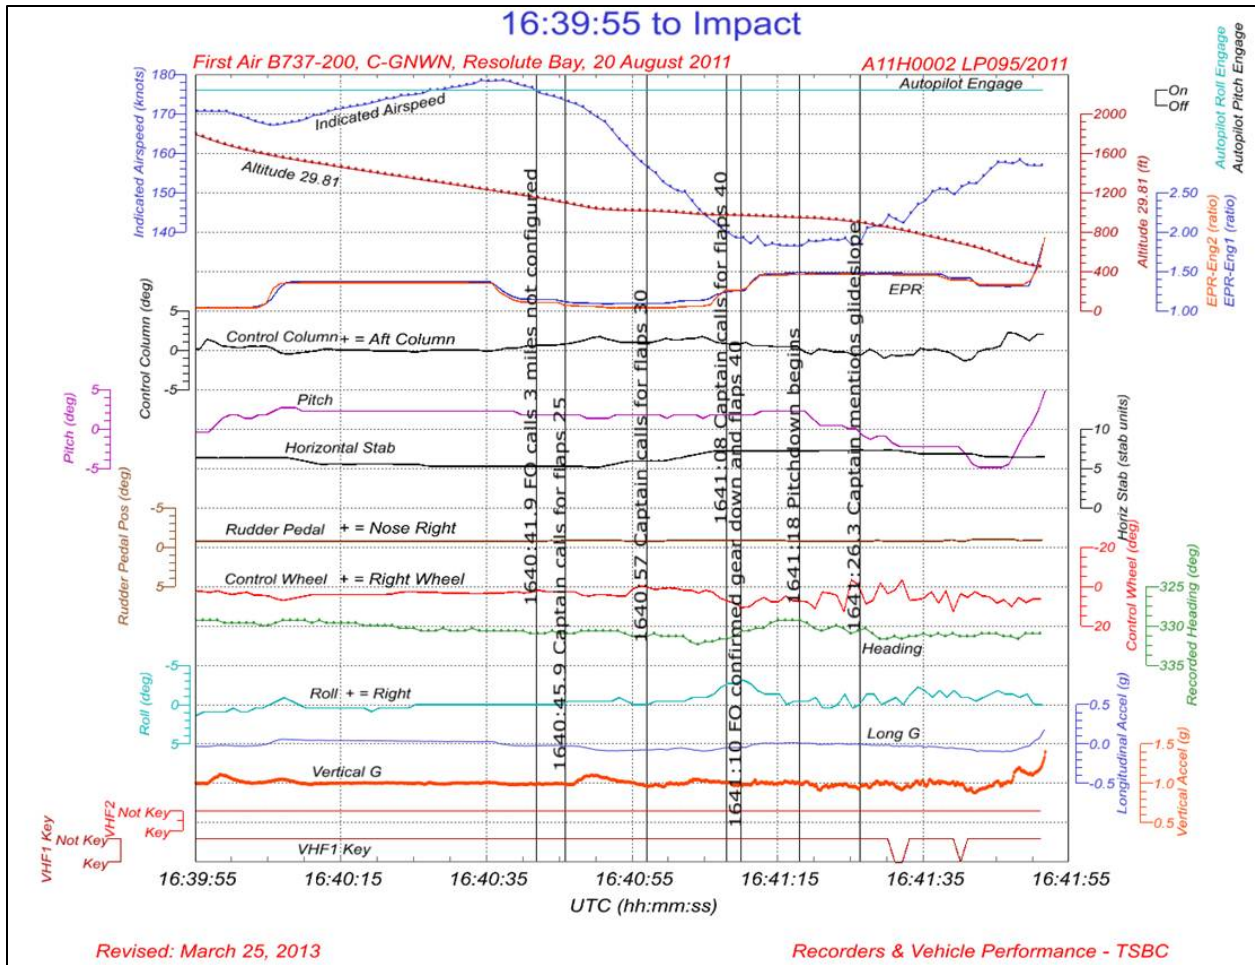
Figure 18. FDR plot of the final approach

At 1640:45.9, the captain instructed the FO to select flaps 25 (Figure 18), and the FO did so. The SOPs required the FO to call out confirmation that the requested flap selection was made, and also a confirmation that the flaps had reached the selected position. However, the FO did not make either of these calls for the flaps 25 selection.
