FINAL REPORT

AAIU Synoptic Report No: 2006-028

Aircraft Type and Registration:	B737-800, EI-DHX
No. and Type of Engines:	Two, CFM 56-7
Aircraft Serial Number:	33585
Year of Manufacture:	2005
Date and Time (UTC):	23 March 2006 @ 18.20 hrs
Location:	Ireland West Airport, Knock, Co. Mayo
Type of Flight:	Public Transport
Persons on Board:	Crew - 6 Passengers - 138
Injuries:	Crew - Nil Passengers - Nil
Nature of Damage:	None
Commander's Licence:	ATPL
Commander's Details:	Male, aged 39 years
Commander's Flying Experience:	7,998 hours (of which 295 were on type) Last 90 days – 261 hours Last 28 days – 62.27 hours Last 24 hours – 5.33 hours
Information Source:	AAIU Field Investigation

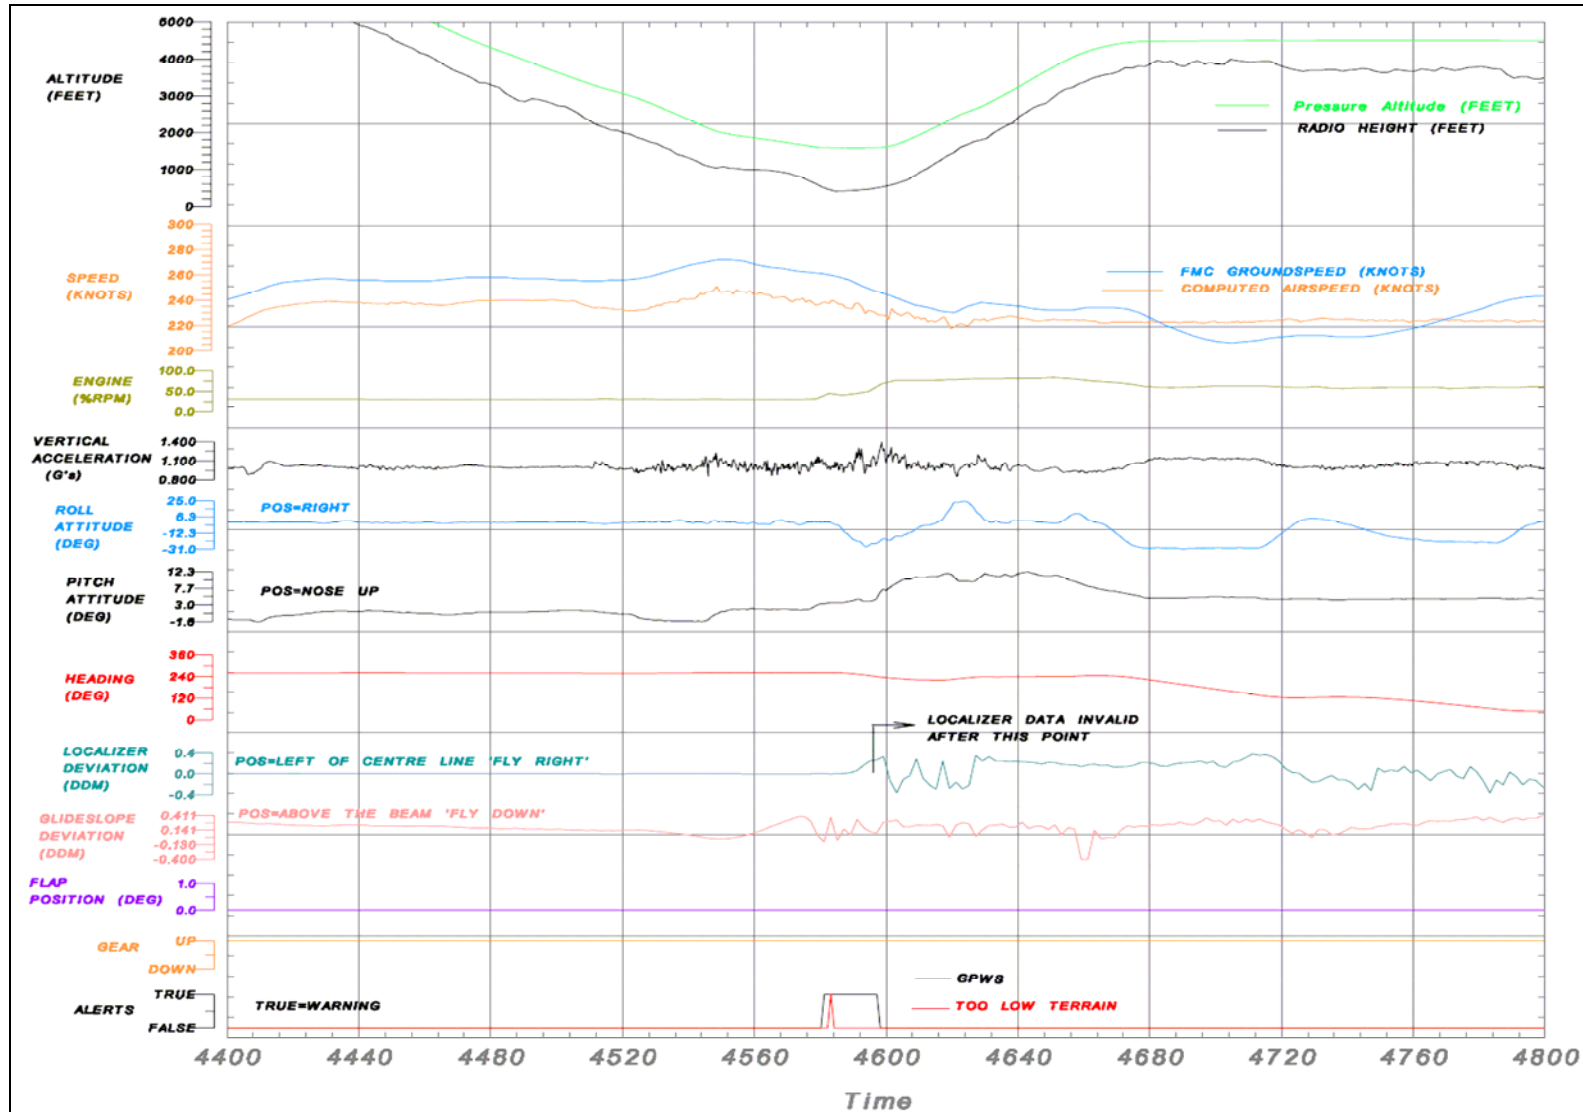
APPENDIX C

Information derived from the Operational Flight Data Monitoring (OFDM) System (**APPENDIX C**) showed that a high energy first approach was carried out to EIKN which contravened many of the Operators Standard Operating Procedures (SOP's), including the non deployment of flaps, landing gear, speed brakes, too high on glideslope (G/S) and culminating in an Enhanced Ground Proximity Warning System (EGPWS) Mode 4A alert, as the aircraft turned port in a Go-around (G/A) non-procedural manoeuvre. The System had triggered a, "*too low terrain*" alert. Mode 4A is active during the cruise and approach with gear and flaps up. It also provides alerting for protection against an unintentional gear up landing.

The Digital Flight Data Recorder (DFDR) derived data from this event was recorded on the Operators OFDM System. OFDM is defined as the systemic, pro-active and non-punitive use of flight data from routine operations to improve flight safety. This fully functioning programme forms an integral part of the Operators Safety Management System and is compliant with the Recommendations of JAR OPS 1.037. In practice, data that is produced during a flight is transmitted from the aircraft after each flight. This data is replayed on a ground-based computer using specialist software. Selected parameters and their associated trigger levels are aligned with the Operator's SOP's. (Full DFDR and Cockpit Voice Recorder (CVR) data had been copied over by the time the AAIU was notified of the subject event). The OFDM data is not a complete set of the data available, in that many DFDR parameters are not available in the OFDM data. Thus, the full analysis of events is restricted by the non-availability of the full DFDR data.
