Air Accident Investigation Unit Ireland

FORMAL REPORT

ACCIDENT
Fairchild Aircraft Corporation
SA 227-BC Metro III, EC-ITP
Cork Airport, Ireland
10 February 2011

AAIU Report No: 2014-001
State File No: IRL00911013
Report Format: Formal Report
Published: 28 January 2014

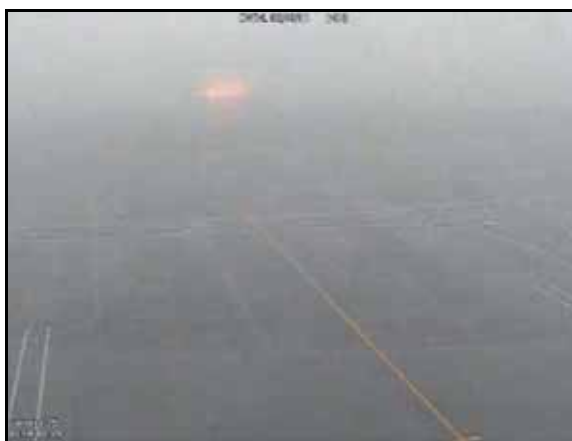
Photo No. 2: Initial flash fire

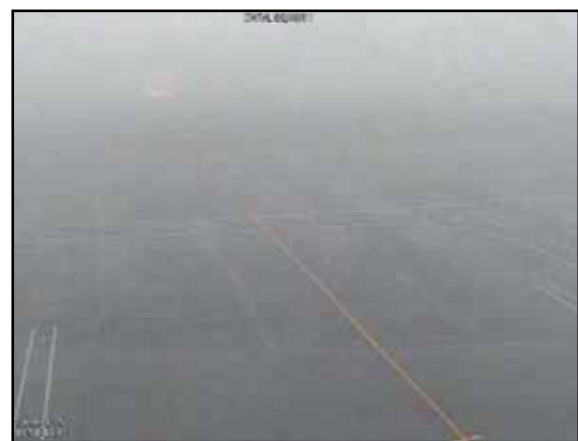
Photo No. 3: Second flash fire

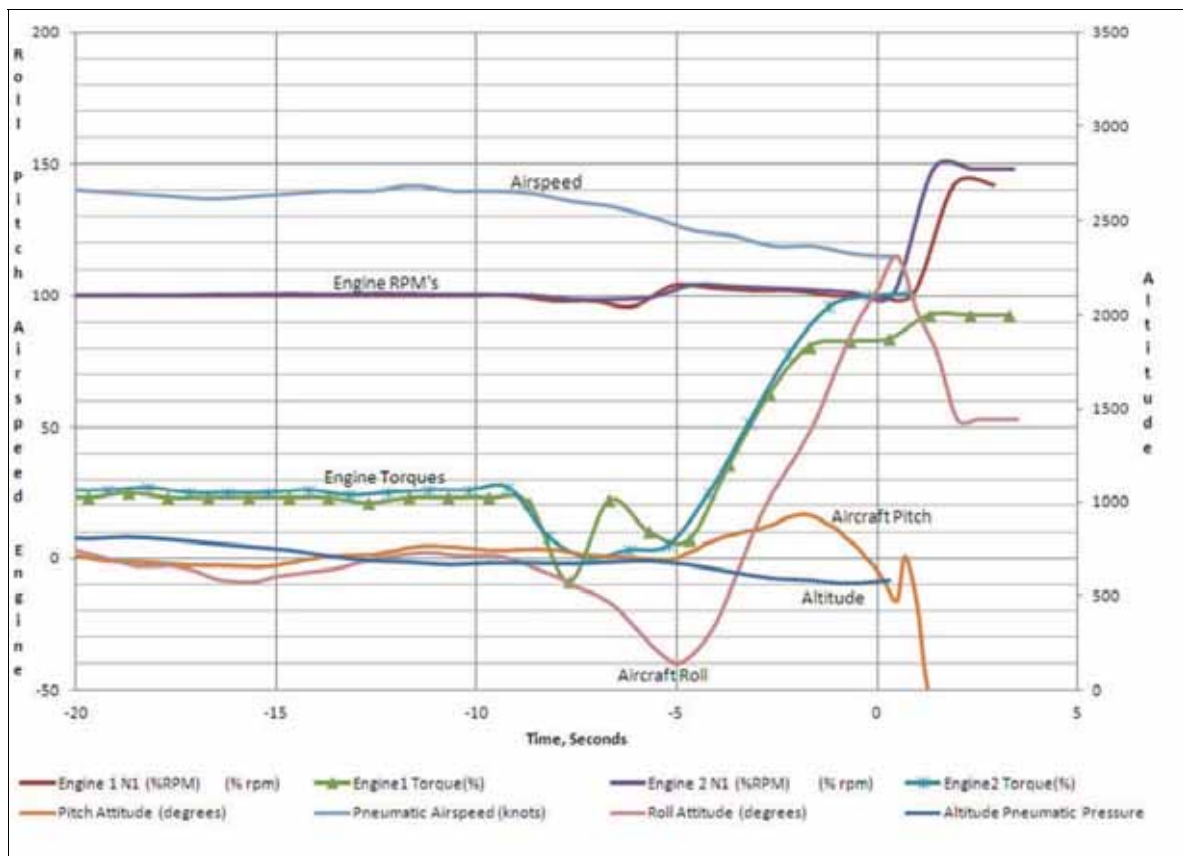
The graph in **Figure No. 5** shows the final 20 seconds of relevant parameters recovered from FDR data. Aircraft heading, not shown for clarity, was consistent with the roll readings. Until approximately 9 seconds before impact, the indicated airspeed recorded by the FDR was consistent with engine power settings and expected aircraft performance. The first significant event was a reduction of delivered engine torque from both engines, commencing approximately 9 seconds before impact, accompanied by a decrease in airspeed.

Figure No. 5: FDR data for final 20 seconds of recording

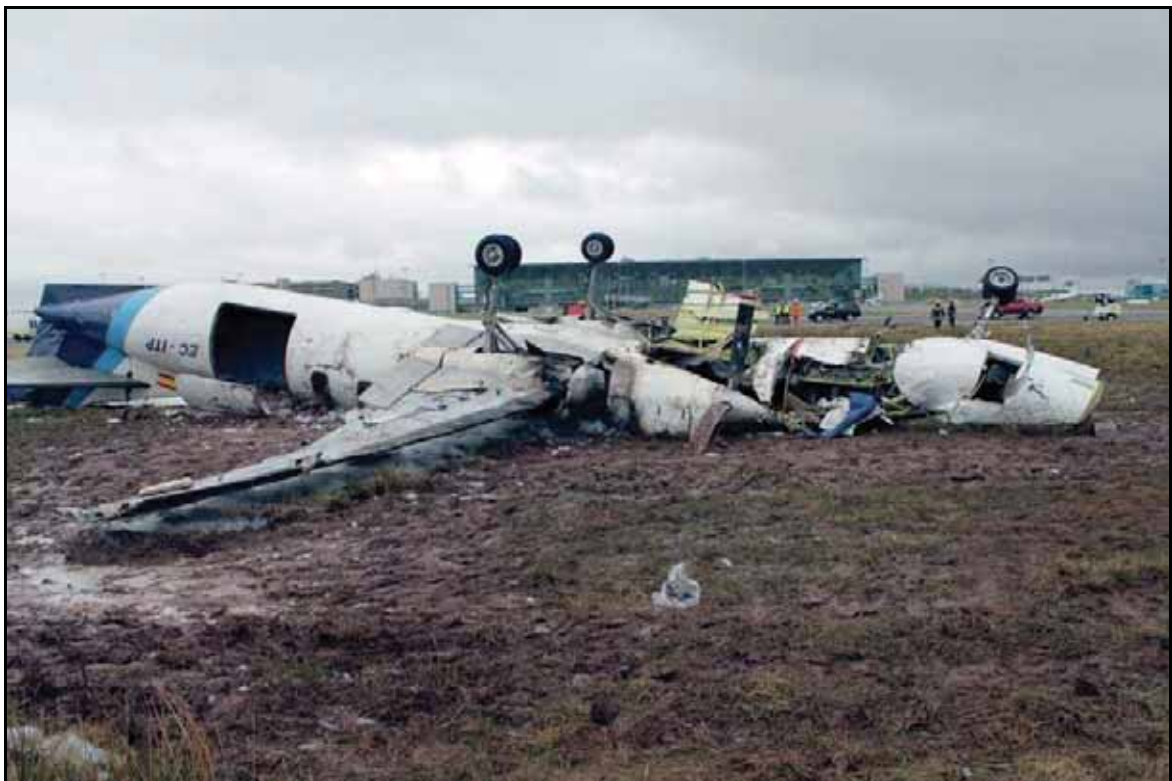
The aircraft wreckage was found in an inverted position, 189 m from the initial contact point and 72 m to the right of the runway centreline. All three landing gear legs were extended and undamaged. The forward fuselage was severely crushed; fire and impact damage occurred to both engines (**Photo No. 4**).

Photo No. 4: Final resting position of EC-ITP

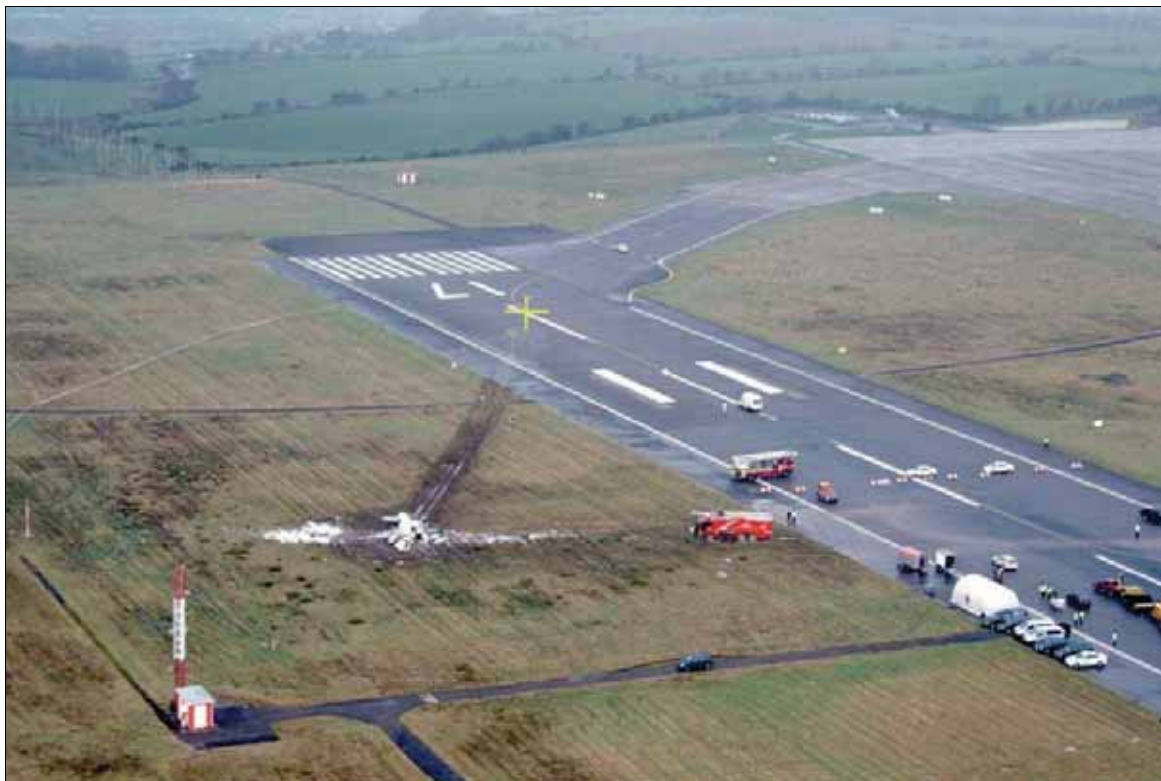
Photo No. 5: Point of initial wingtip contact (identified by the yellow reference mark), debris trail and final position of wreckage

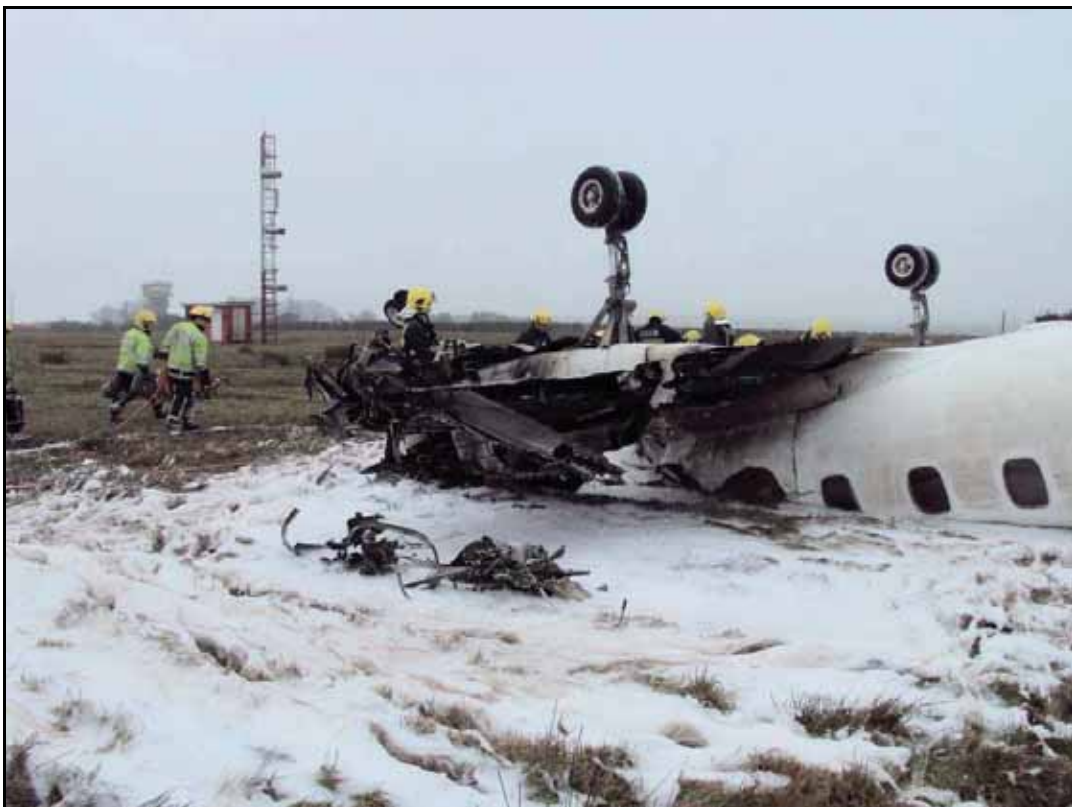
The portion of right wing and flap that remained attached to the fuselage ended several feet outboard of the right engine nacelle. Damage to the right wing had three distinct visible areas; the outboard section, the mid-section and the leading edge. The remnants of the wing attached to the nacelle had extensive fire damage (**Photo No. 6**). The structure had broken downwards at the outer end of the fractured wing.

Photo No. 6: Damage to right wing

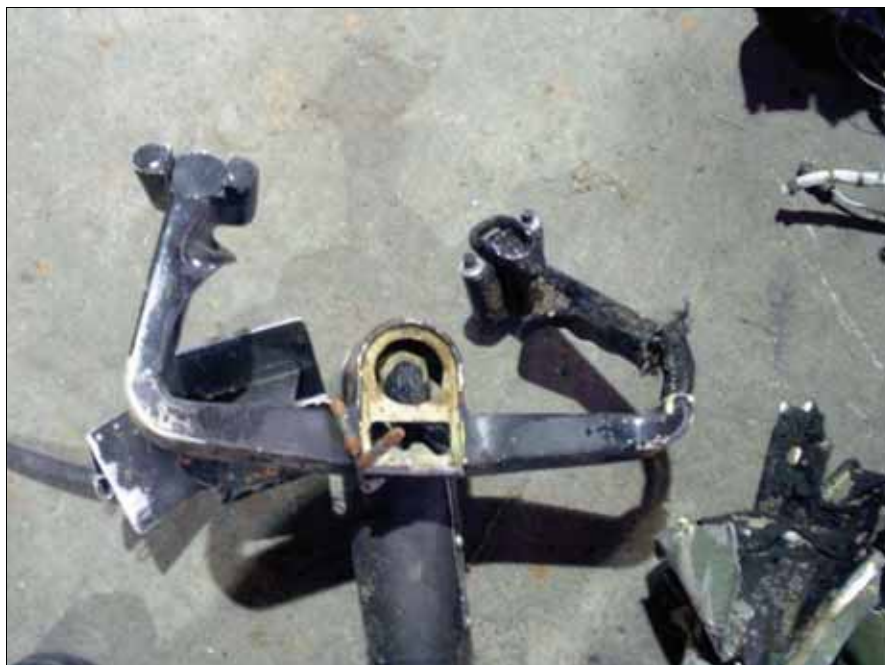
Photo No. 7: Co-pilot control wheel showing fracture of right-hand control grip

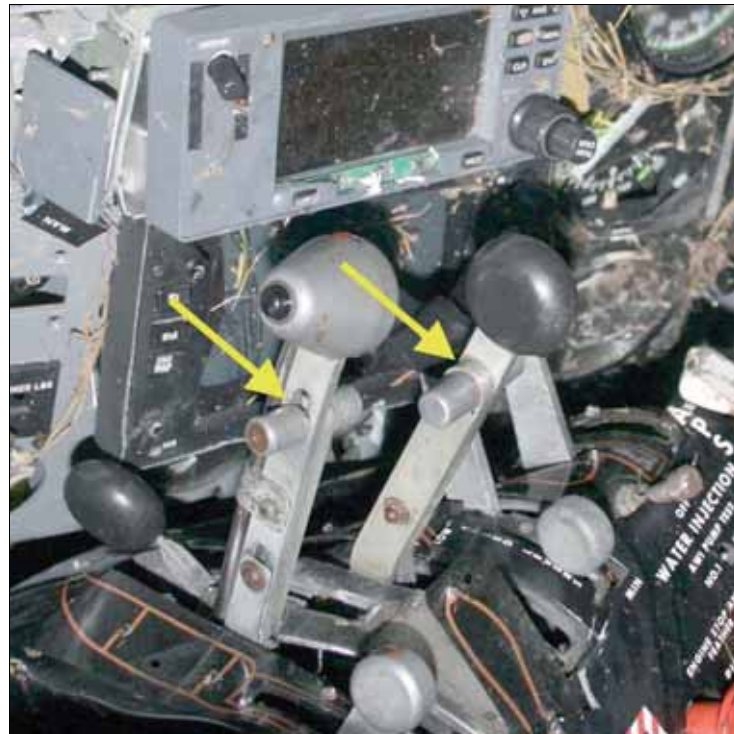
The engine control quadrant and control linkages were damaged by impact. As a result of this damage, the power levers and speed (RPM) levers were restricted in movement. The left Beta latch lever was found in the normal (down) position. The right Beta latch lever was found in the raised position (**Photo No. 8**). Both power levers were bent to the right. When the levers were straightened with minimal pressure, both mechanisms functioned correctly.

Photo No. 8: Left and Right Beta Latch lever positions

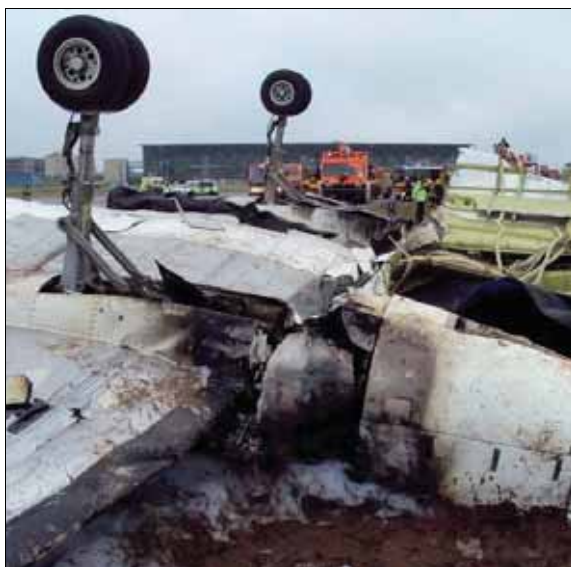
Photo No. 9: Left Engine Fire damage

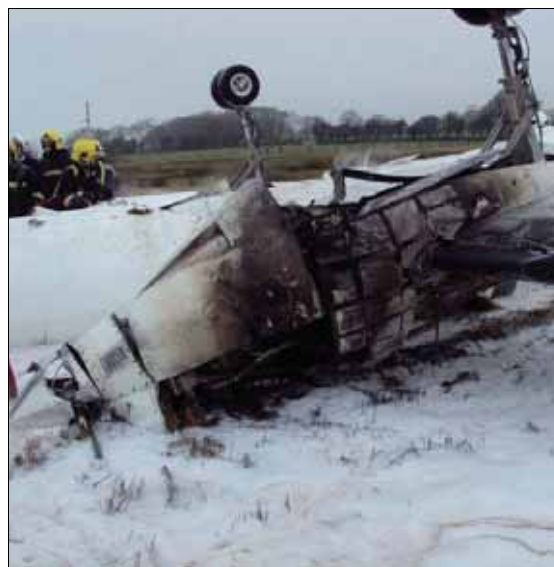
Photo No. 10: Right Engine Fire damage

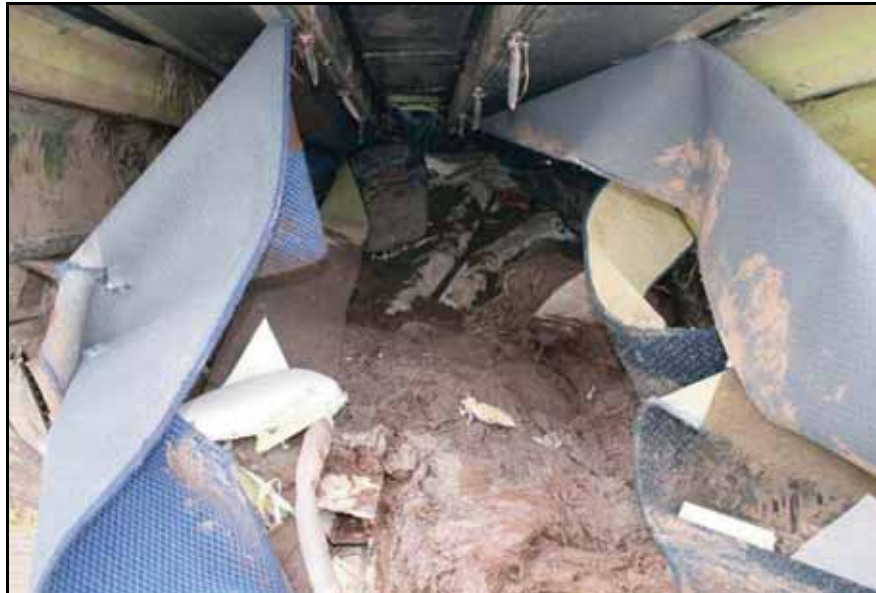
The cockpit and forward cabin were severely crushed in the impact, thus greatly reducing the volume of survival space. Furthermore, the opening in the upper fuselage allowed large amounts of soil to enter the forward cabin as the aircraft transited the grass area (**Photo No. 11**).

Photo No. 11: Forward view of inverted passenger cabin following rescue operation

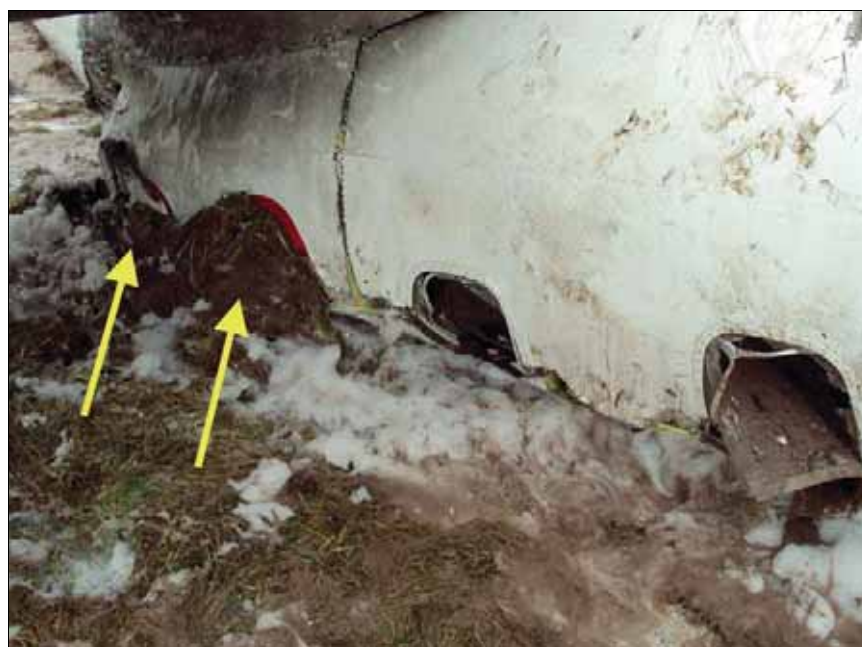
The AFS could not gain entry into the aircraft by normal means as the passenger door at the front left of the fuselage was severely crushed and could not be opened. The three emergency exits in the cabin were unusable due to crushing and were also blocked with soil from inside the cabin (**Photo No. 12**).

Photo No. 12: Starboard Emergency Exits

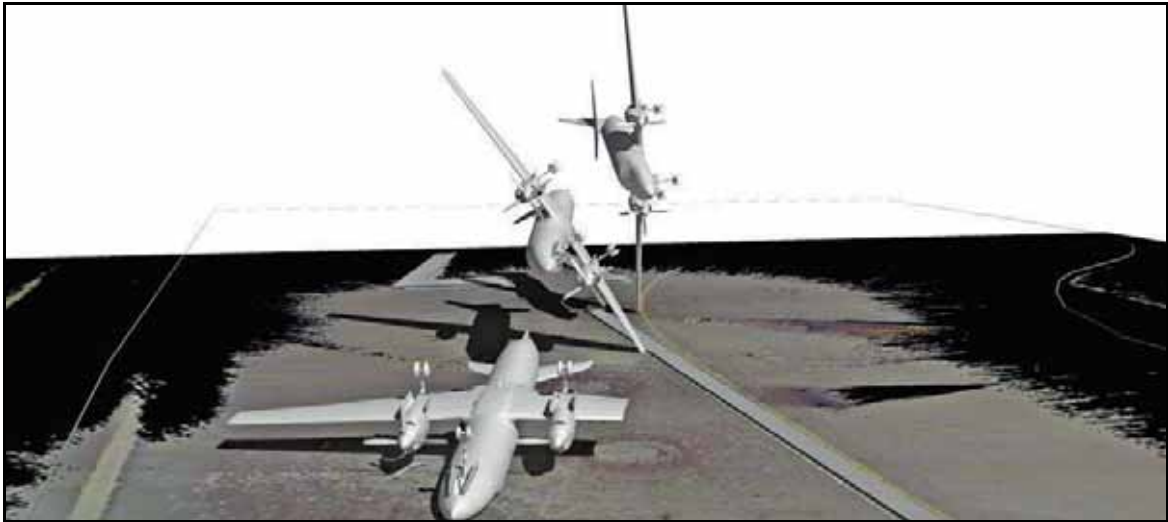
Impact evidence showed that the aircraft first contacted the runway surface with the right wingtip. At that moment the aircraft was at a roll angle of 97 degrees to the right, following which it continued to roll right, impacting the runway surface in an inverted position (**Graphic No. 5**).

Graphic No. 5: Reconstruction of initial impact sequence

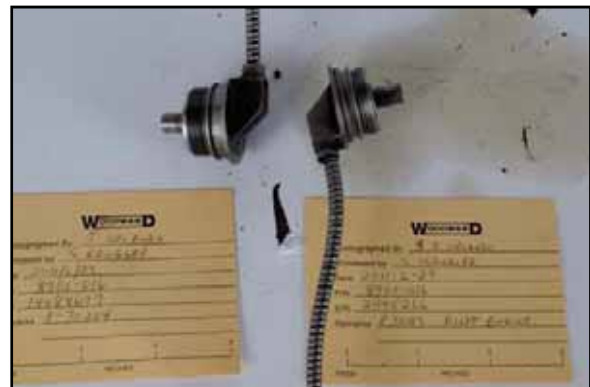
Photo No. 2:

According to the component manufacturer, the P_{T2}/T_{T2} Sensor was produced in August 1999 and was not returned to the manufacturer for any subsequent maintenance. The P_{T2}/T_{T2} sensor bellows displacement was measured using measuring tool WT-51467 # 1 (**Photo No. 1**). The height of the bellows was measured from the inside of the outer flange to the center of the bellows stem measured was 0.947 inches at a room temperature of approximately 75°F (specification is 1.023 ± 0.002 inches at 75°F). This is consistent with the sensor reading a lower temperature value than actual. The height of the bellows being considerably shorter than required would be consistent with a breach within the system (**Photo No. 2**).

Bellows height comparison

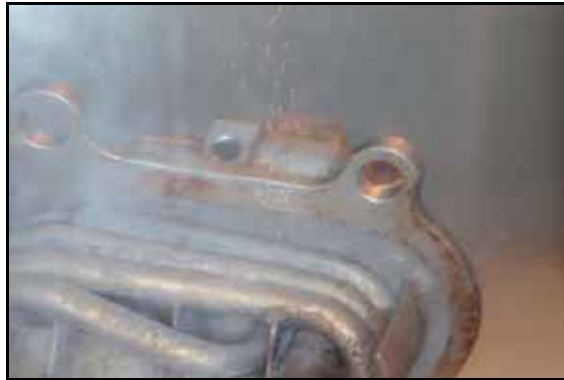
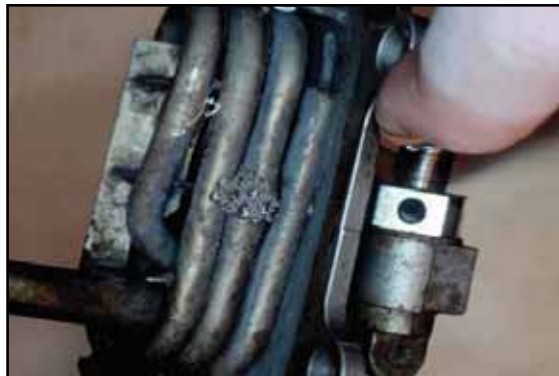
No leak (bubbles) was noted coming from the bellows but a streak of bubbles was noted coming from the sensing tube (**Photo No. 4 & Photo No. 5**). The sensing tube was marked where the bubbles appeared to have been coming from (**Photo No. 6**). Additional examination will be needed to determine the exact location and cause of the breach.

Photo No. 4: Sensing tube leak

Photo No. 5: Sensing tube leak

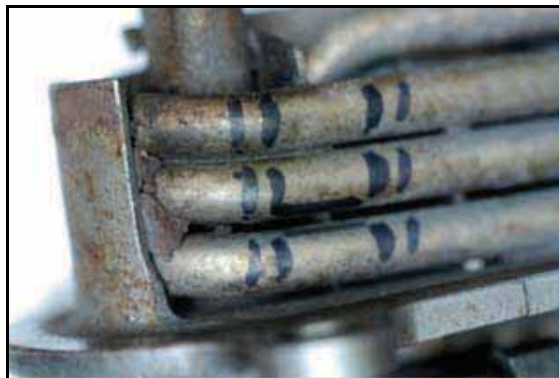
Photo No. 6: Possible sensing tube breach location

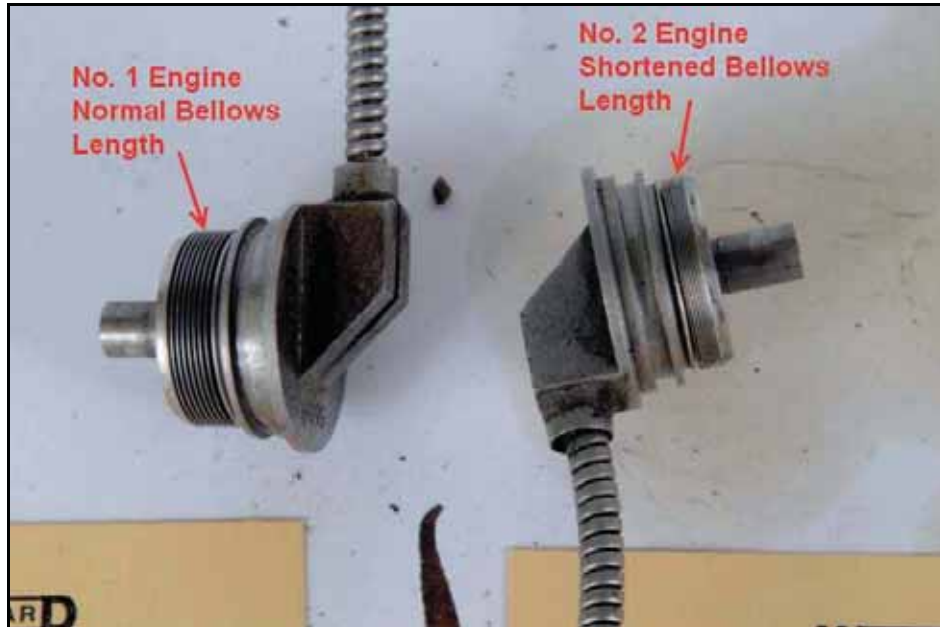
The length of the No. 2 engine bellows being considerably shorter than specified is consistent with a breach or leak within the system.

Photo No. 1: P_{T_2}/T_{T_2} sensor bellows from No. 1 and No. 2 Engines

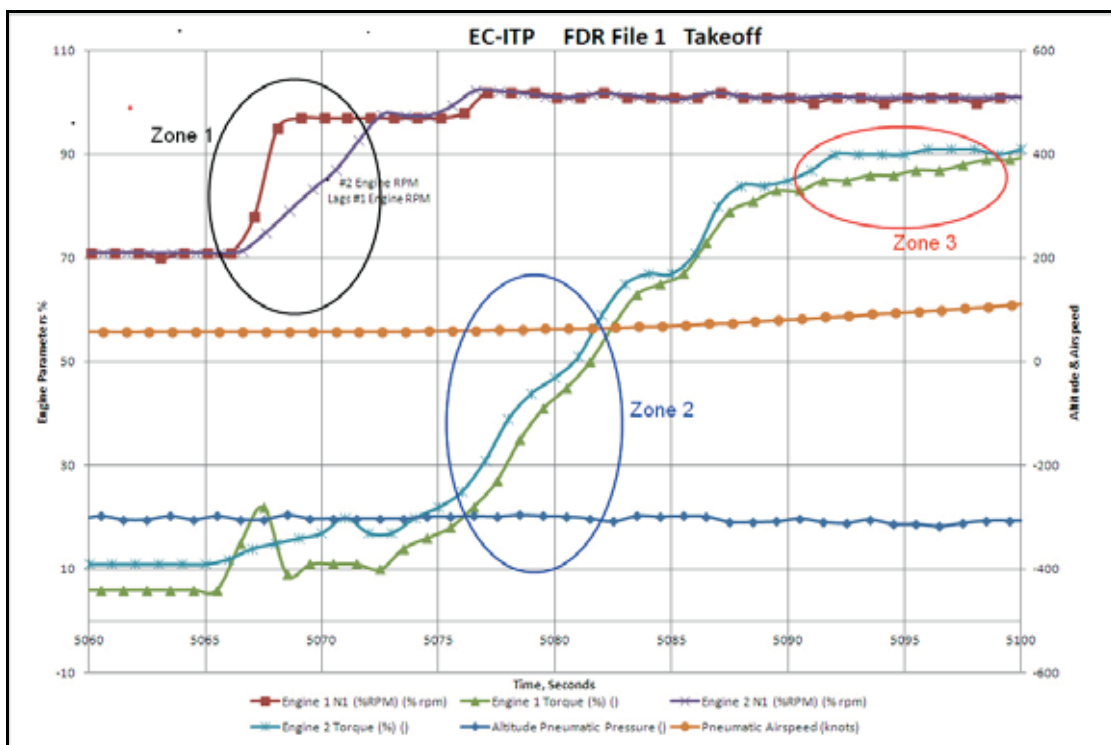
Figure No. 1 shows FDR recorded parameters from EC-ITP on a take-off several weeks before the accident flight indicating that the P_{T2}/T_{T2} anomaly existed at that time.

Figure No. 1: Previous Take-off FDR Parameters

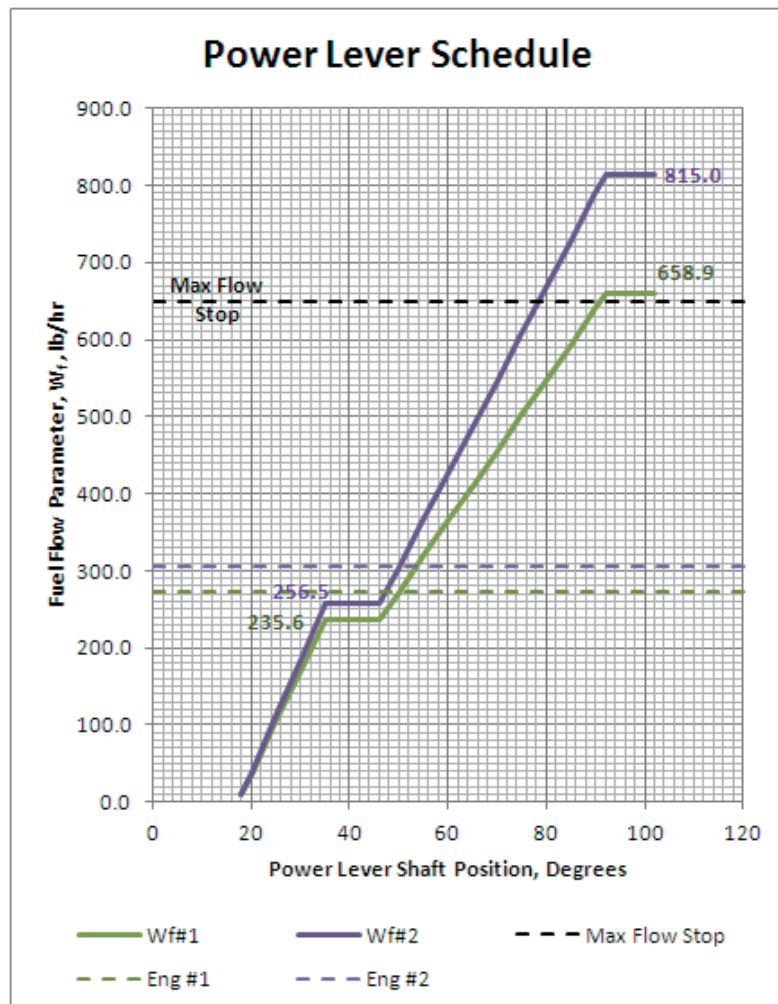
Figure No. 3 shows the comparative power lever schedules for the two engines on EC-ITP. The power lever position fuel flow schedule for engine No. 1 is shown in green, representing compensation for the correct inlet temperature as sensed by the normal P_{T2}/T_{T2} sensor. The schedule for engine No. 2 (in purple), shows fuel flow against power lever position compensated for the negative temperature bias being transmitted from the P_{T2}/T_{T2} sensor with the shortened bellows. It can be seen that, for a given power lever angle, No. 2 engine fuel flow is higher than that for No. 1 engine.

Figure No. 3: Power Lever Schedule for EC-ITP Engines (*Honeywell*)
