Accident: Windjet A319 at Palermo on Sep 24th 2010, touched down short of runway

Aviation Herald translation from official report.

Italy's ANSV have released their final report in Italian concluding the probable cause of the accident was:

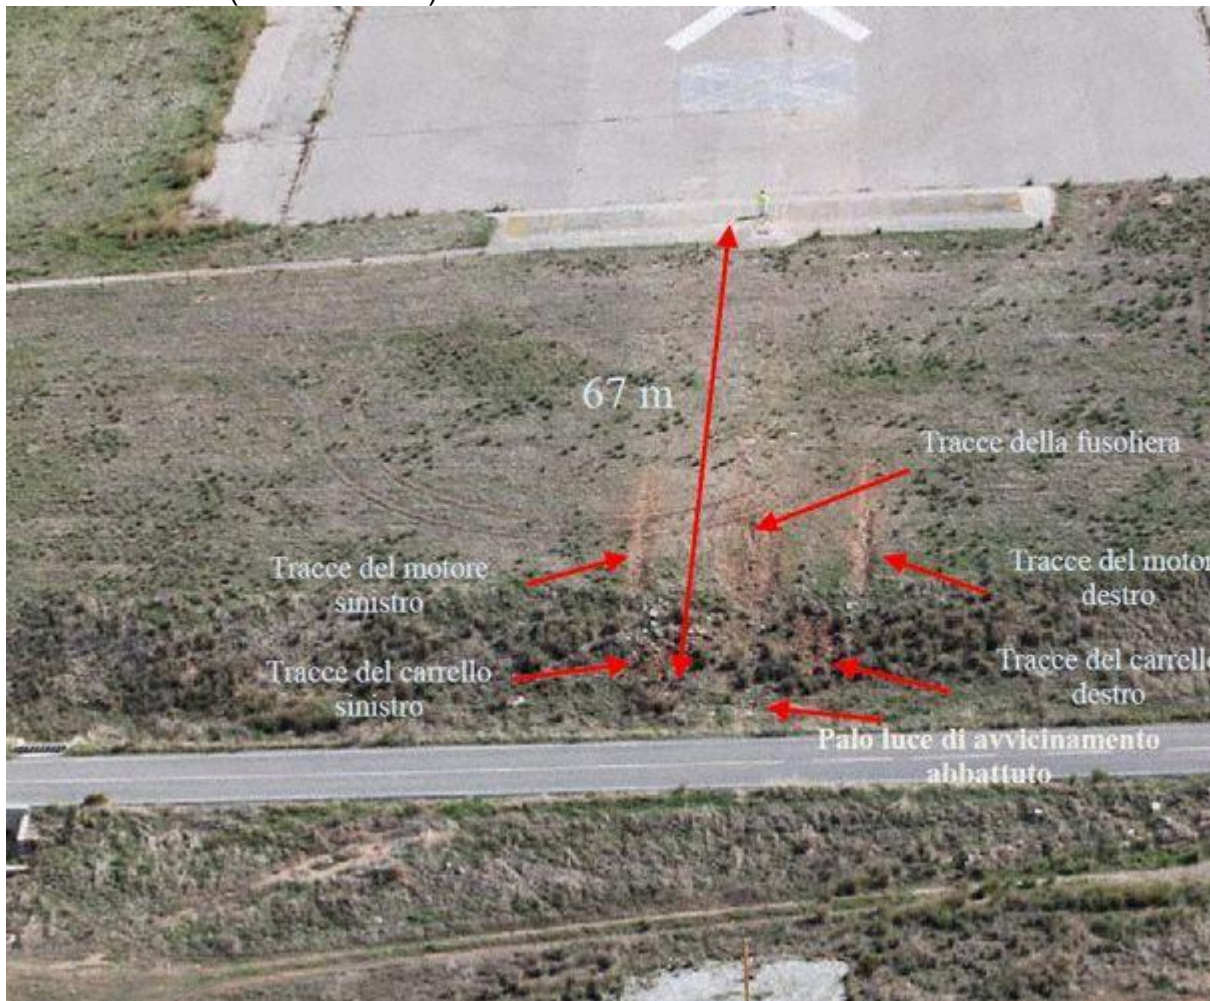
The main gear contacted an embankment rising from about 6 meters above mean sea level to 8 meters above mean sea level about 367 meters before the runway threshold at about 512 feet/minute rate of descent, 8 degrees of nose up angle and about 128 knots over ground, bounced with both engines and flight data recorder stopped upon first impact and touched down a second time, impacted the localizer antenna runway 25 and came to a stop about 850 meters past the runway threshold at the intersection with runway 02/20. The captain ordered the evacuation of the aircraft, the passengers and crew evacuated into intense rain and walked "disorderly" towards the lights of the airport buildings in about 900 meters distance.

Aerial overview (Photo: ANSV):

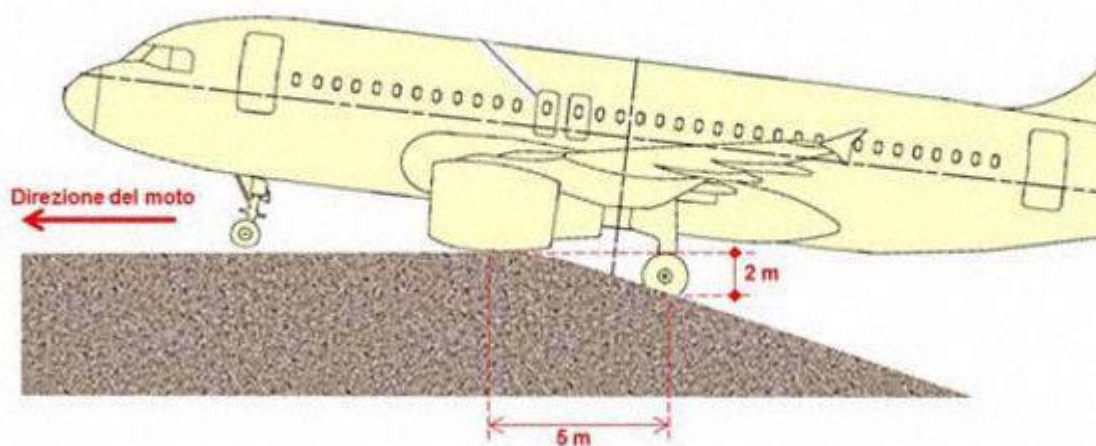
Sketch of the embankment of first contact (Graphics: ANSV):

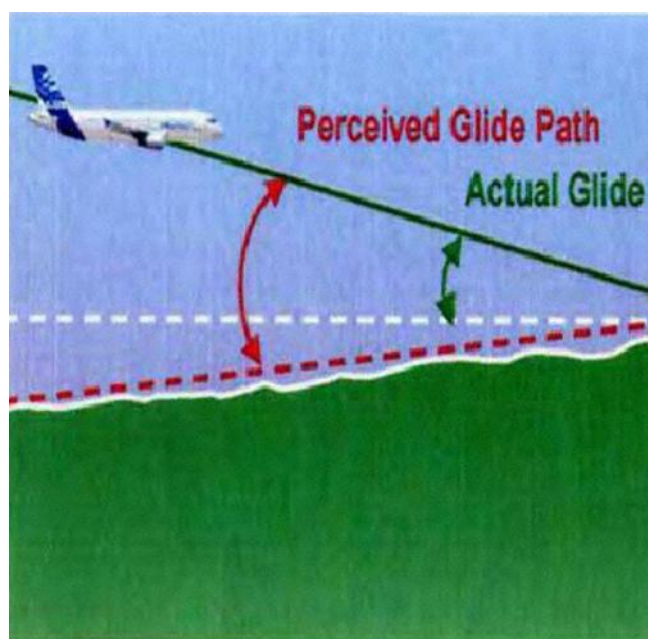
- The decrease of the light beam performance of the semi flush threshold lights in extreme rain; the only bright reference for the crew were the cross bars of the simple approach lighting system, which were probably mistaken for the threshold of the runway.

The ANSV continued analysis that the extreme rain caused refraction due to water accumulation on the windshield despite screen wipers produces effects of apparent brightness of approach lights which make the runway appear closer than it actually is. In addition, the approach over the sea towards the coastline rising from about 2 to 8 meters MSL, could have produced the illusion of being higher than they actually were ("black hole illusion").

Reconstruction of visual cues available (Graphics: ANSV):
