PAKISTAN CIVIL AVIATION AUTHORITY

(SAFETY INVESTIGATION BOARD)

INVESTIGATION REPORT

AIR BLUE FLIGHT ABQ-202 A-321 REG AP-BJB PAKISTAN
CRASHED ON 28 JULY 2010
AT MARGALLA HILLS
ISLAMABAD

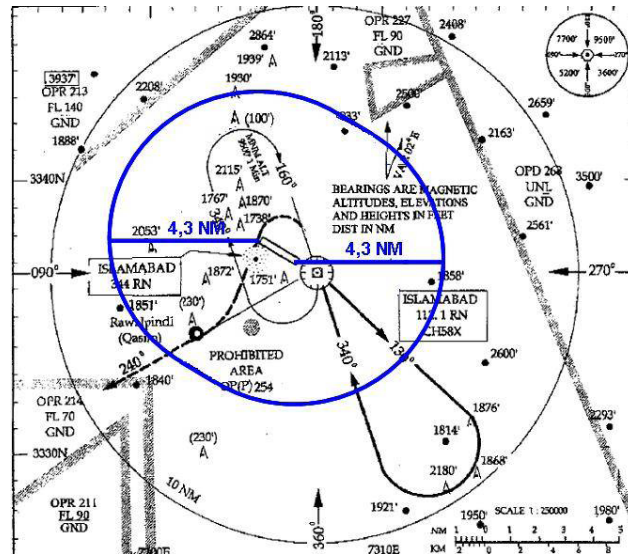
- 6.7.1 These conditions give an arc radius of 4.3 NM, and the following visual maneuvering area:

- 6.7.2 The highest obstacle in this area on the AIP Pakistan chart has an elevation of 2,115 ft. ICAO Doc 8168 requires an obstacle clearance of 394 ft for category C aircraft (in line with the published MDA of 2,510 ft). The accident aircraft left the protected area, and impacted the hill 7.3 NM from runway 12 threshold (9.6 NM from VOR).

- 10.20 The protected circling airspace to fly at MDA was available till 4.3 NM. Contrary to the recommended procedures, the mishap aircrew took the aircraft out of the protected area to 7.3 NM from RWY-12 threshold.
