AIRCRAFT ACCIDENT REPORT 1/2016

**Report on the accident to
AS332 L2 Super Puma helicopter, G-WNSB
on approach to Sumburgh Airport
on 23 August 2013**

Air Accidents Investigation Branch

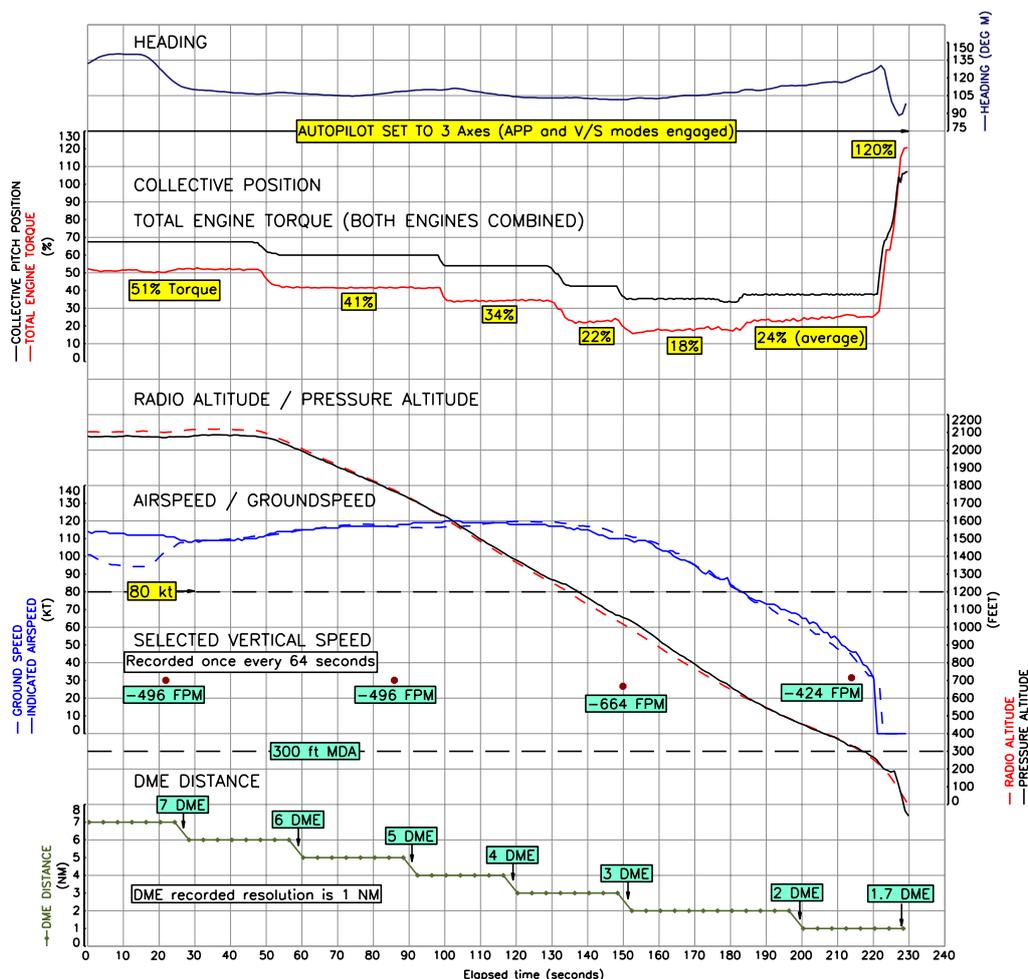
Figure 3

Shortly thereafter the co-pilot drew the commander's attention to the airspeed, which was now about 35 kt and the helicopter was now descending at 1,000 fpm. The commander acknowledged the co-pilot and began to increase the collective pitch. At this point there was a second AVAD 'CHECK HEIGHT' warning.

The commander increased the collective pitch initially to about 63% engine torque. He then made an exclamation and raised the collective pitch lever further, resulting in a maximum value of 120% engine torque. The rate of descent was now 1,800 fpm and he was not able to prevent the helicopter from impacting the water.⁹

G-WNSB final approach vertical profile

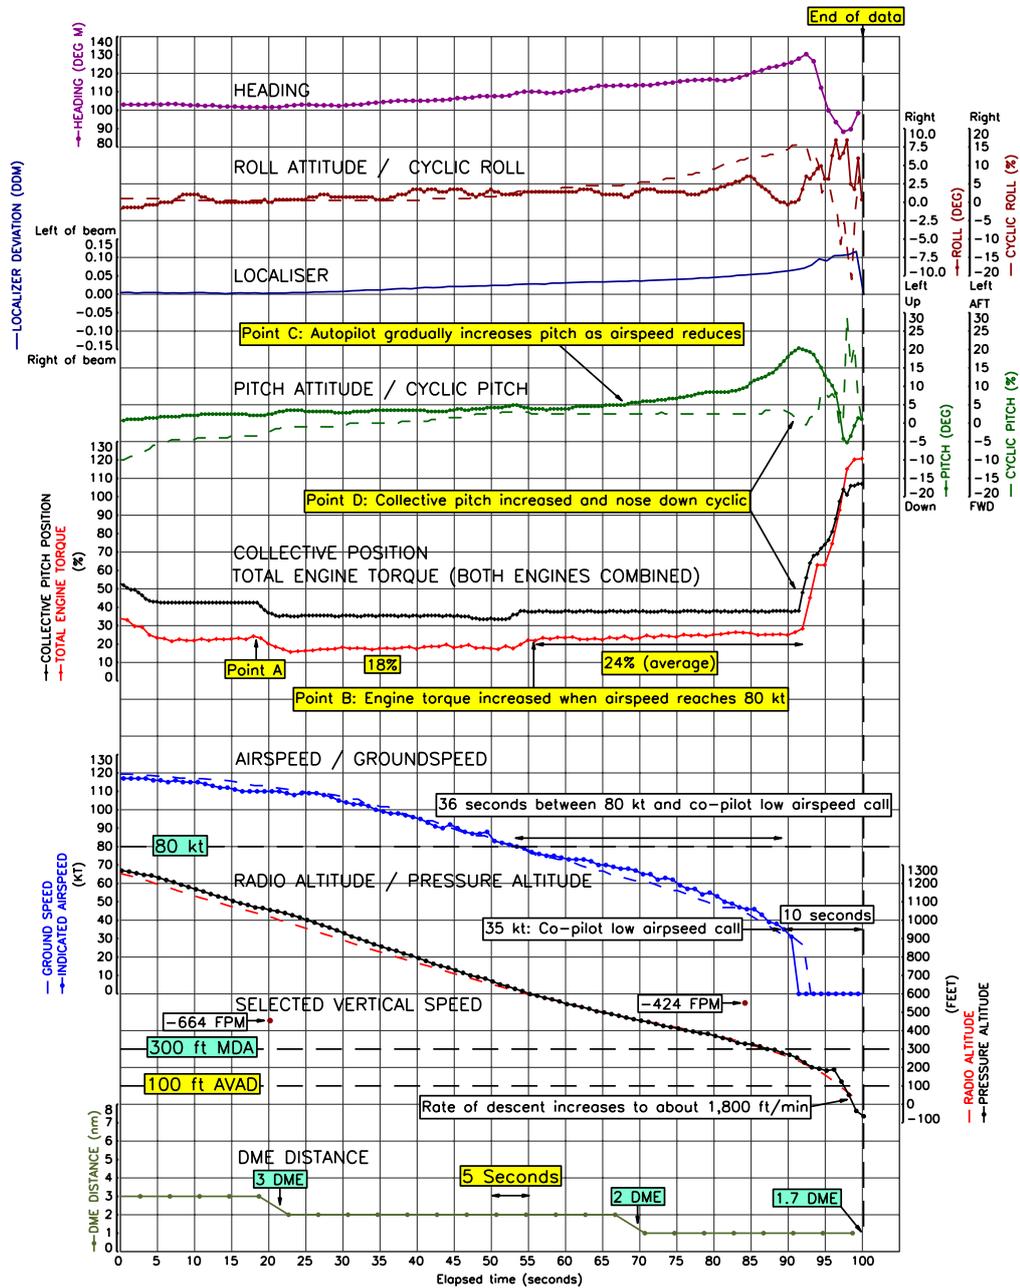
Figure 12

At 3 nm DME the helicopter was at 1,050 ft, 20 ft above the vertical profile, and its airspeed was 110 kt. The selected vertical speed was 664 fpm. Shortly after, at 1715 hrs, the helicopter was cleared to land. The collective pitch was reduced and engine torque stabilised at about 18% (Figure 12, Point A), with airspeed reducing gradually at a rate of about 1 kt/sec.

At 630 ft the airspeed had reduced to 80 kt, at which point there was an increase in collective pitch (Figure 12, Point B), with engine torque increasing from 18 to about 24%. The airspeed continued to reduce gradually at a rate of just less than 1 kt/sec.

G-WNSB vertical descent path, engine torque and airspeed from 1,200 ft

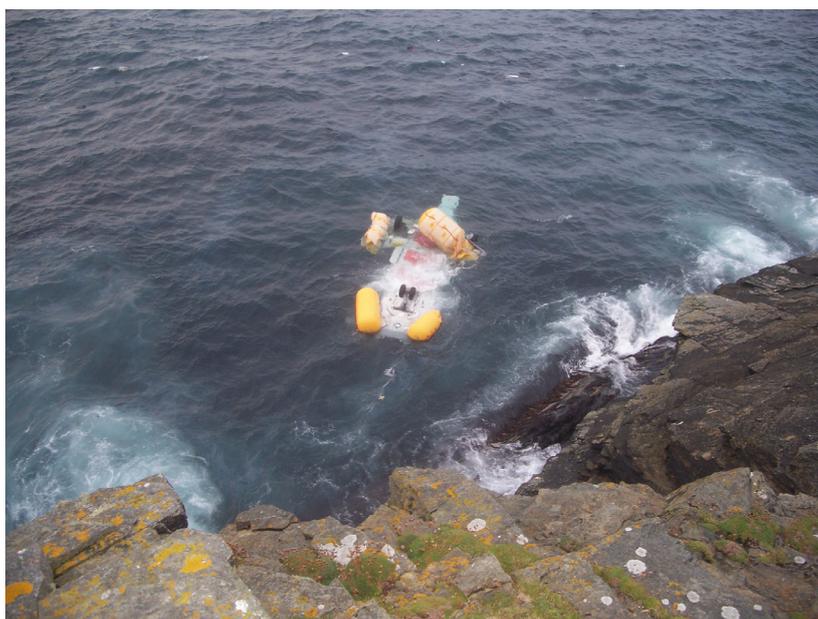
Figure 15

As the helicopter had drifted onto the rocky shoreline following the accident, the extent of the damage caused by the impact with the water was difficult to assess from the recovered wreckage. However, a number of other sources of evidence were available, including images of the floating fuselage taken prior to it reaching the coastline. Evidence was also available from survivor statements and the distribution of the wreckage along the coast. Images of the helicopter taken while it was floating inverted showed that it appeared to be largely intact and relatively undamaged; however, the tail section aft of the rear baggage compartment was missing. The main rotor and tail rotor blades were significantly damaged, consistent with high energy contact with the water. Two of the main rotor blades had broken off at the blade root, which remained attached to the rotor head. The remaining blades had detached at their mounting hinge. Statements from the passengers and crew also indicated that most of the windows on the left side of the cabin had been removed by the force of the impact with the water.

Significant additional damage occurred to the helicopter due to repeated contact with the rocks as it drifted onto the shoreline. This resulted in the remaining fuselage breaking into two main sections, failing circumferentially at the forward end of the main cabin doors. It also caused damage to the engines, main rotor head and gearbox, all of which had broken away from the fuselage, along with the right sponson.

G-WNSB wreckage contacting coastline

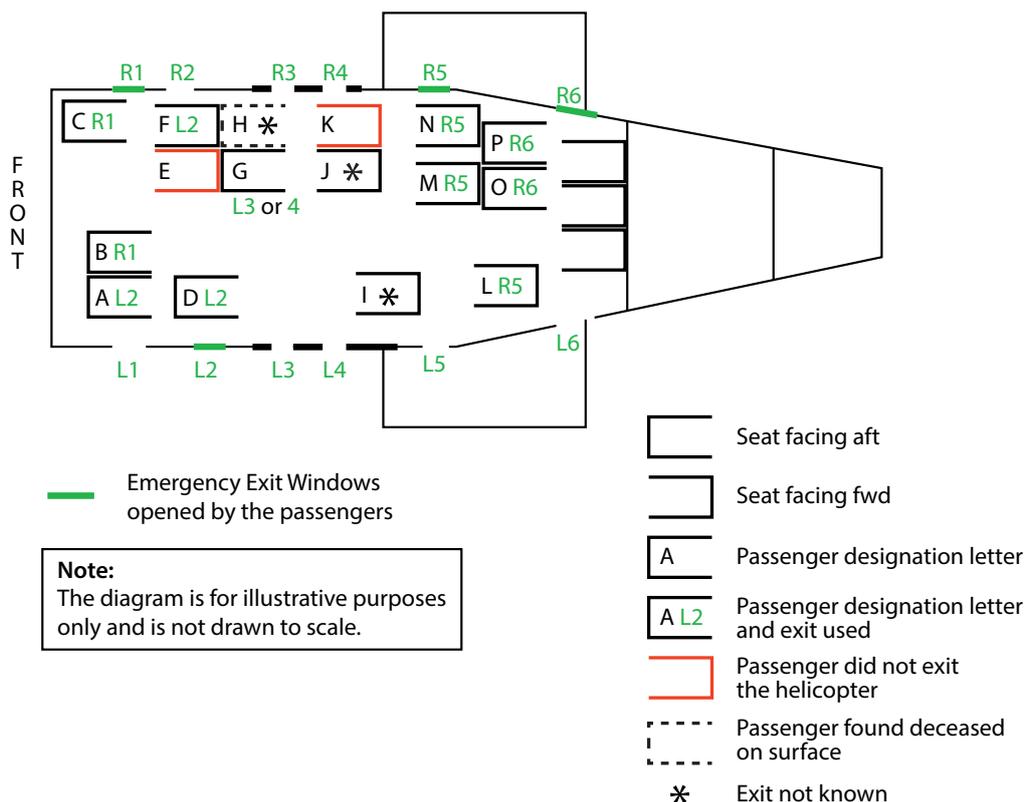
Figure 16 shows the passenger seating positions and evacuation exits used. A brief summary of all the occupants' seating positions, together with the survivors' recollections of their escape and exits used, is provided at Appendix G.

Passenger seating positions and evacuation diagram

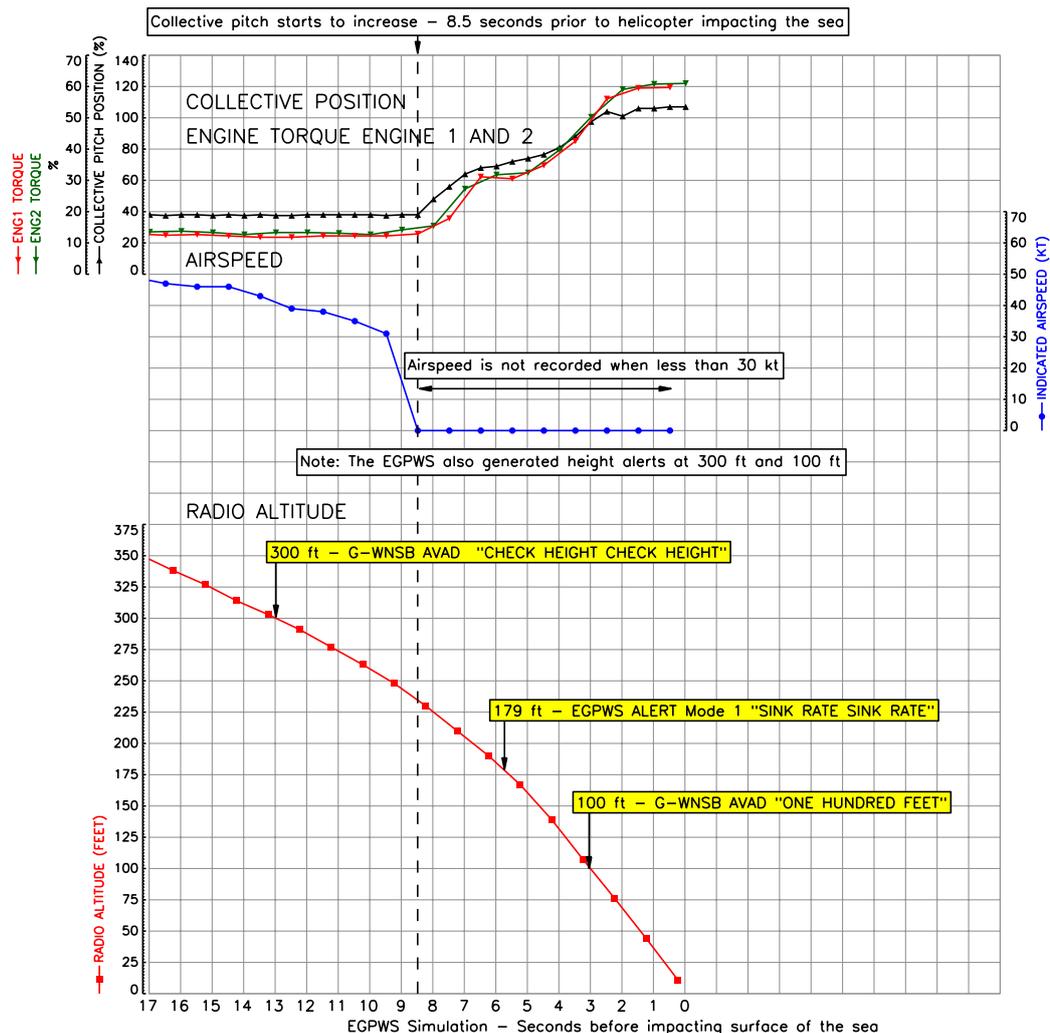
The results of the simulation were that: at a height of 179 ft, about 5.7 seconds before G-WNSB struck the surface of the sea, a Mode 1 'SINK RATE SINK RATE' audio alert would have been generated. Figure 17 provides details of the EGPWS Mode 1 envelope used to trigger the alert and Figure 18 is a time series plot of when the alert would have occurred relative to other alerts and impact with the sea.

EGPWS Simulation with Mode 1 alert triggered at 179 ft

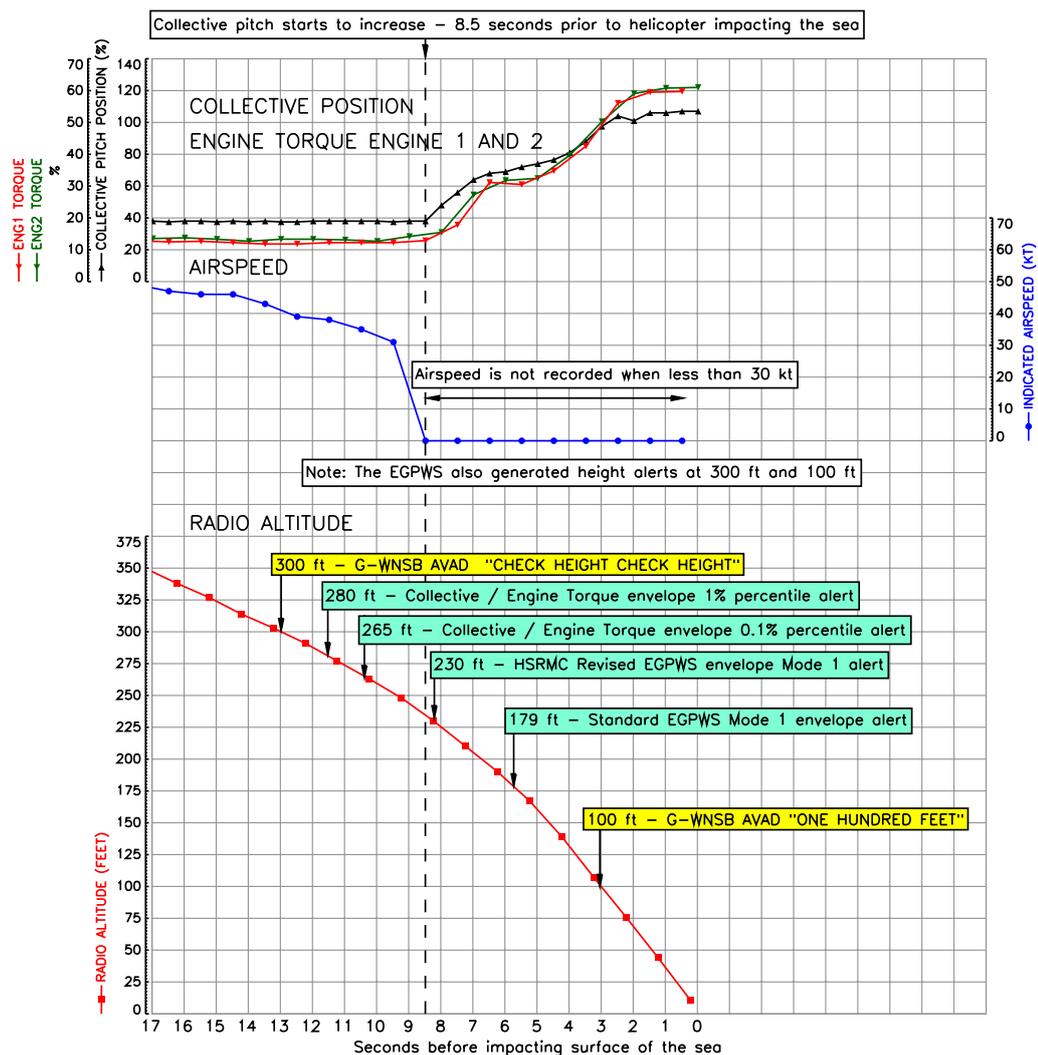
Figure 19

Initial research focused on the relationship between engine torque and airspeed during the latter stages of an approach. Two envelopes were created to reflect the statistical measures of 1% and 0.1% percentile, which were then compared against the accident approach of G-WNSB. The 1% and 0.1% envelopes were exceeded 11.5 and 10.5 seconds respectively before the helicopter struck the sea (Figure 19). At 11.5 seconds G-WNSB’s airspeed was 38 kt and it was at a height of 280 ft. At 10.5 seconds its airspeed was 34 kt and the height was 265 ft.

The project also analysed other parametric relationships, including collective pitch position and airspeed, to determine if the alerting time could be further improved upon. It was found that the warning based on engine torque and airspeed continued to provide the greatest alerting time for the accident approach profile.

Alert activation times of EGPWS developmental envelope, revised Mode 1 envelope and current Mode 1 envelope

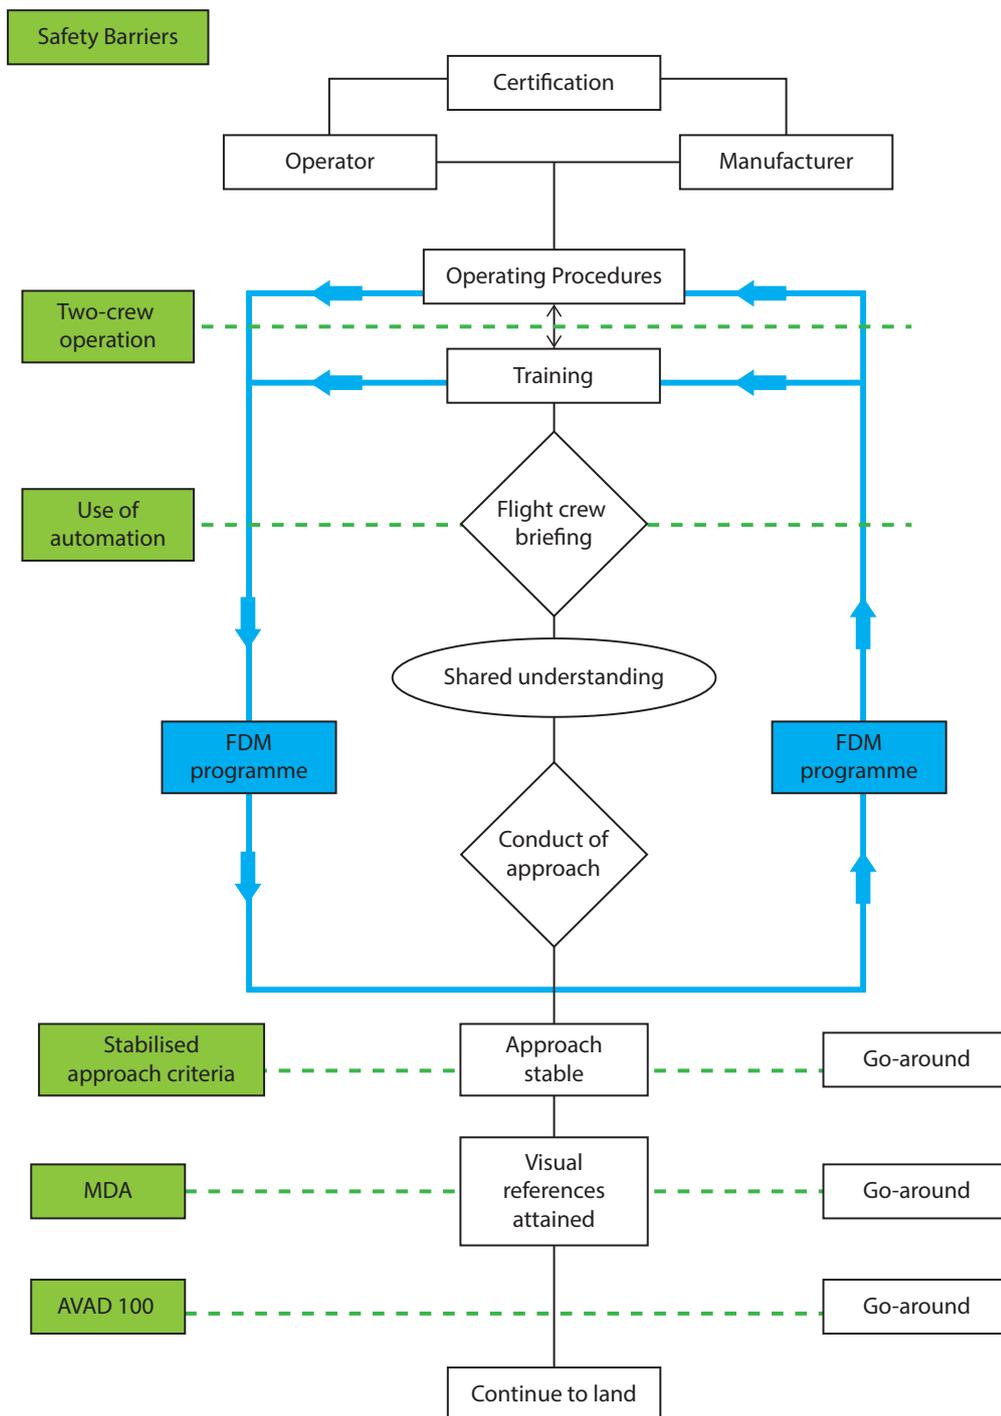
Figure 23
Operational Safety Barriers

Safety barriers were designed within the operation to ensure that instrument approaches were performed safely, whether to a landing or, if visual reference was not acquired, to a go-around. These safety barriers proved to be ineffective. This suggests that safety actions are required to improve their effectiveness, in order to prevent a similar accident in the future. Figure 23 presents a schematic showing the operational safety barriers (highlighted in green); these are considered in turn.

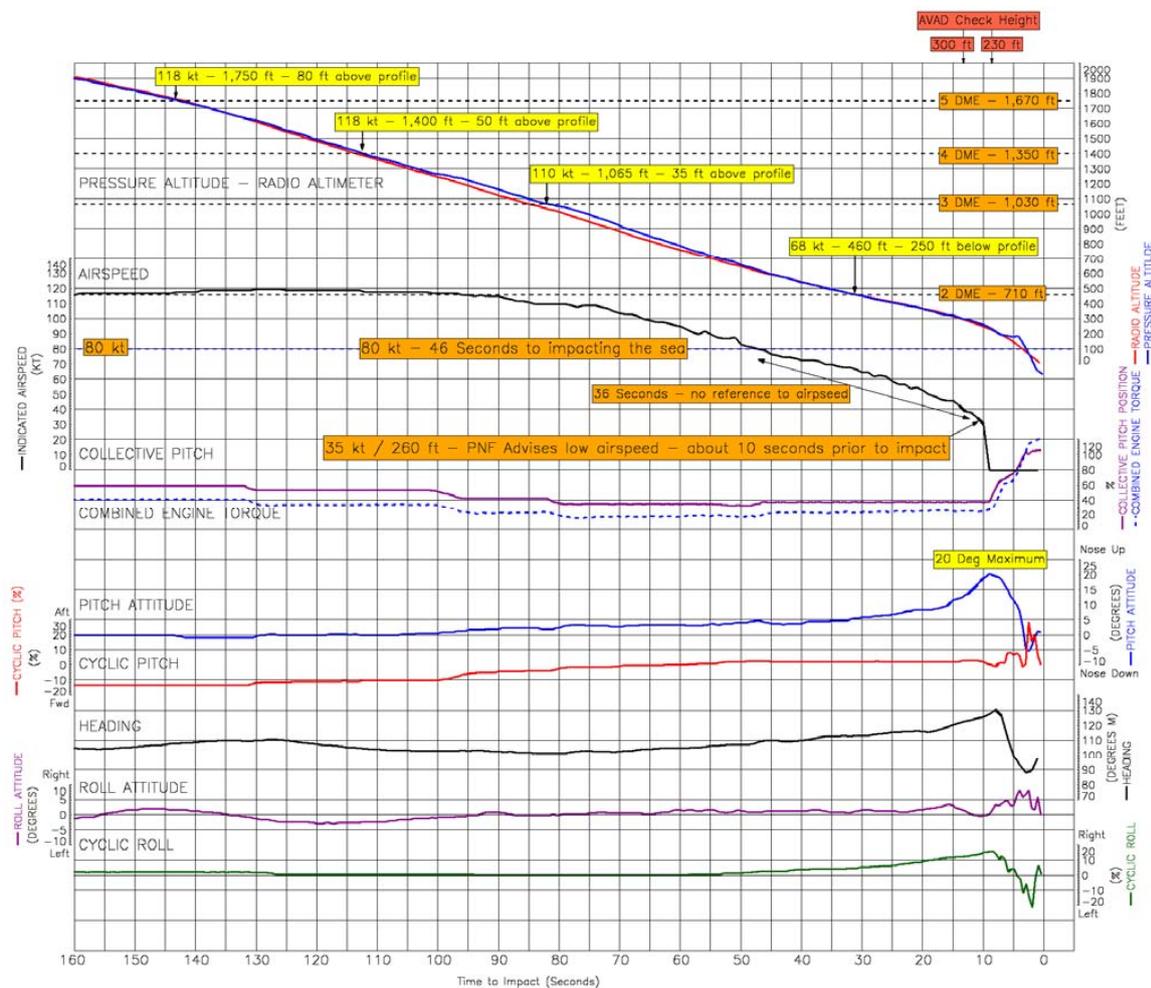
Figure 3: FDR trace

32. Torque adjustment. At approximately 46 seconds prior to impact the Commander adjusted the torque to attempt to maintain the airspeed of 80 kts. However, this input was not sufficient and the airspeed continued to decrease. Torque adjustment is a skill-based task, which would have been routine and automatic for the Commander due to his experience levels. In any skill-based task, however, there remains a possibility of error. It is understood that there was only a small difference between the required collective movement (to maintain airspeed at 80 kts) and the actual collective movement made by the Commander. Where minor adjustments are required the margin for error is reduced and so the risk of error is increased (compared to tasks that have a larger margin for error). Given the scope for error that exists in skill-based tasks that involve minor adjustments, it is important to consider workload and point of focus during the time following the torque adjustment and what cues were available to the crew to check that the torque adjustment had been effective.

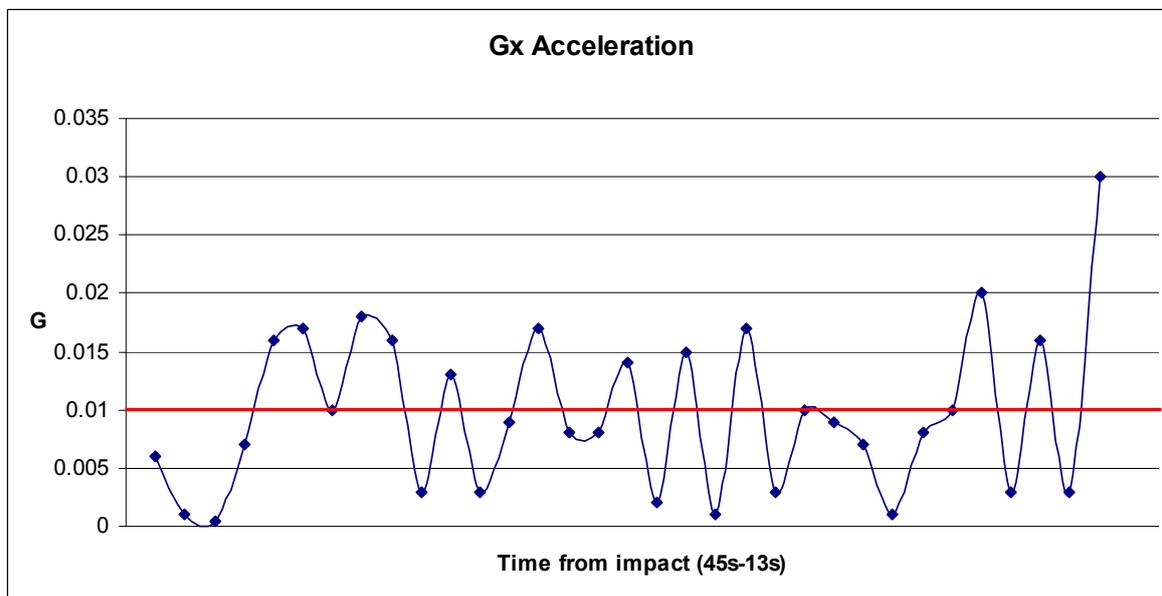
Figure 4: Gx acceleration for G-WNSB

- c. **Somatogravic illusion.** In the absence of external visual cues, the brain is more prone to misperceptions. When an aircraft decelerates it will give a false-sensation of pitch down and so if accompanied with an actual nose-up attitude may cause the aircraft to feel level²³. As the aircraft gradually decelerated, the pitch-up attitude of G-WNSB gradually increased. Therefore, the associated counteracting forces may have led the crew to perceive that the aircraft was straight and level with no decrease in airspeed, when in fact it was nose-up and losing airspeed.
