**SERIOUS INCIDENT**

<b>Aircraft Type and Registration:</b>	Airbus A319-111, G-EZDN	
<b>No &amp; Type of Engines:</b>	2 CFM56-5B5/3 turbofan engines	
<b>Year of Manufacture:</b>	2008 (Serial no: 3608)	
<b>Date &amp; Time (UTC):</b>	13 May 2015 at 2135 hrs	
<b>Location:</b>	On approach to Bristol Airport	
<b>Type of Flight:</b>	Commercial Air Transport (Passenger)	
<b>Persons on Board:</b>	Crew - 6	Passengers - 99
<b>Injuries:</b>	Crew - None	Passengers - None
<b>Nature of Damage:</b>	None	
<b>Commander's Licence:</b>	Airline Transport Pilot's Licence	
<b>Commander's Age:</b>	56 years	
<b>Commander's Flying Experience:</b>	11,500 hours (of which 5,000 were on type) Last 90 days - 172 hours Last 28 days - 60 hours	
<b>Information Source:</b>	Aircraft Accident Report Form submitted by the pilot, and the Company safety report

**Synopsis**

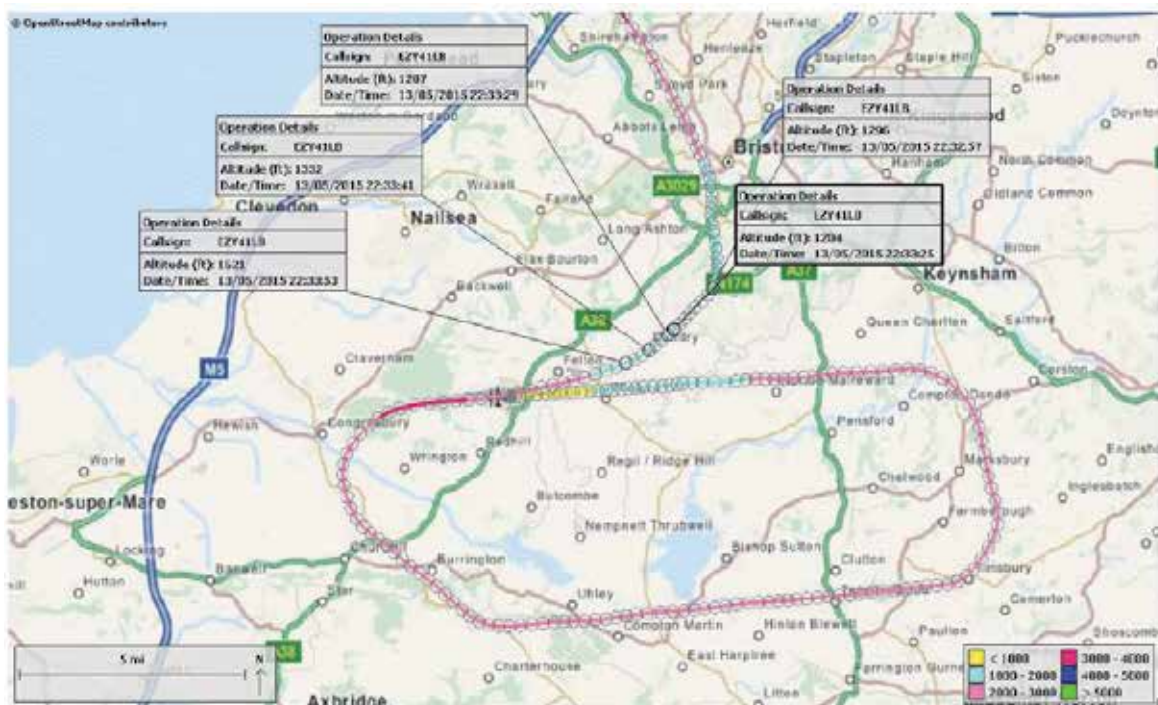
Figure 1  
Bristol Airport noise trace

The go-around was commenced just to the north of the village and the lowest radio altimeter reading recorded during the manoeuvre was 488 ft agl. The aircraft was then repositioned for an ILS approach onto Runway 27 from which it landed safely.

The company investigation made use of data from a wireless quick access recorder and the noise monitoring system at Bristol Airport gave a pictorial representation of the aircraft's track and height amsl. (Figure 1)

The aircraft made its turn towards Runway 27, approximately 2 nm to the north of the runway centreline at a slant range from the threshold of 4.3 nm. The aircraft was turned through 50° and its rate of descent was reduced. The aircraft then flew level at 1,200 ft for 25 seconds, during the last 10 seconds of this, the indicated radar altimeter height reduced from 950 ft to 488 ft. The go-around was executed at 2.75 nm slant range from the threshold, still approximately 1 nm north of the centreline. The go-around altitude was set in the altitude window of the FCU during the manoeuvre.
