INCIDENT

Aircraft Type and Registration:	Airbus A320, EI-DIJ	
No & Type of Engines:	2 CFM 56-3A3 turbofan engines	
Year of Manufacture:	1992	
Date & Time (UTC):	29 March 2006 at 1330 hrs	
Location:	Ballykelly, County Londonderry, Northern Ireland	
Type of Flight:	Public Transport (Passenger)	
Persons on Board:	Crew - 6	Passengers - 39
Injuries:	Crew - None	Passengers - None
Nature of Damage:	None	
Commander's Licence:	Airline Transport Pilot's Licence	
Commander's Age:	57 years	
Commander's Flying Experience:	14,000 hours (of which 1,800 hrs were on type) Last 90 days - 69 hours Last 28 days - 69 hours	
Information Source:	AAIB Field Investigation

Synopsis

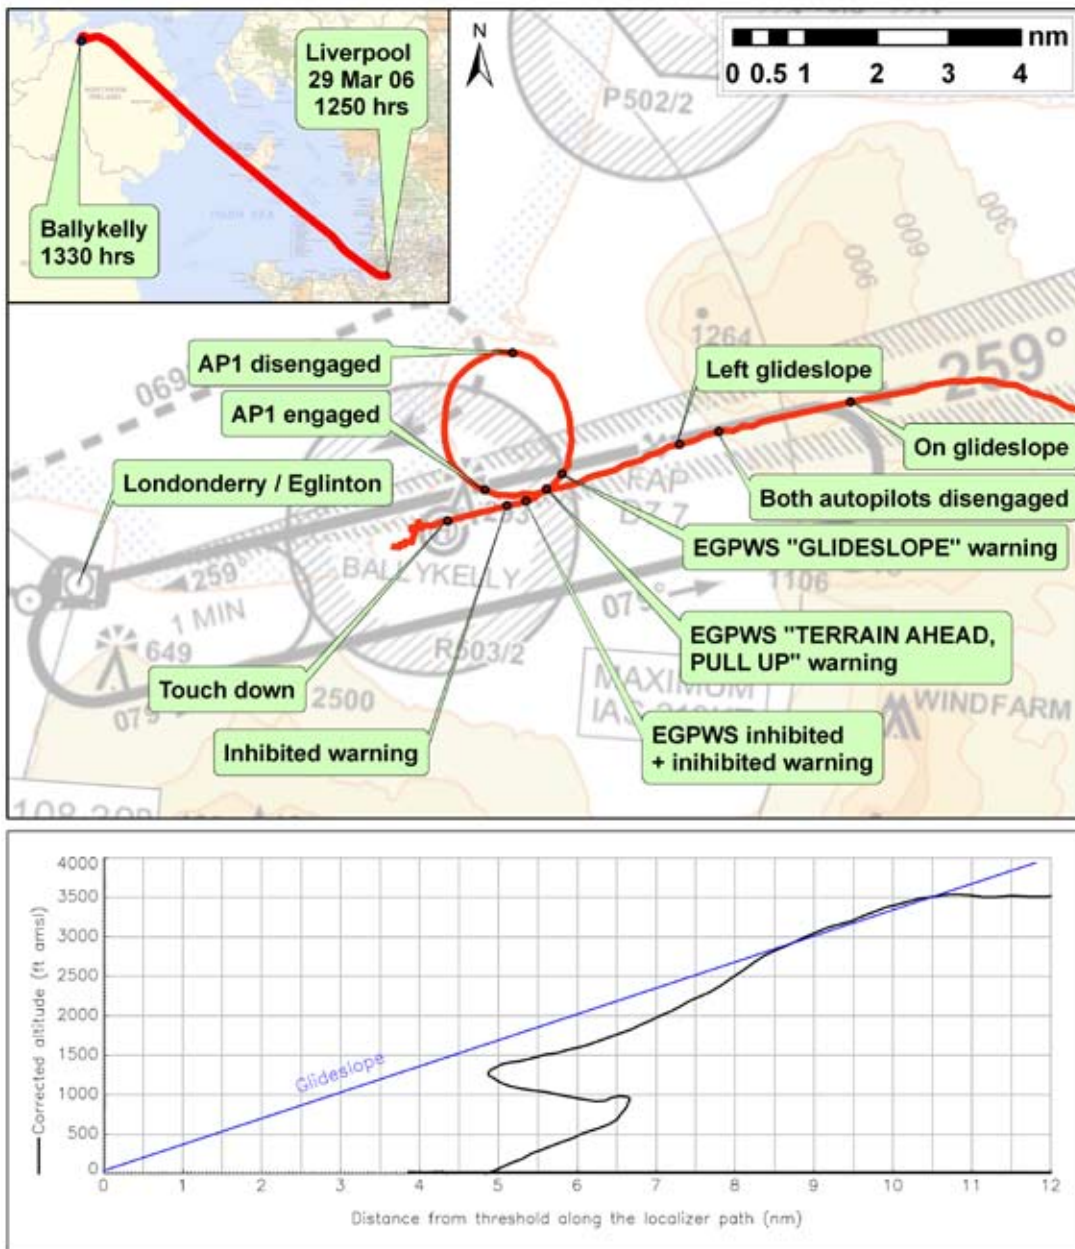
A Mode 5 ‘soft’ EGPWS “GLIDESLOPE” alert¹ was triggered just before the orbit was complete, at a radio altitude of approximately 592 ft agl. At this time the glideslope deviation was greater than five dots. Before this, the enabling conditions for a glideslope alert had not been met, despite the large glideslope deviations². The descent continued and, ten seconds later, at 509 ft agl, an EGPWS “TERRAIN AHEAD, PULL UP” warning was triggered; which would have repeated continuously whilst the ‘threat’ existed. At the time of the alert, the commander had ‘terrain’ displayed on his Navigation Display (ND) and this alert would have highlighted the ‘threatening’ terrain on his display. The co-pilot did not have terrain displayed on his ND but the alert would have caused that page to appear. Ten seconds later, at 384 ft agl, the EGPWS look-ahead functions were inhibited using the TERR OFF selection on the overhead panel. This inhibited a further three alerts that would have otherwise been given. The aircraft touched down at Ballykelly 34 seconds later. The Flight Management System position indicated that the aircraft was within 175 m of the intersection of the runways at Ballykelly when the aircraft touched down. Figure 1 shows the final section of the flight.

Approach and Landing Section of the Flight derived from the Flight Recorders

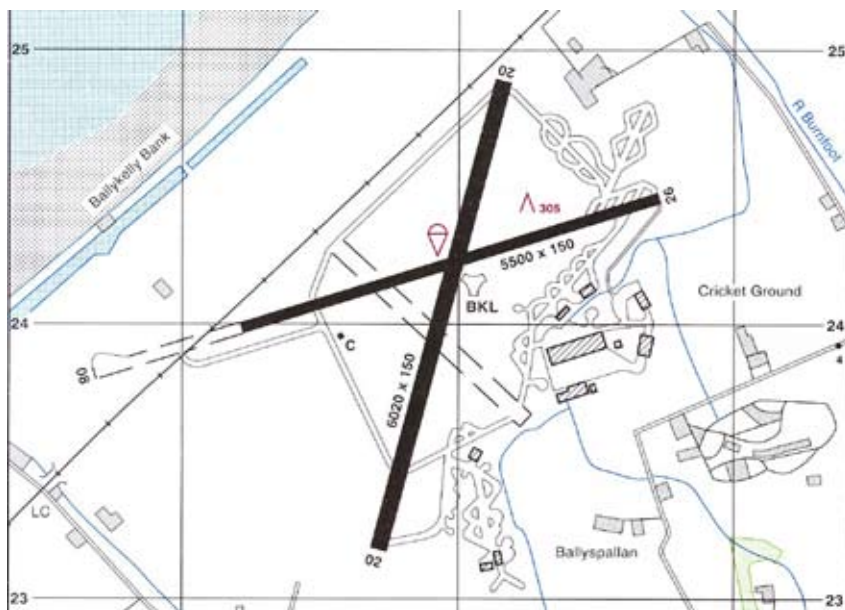
Figure 2

Diagram of the layout of Ballykelly Airfield

Runway 26 at BKL is mostly made of concrete that, in places, was showing signs of break-up. A tarmac section in a good state of repair, 662 m in length, had been laid in the middle of the runway. No runway lights were installed.

Only one set of aircraft touchdown tyre marks were found on the runway, ie two sets of 'double' tyre marks, and these were a short distance past the runway designator numbers. This was close to the touchdown position computed from the FDR data (see paragraph headed Flight Recorders). The spacing between these marks, for both sets of main gear tyres, was measured at 91 cm. The aircraft manufacturer reported that, for the A320, this dimension is 92.7 cm. Given

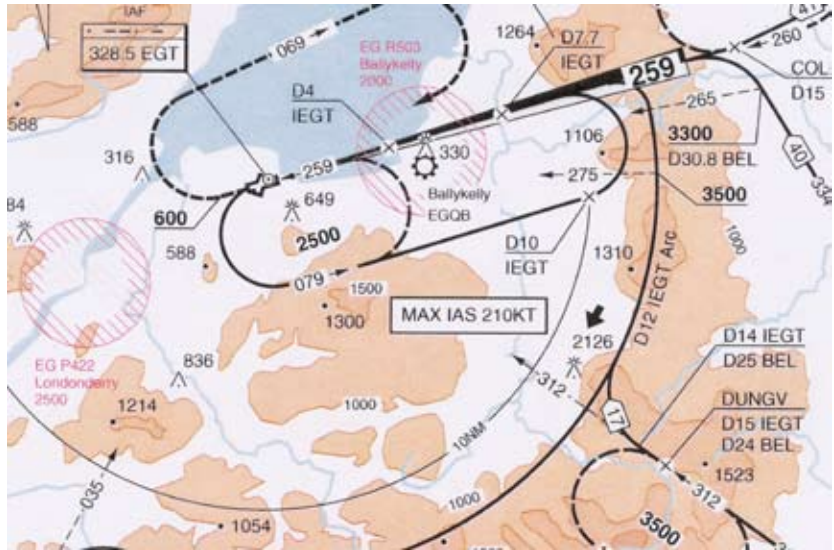
Figure 4

The operating company had provided the operating crew with airfield charts for LDY that had been published by a commercial provider, Figure 4. For three days prior to the incident flight, the commander tried in vain to obtain a copy of the LDY airfield charts, through the LPL operations office and another commercial provider. This was to be fully prepared for the flight into this limiting airfield. However, he did obtain a copy of these charts the day after the incident and stated that, had he seen these previously, he would have been fully aware of the existence of BKY and would not have landed there. This was due to the different presentation of the data, in particular, the manner in which BKL was

Section of approach chart used by the crew of EI-DIJ

Throughout flying training, pilots are taught to believe their flight instruments unless they have good reason to doubt the information being presented. Once visual with BKL, the crew of the A320 were convinced that this was their destination airfield. Distracted by what they perceived was a problem with the ILS glideslope and DME, and the perceived slight sense of urgency from the ATCO, they became focused on landing at the only airfield they could see. Whilst BKL was marked on their approach plates, they failed to recognise the depiction as an airfield.

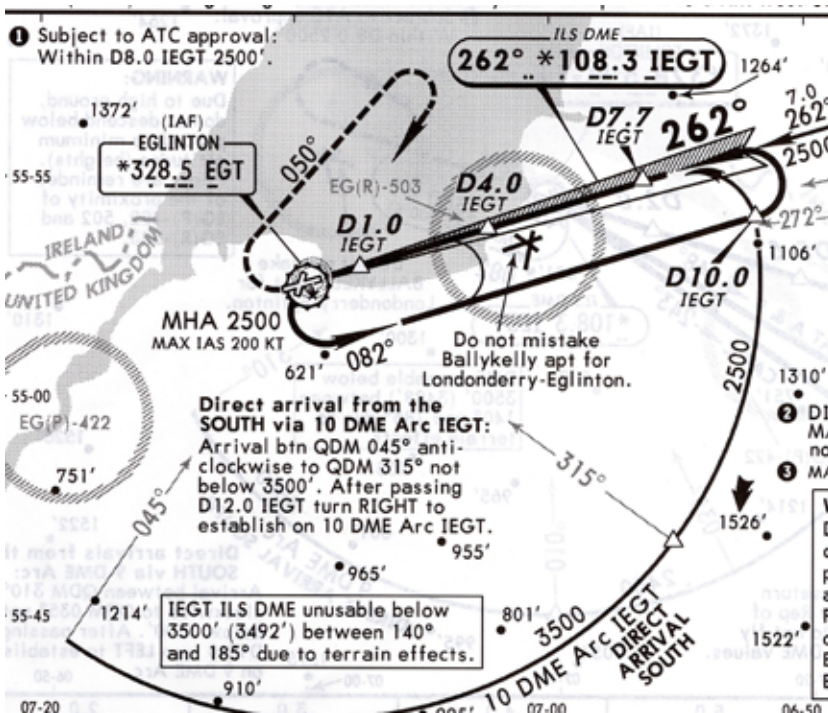
Figure 5

Section of the approach chart that the commander of EI-DIJ attempted to obtain prior to the flight, showing warning note re Ballykelly

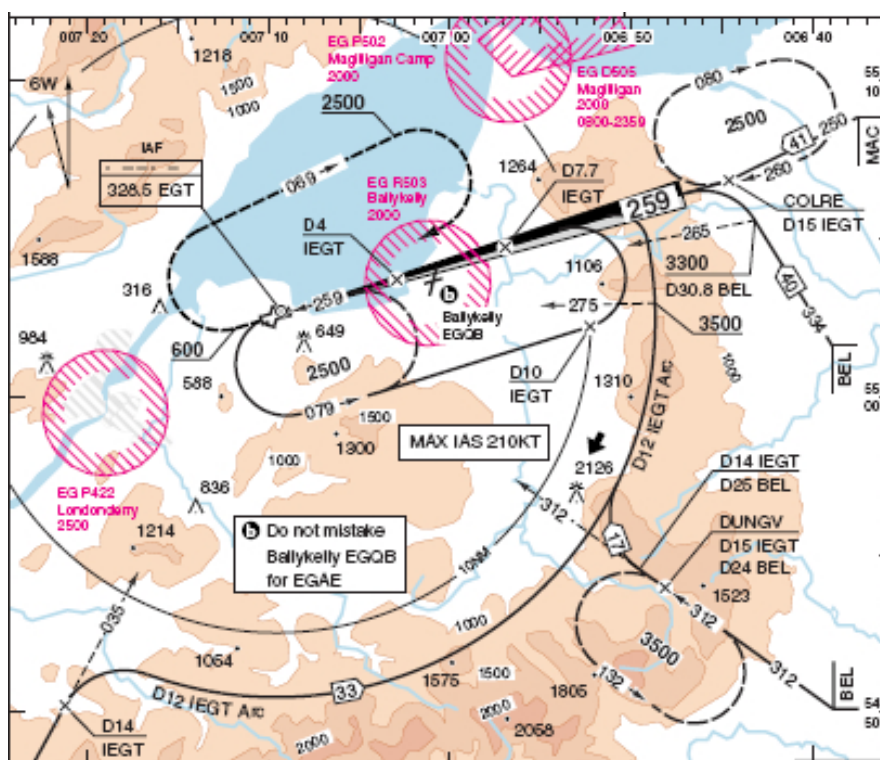
Figure 6

Modified version of the chart shown in Figure 4

provider of airfield charts. As a result of this incident, they have changed their provider, although their original provider has now amended its charts, including a change to the symbol for BKL, to clarify the information presented to flight crews, Figure 6.
