# CAPTAIN FIRED AFTER NOSE-WHEEL LANDING

The Captain of a Boeing 737-700 landed hard at LaGuardia Airport, collapsing the nose gear. But it's actually what happened leading up to the hard landing that makes this particular case interesting. The final report has not been released; however various public documents, including the Chariman's factual reports, are now available on the NTSB site:

Southwest Airlines flight 345 on 22 July 2013 was a scheduled passenger service from Nashville International Airport in Tennessee to LaGuardia Airport in New York carrying 145 passengers and 5 crew. The Captain started her sequence of trips on the 21st of July and the First Officer began his on the 19th. They met up on the morning of the 22nd at Los Angeles International. They had not previously flown together. They flew into Nashville International Airport, arriving at noon, and changed aircraft to the Boeing 737-700. The Captain invited the First Officer to do the next leg as the Pilot Flying and the Captain would take the role of Pilot Monitoring. An American Airlines pilot was in the jumpseat of the cockpit for the trip to New York.

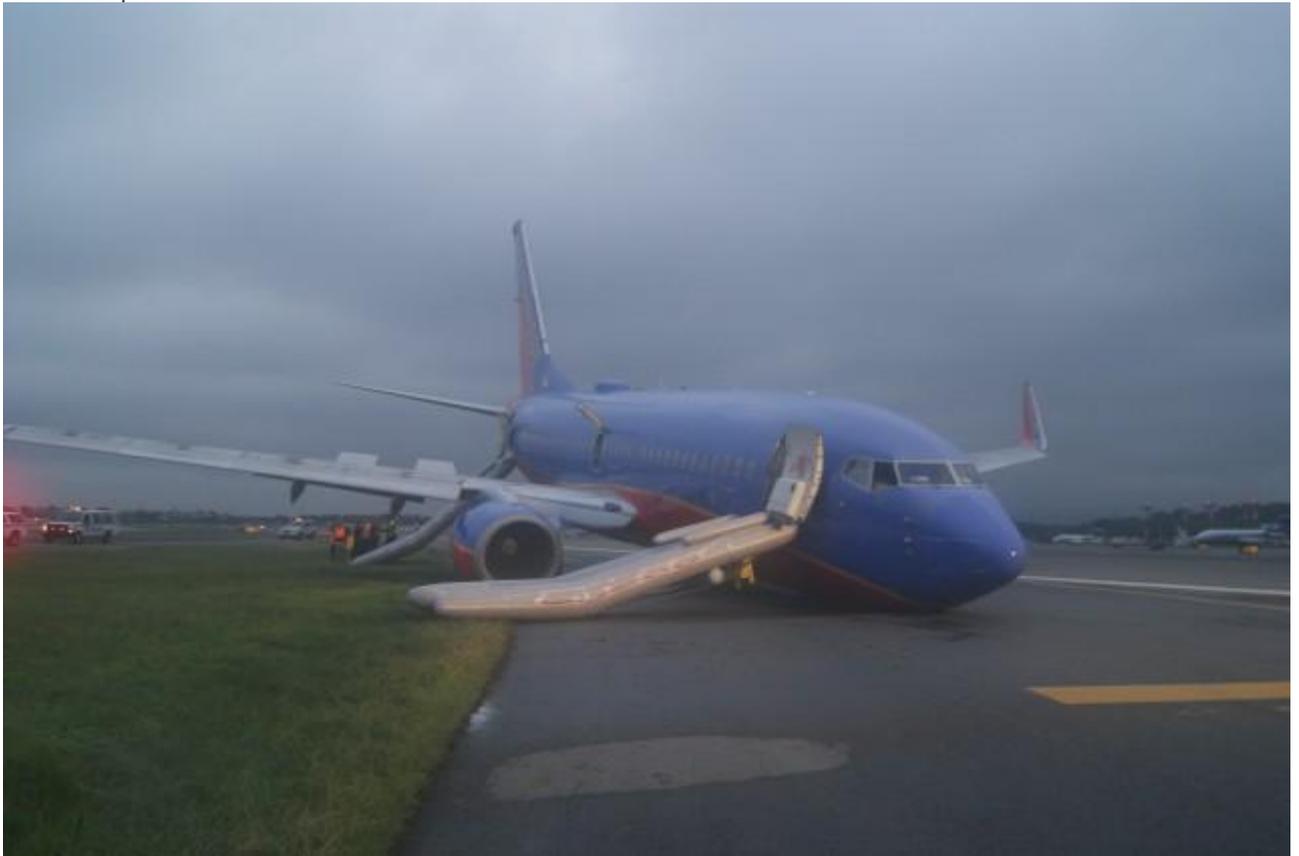
The captain said that she saw the nose hit the runway, and felt the impact of the nose hitting, but did not feel the nose wheel hit, and had no recollection of which gear hit first. She said it was a hard impact, and the airplane started sliding. She said she tried to control the airplane with rudder and brakes. The airplane veered slightly to the right before stopping on the runway.

Asked his impression of what section of the airplane touched down first, [the American Airlines pilot in the jumpseat] said the nose wheel first. He did not remember how far down the runway they touched down. He did not recall any markings on the runway before they touched down. He was looking "at concrete" but he was looked at the centerline. When they did the pitch over when the nose hit, it felt like "one big jarring moment" and then the nose was on the ground. He did not feel an arresting sensation like the nose wheel touched first and then collapsed. The nose was on the ground and they were sliding and he thought a panel or 2 became

dislodged in the cockpit. After a few seconds, smoke entered the cockpit from underneath the floor boards and around the pedestal.

Due to the early reduction in thrust to forward idle, the absence of control column input prior to touchdown, and the nose-down pitch tendency in ground effects, the airplane pitch attitude decreased to a nose-down attitude of - 3.1 degrees and touched down on the nose gear prior to the main gear touching down.
