Crash During a Nighttime Nonprecision Instrument
Approach to Landing
UPS Flight 1354
Airbus A300-600, N155UP
Birmingham, Alabama
August 14, 2013

NTSB/AAR-14/02
PB2014-107898

Aircraft Accident Report

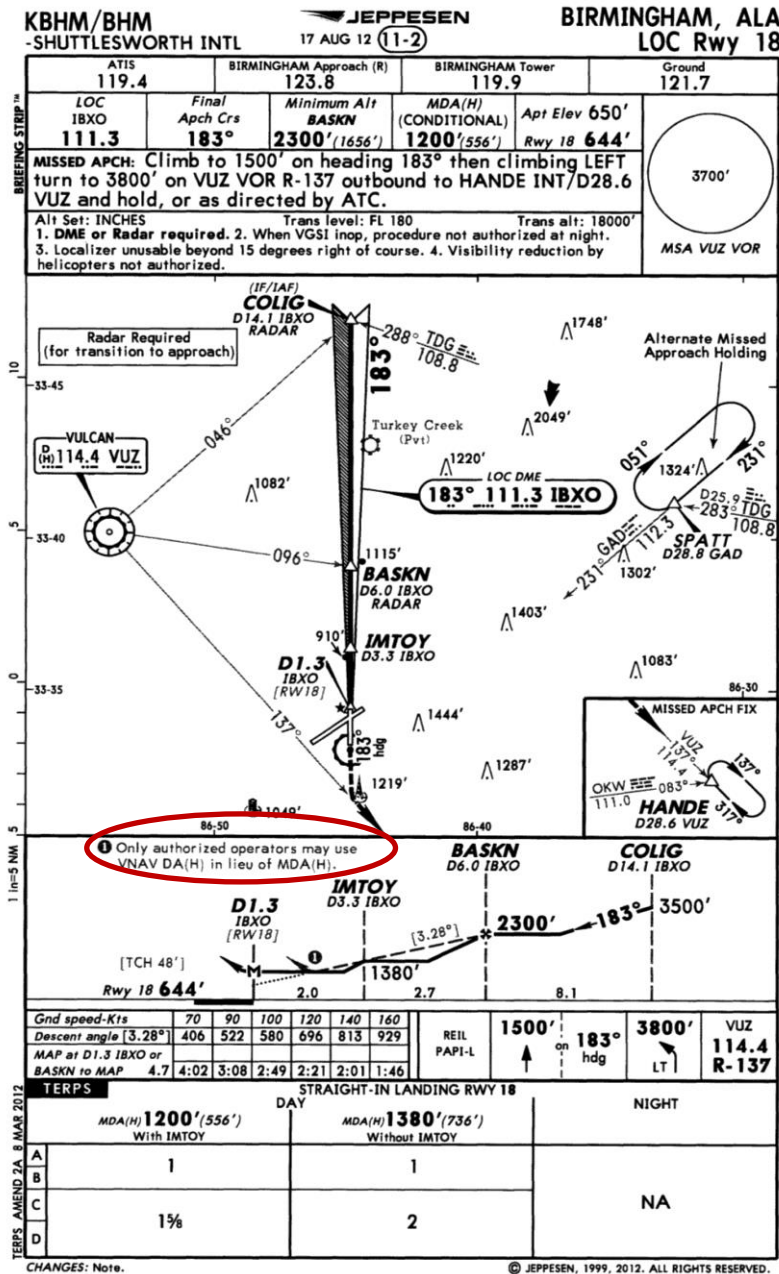
Figure 2. Instrument approach chart for the localizer approach for runway 18 at BHM at the time of the accident with the ball note circled in red.

The glidepath for the runway 18 localizer approach, indicated by the dashed line and 3.28° at the bottom of figure 2, is defined by the minimum crossing altitude at three approach fixes (COLIG, BASKN, and IMTOY) aligned north of the extended runway 18 centerline. The localizer approach to runway 18 had a minimum descent altitude of 1,200 ft msl. Because the crew was initially flying a profile approach, they were to descend to a decision altitude (also

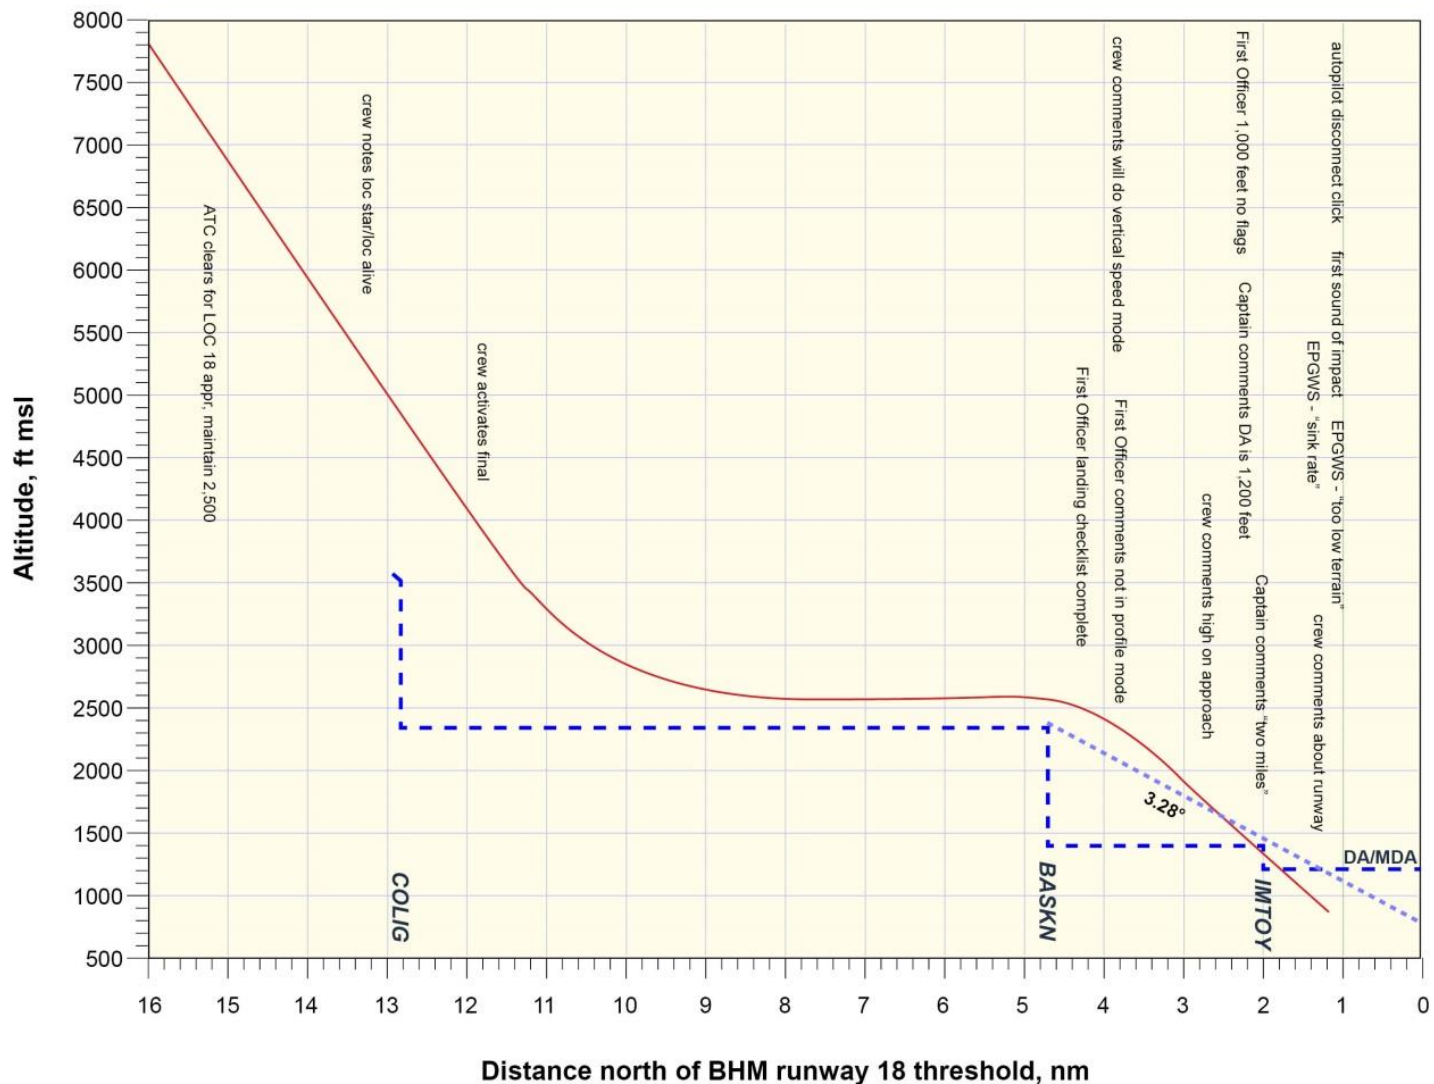
The airplane was 2.4 nautical miles (nm) from COLIG and 10.5 nm from the BASKN final approach fix (FAF) at this time (see figure 3, which shows the airplane’s descent path). It was established on the localizer when it descended through 3,800 ft msl and was aligned laterally with the extended centerline of runway 18; the airplane maintained lateral alignment with the extended centerline for the remainder of the flight. When the airplane reached 2,500 ft msl about 4 nm from BASKN (about 9 nm from the runway), it leveled off, even though it was established on the localizer and could have descended to 2,300 ft, as shown in figure 3.

1 **Figure 3.** UPS flight 1354's actual descent and altitudes.

As the airplane neared the BASKN FAF, the controller cleared the pilots to land on runway 18, and the first officer performed the Before Landing checklist. The airplane approached BASKN at an altitude of 2,500 ft msl, which was 200 ft higher than the FAF's minimum crossing altitude and contrary to the UPS A300 Pilot Training Guide (PTG) recommendation that the airplane descend to the FAF crossing altitude before intercepting the profile path. Because the approach was still sequenced for a direct-to-KBHM course, the airplane continued flying toward BASKN at 2,500 ft and did not capture the desired profile glidepath. During this time, the captain changed the autopilot mode from the previously briefed profile approach to vertical speed mode,²⁰ initially setting the vertical descent rate to about 700 ft per minute (fpm), then increasing it to 1,000 fpm; however, he did not brief the first officer about the autopilot mode change.

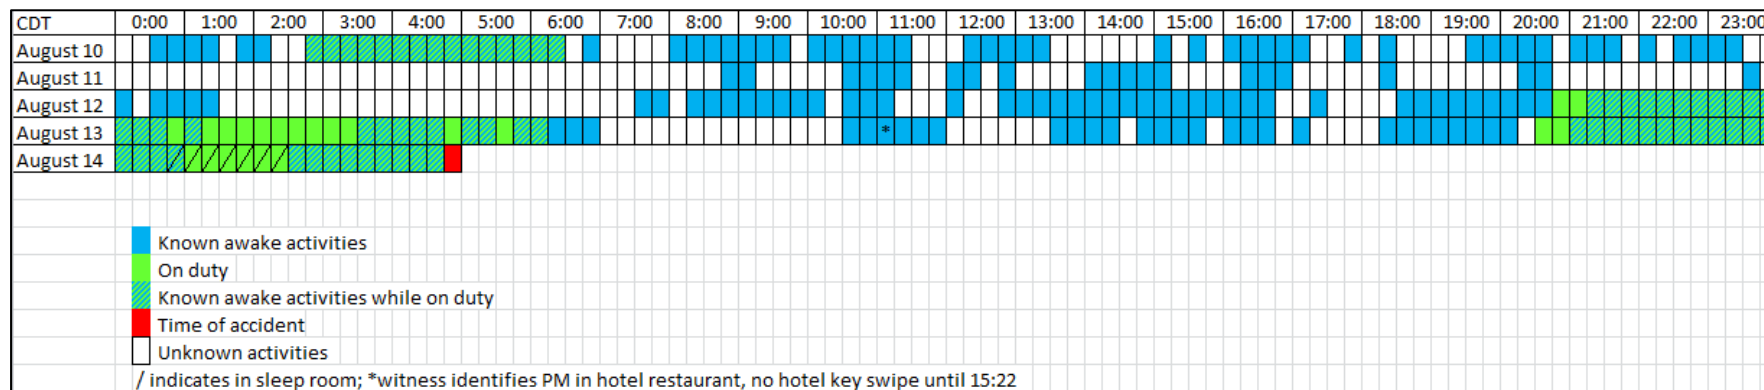
Upon arrival in SDF, the flight crew took the shuttle to the air services center about 2358. The first officer logged into the crew flight operations system about 0009 on August 14 and checked in to a sleep room about 0011. She spoke to a colleague in the briefing room about 0020 before entering the sleep room about 0048. PED activity stopped about 0050. About 0241, closed circuit television footage showed the first officer exit the sleep room. The flight crewmembers took the shuttle to the airplane about 0306, and they pushed back from the gate at SDF about 0355. The first officer’s preaccident activities are shown in figure 7.

5 **Figure 7.** First officer's preaccident activities.
