## Air Canada Flight 624 Accident, Halifax Nova Scotia, 29 March 2015.

### Accident report critique by Capt. Steve Last

## Air Canada 624 Halifax Accident Report Critique - introduction.

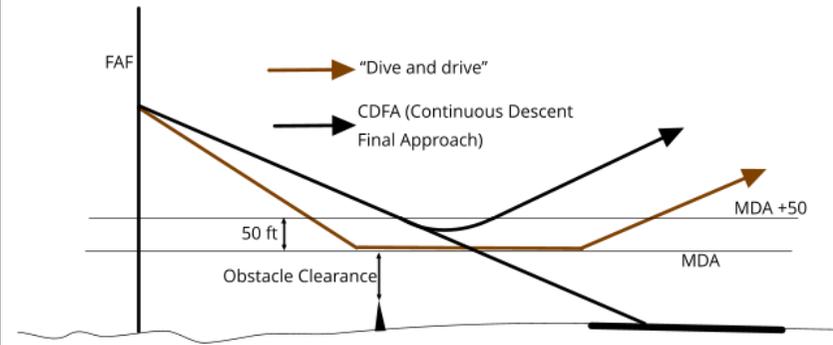
5.	MDA correction	The MDA was calculated at 813 feet ASL, based on the published MDA of 740 feet ASL plus a cold temperature correction of 23 feet, plus 50 feet added to the corrected MDA, as required by Air Canada's <i>Flight Operations Manual</i> (FOM).	The 50ft FOM addition is applied to a Continuous Descent Final Approach (CDFA) which is recommended as safer than a "Dive and Drive" non-precision approach. Adding 50ft to the cold-weather adjusted MDA allows a decision to go-around to be implemented without the aircraft infringing the actual MDA, which assures obstacle clearance. The 50 ft height loss allowance accepts that the aircraft will descend somewhat after the decision is made, as it takes time before the aircraft can respond when the go-around is initiated. With a "Dive

and drive" approach there is no height loss as the aircraft is not descending when the go-around is initiated.
