**AVIATION INVESTIGATION REPORT
A11H0002**

CONTROLLED FLIGHT INTO TERRAIN

**BRADLEY AIR SERVICES LIMITED (FIRST AIR)
BOEING 737-210C, C-GNWN
RESOLUTE BAY, NUNAVUT
20 AUGUST 2011**

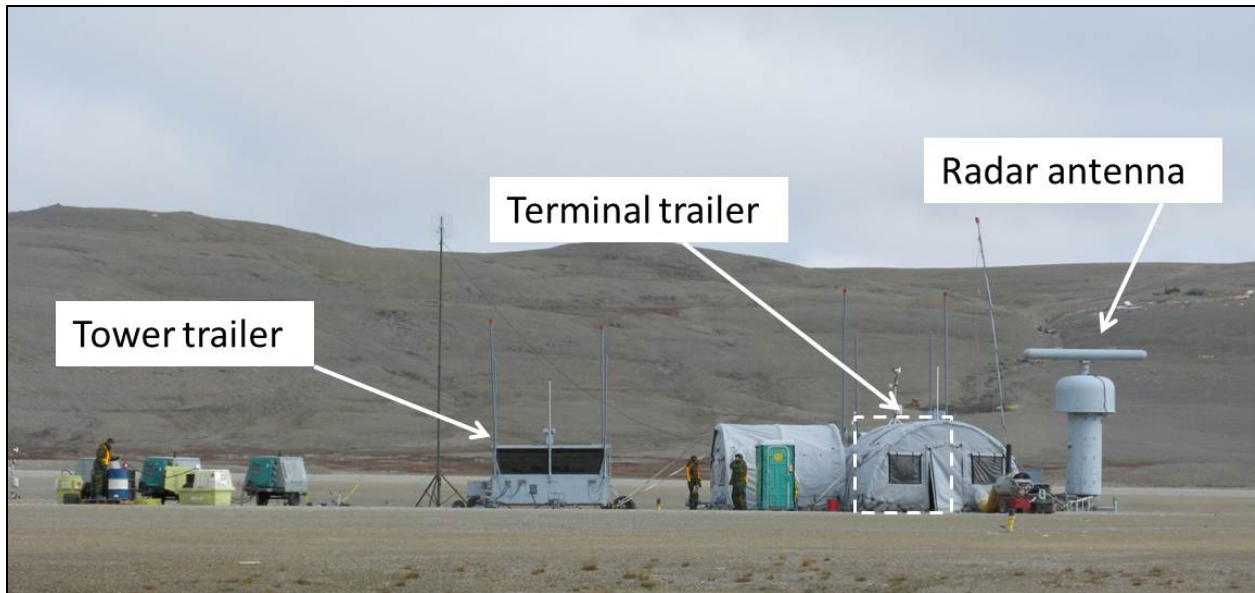
Photo 5. Temporary military air traffic services (ATS) facility at Resolute Bay (CYRB). The terminal trailer is located behind the tents.

Portable trailers at CYRB housed both the tower and terminal controller work stations (Photo 6). Both work stations were equipped with communication equipment and multiple information display monitors. One monitor in the tower provided radar information. The terminal control work station was equipped with several displays for ASR and PAR.

Although the radar had not been flight-checked, it was operating. Radar data were being recorded and fed to both trailers. The terminal controller was at the control work station monitoring the arrival of air traffic and issuing departure clearances to departing flights. Radar information was displayed, but was not being used for control purposes.

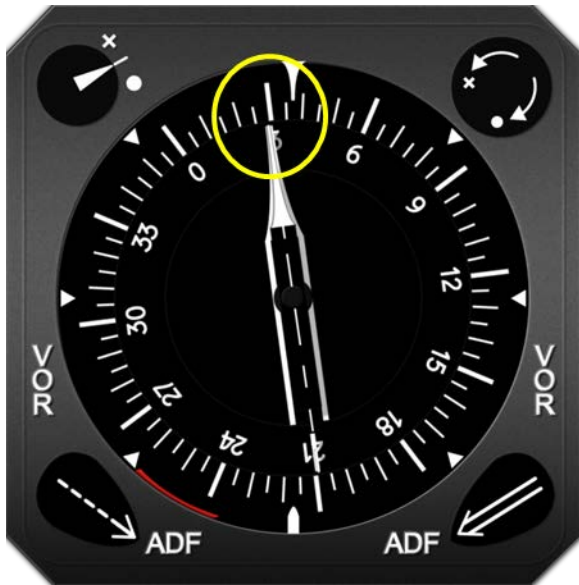
Figure 12. 1625:07: Exemplar of first officer (FO) radio-magnetic indicator (RMI) (no. 2 compass), showing expected true indications with no heading error

Radar and wind data show that the aircraft was tracking 037°T to MUSAT with no wind drift. The correct post-procedure radio-magnetic indicator (RMI) indications, assuming no NDB/ADF (automatic direction finding) error influence, should have been ADF bearing pointer head at 029°T, with the resultant true heading 037°, under the lubber line (Figure 12).

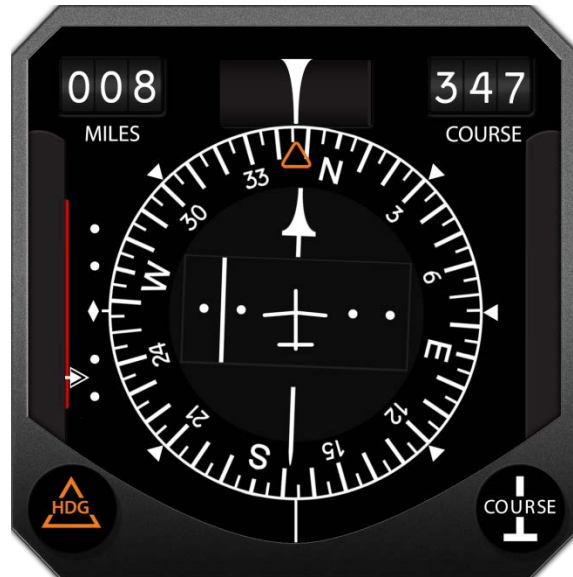
Figure 17. Exemplar of captain's HSI (no. 2 compass) indications at 1639:10, had there been no heading error

As shown in Figure 16, the indicated heading of 330° would have given the captain the perception that he had a 17° intercept angle to return to the localizer centreline track of 347°.

The HSI is the primary navigational instrument for both pilots. The angular relationship between heading and localizer (Figure 16) would have been a powerful visual confirmation to both pilots that the intercept angle was satisfactory, and that it should return the aircraft to the localizer centreline. However, due to a -16° compass error at this point in the flight, the aircraft's true heading was 346°, as shown in Figure 17. With 3° of wind drift to the right, the resultant aircraft track (349°T) diverged further to the right of the localizer.

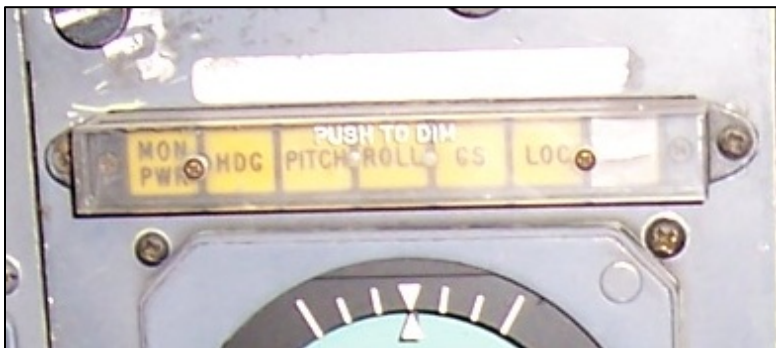
Photo 6. C-GNWN captain's instrument comparator

An instrument warning system is installed which compares the captain's and FO's compass headings, pitch and roll attitude indications, and localizer and glideslope deviation outputs from the no. 1 and no. 2 VHF NAV units. An instrument comparator annunciator (Photo 6) is located above each pilot's instrument display.

For heading information, the comparator will illuminate amber lights on both annunciators when the difference between the no. 1 and no. 2 compasses exceeds the following tolerances:

- Wings level $6^{\circ} \pm 2^{\circ}$
- 20° bank $10^{\circ} \pm 2.5^{\circ}$
- Glideslope captured $4.5^{\circ} \pm 1^{\circ}$

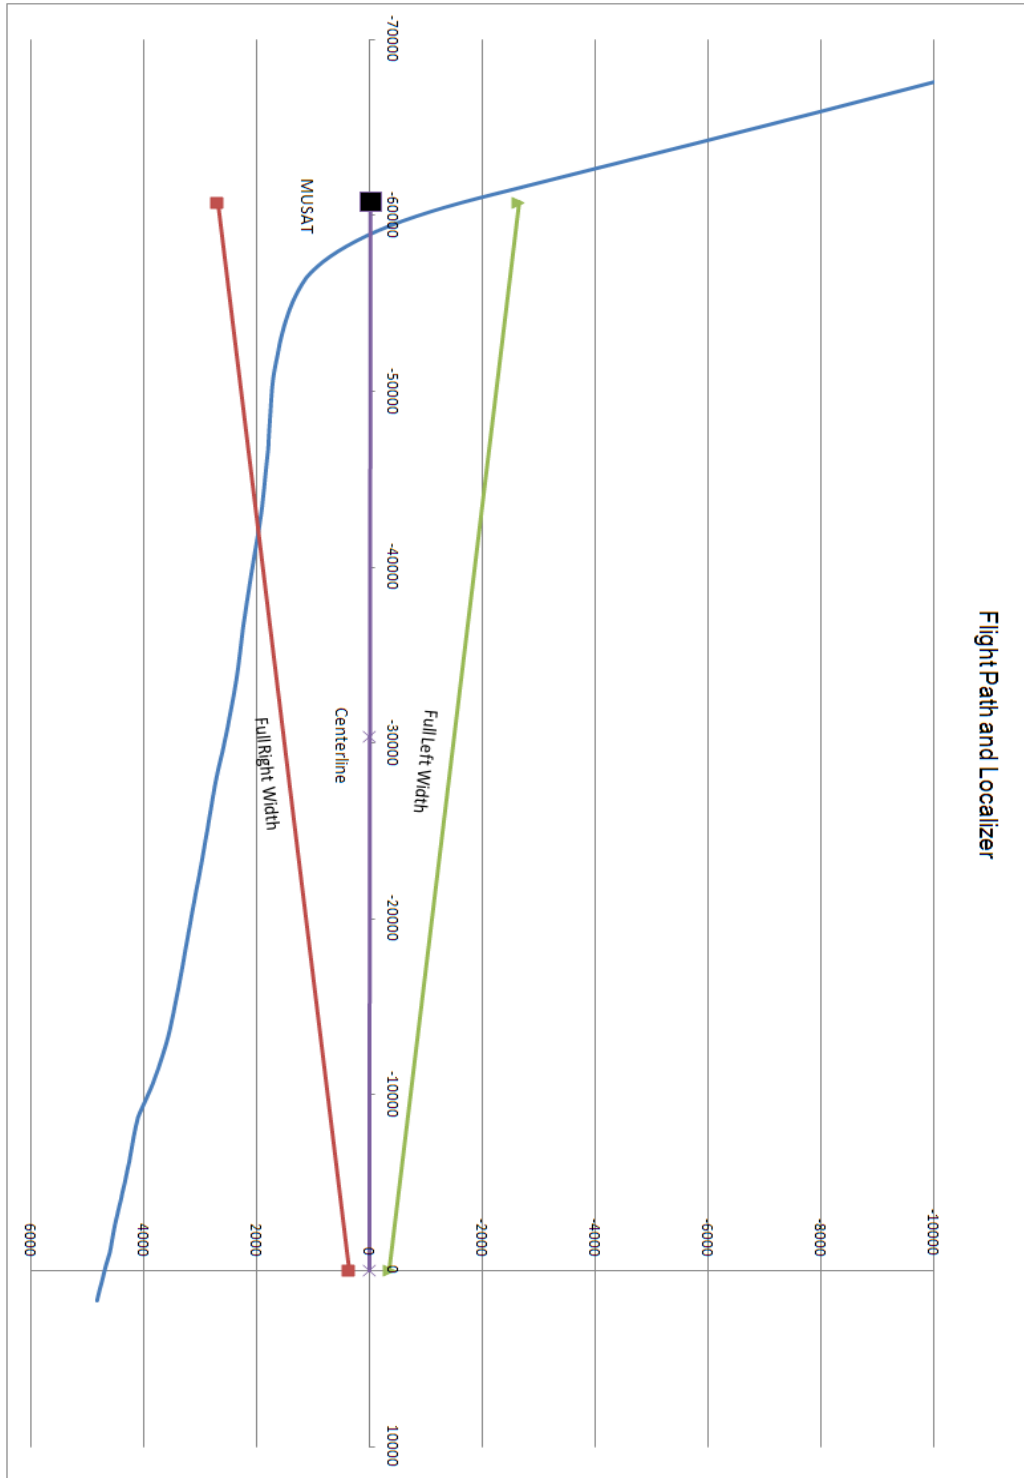
Appendix P – Flight path and localizer

NOTE: Given that the aircraft left the localizer beam, the results obtained from the glideslope calculation are mathematical, were used for illustrative purposes only, and may not be what the aircraft instruments would have shown (as the aircraft may not have been within receiving range of the antenna's signal).
