Air Accident Investigation Unit Ireland

FORMAL REPORT

ACCIDENT
Fairchild Aircraft Corporation
SA 227-BC Metro III, EC-ITP
Cork Airport, Ireland
10 February 2011

AAIU Report No: 2014-001
State File No: IRL00911013
Report Format: Formal Report
Published: 28 January 2014

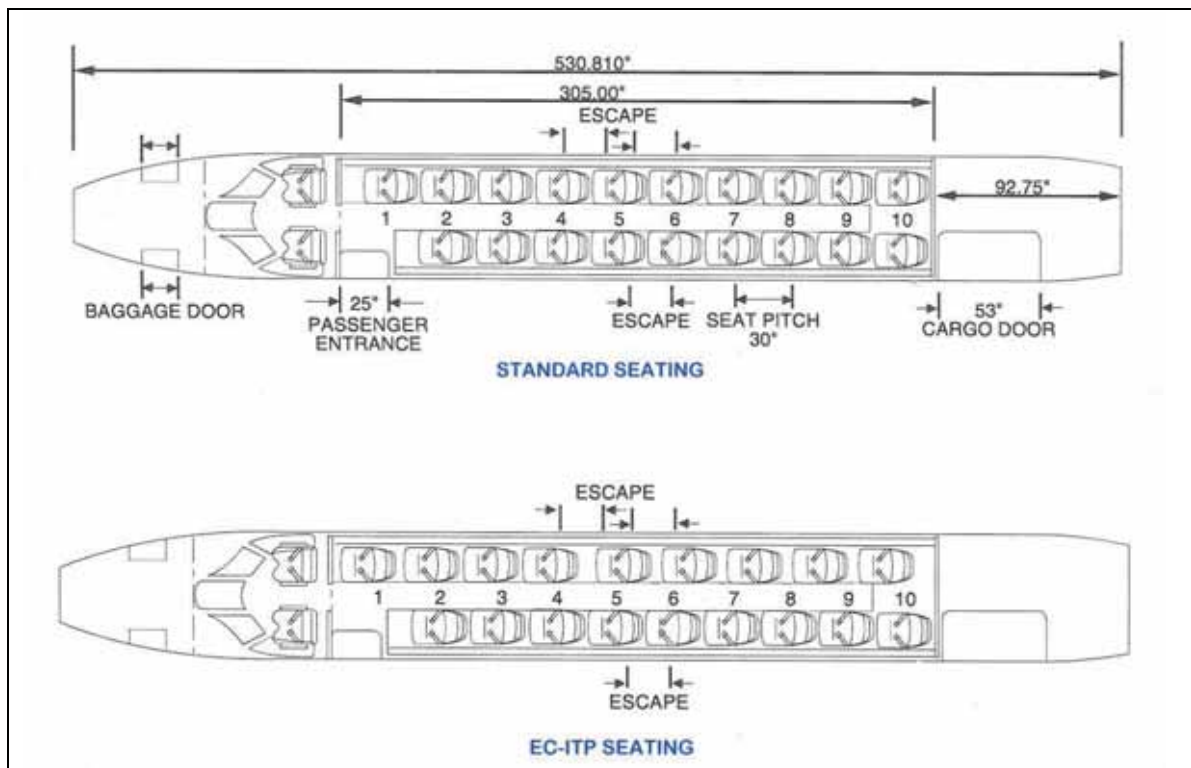
The seat pitch on the right-hand side commenced at 20 inches with a pitch of 38 inches provided adjacent to the aft emergency (escape) exit at the position of seat 5R. Seats behind 5R to the aft bulkhead were arranged with a pitch of 33 inches (**Figure No. 4**).

Figure No. 4: Standard 19-seat passenger layout and non-standard 18-seat layout as found on EC-ITP (adapted from SA 227 AFM)

AFS personnel removed all but two of the passenger seats to gain access to the casualties. In most cases the aisle-side seat legs were cut; some of the seats were forcibly wrenched free resulting in twists and fractures to the seat legs. Following recovery of the wreckage to the AAIU facility, the seats were examined. The Investigation compared the cut and fractured seat legs on the removed seats and established the location of each passenger seat in the cabin prior to the accident. The examination revealed a non-standard layout and seat pitch on the right hand side of the aircraft (**Figure No. 4**).

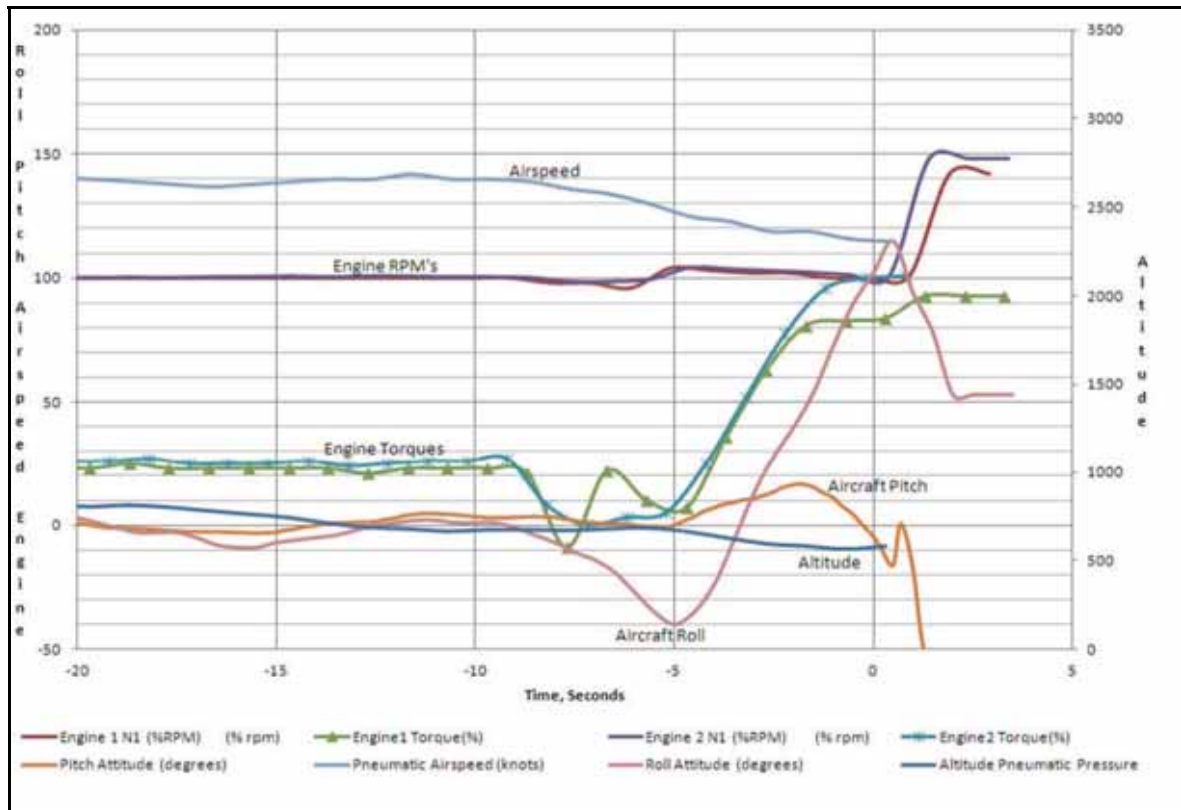
Relevant FDR parameters for the final 20 seconds of the flight are illustrated in **Figure No. 5a** (this is a reproduction of **Figure No. 5** to assist the reader).

Figure No. 5a: FDR Data for final 20 seconds of recording

The Investigation, with the assistance of the NTSB and the manufacturers of the engines and the engine control components, undertook a detailed analysis of the recorded torque mismatch. The Investigation also carried out an analysis of the recorded engine parameters during the final seconds of the flight. This analysis is attached in **Appendix L**.

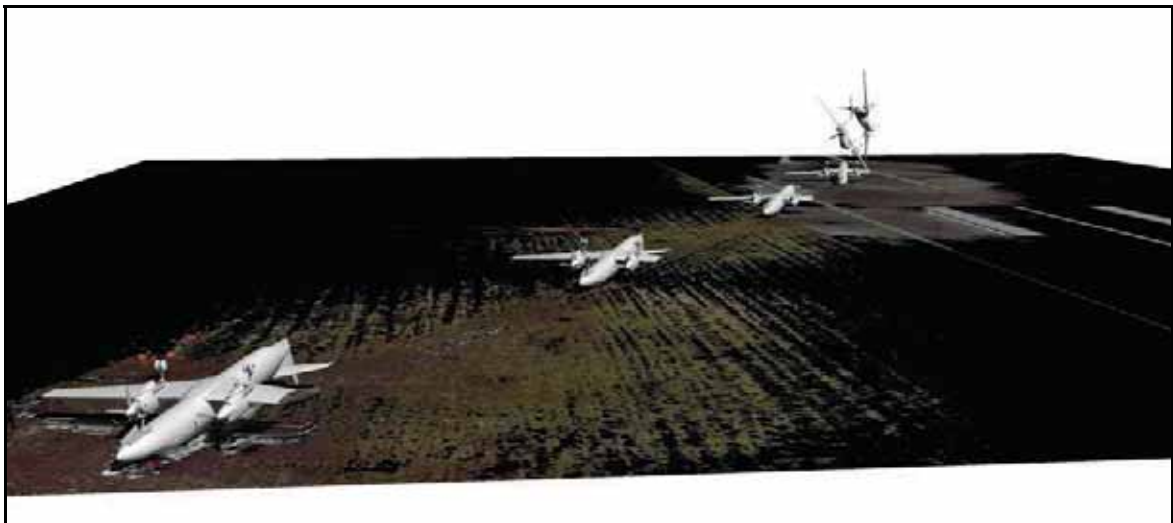
Three of the right propeller blades detached as contact was made with the runway surface and were found at various distances from the main wreckage. The aircraft left the paved area and decelerated rapidly in the soft ground (**Graphic No. 6**). At this point the roof of the forward fuselage ruptured allowing a substantial quantity of soil to enter the cabin.

Graphic No. 6: Reconstruction of ground path to final resting place

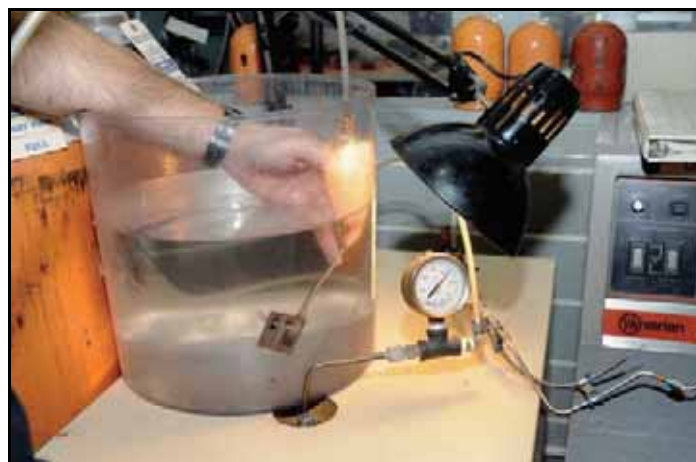
The P_{T2}/T_{T2} sensor was cut midway in the capillary tube to isolate the bellows from the probe to determine which end may be breached. Each half was pressured using helium, then dunked into a tank of Stoddard Fluid (MIL-F-7024 type II) (**Photo No. 3**).

Photo No. 3: P_{T2}/T_{T2} leak check test

No leak (bubbles) was noted coming from the bellows but a streak of bubbles was noted coming from the sensing tube (**Photo No. 4 & Photo No. 5**). The sensing tube was marked where the bubbles appeared to have been coming from (**Photo No. 6**). Additional examination will be needed to determine the exact location and cause of the breach.

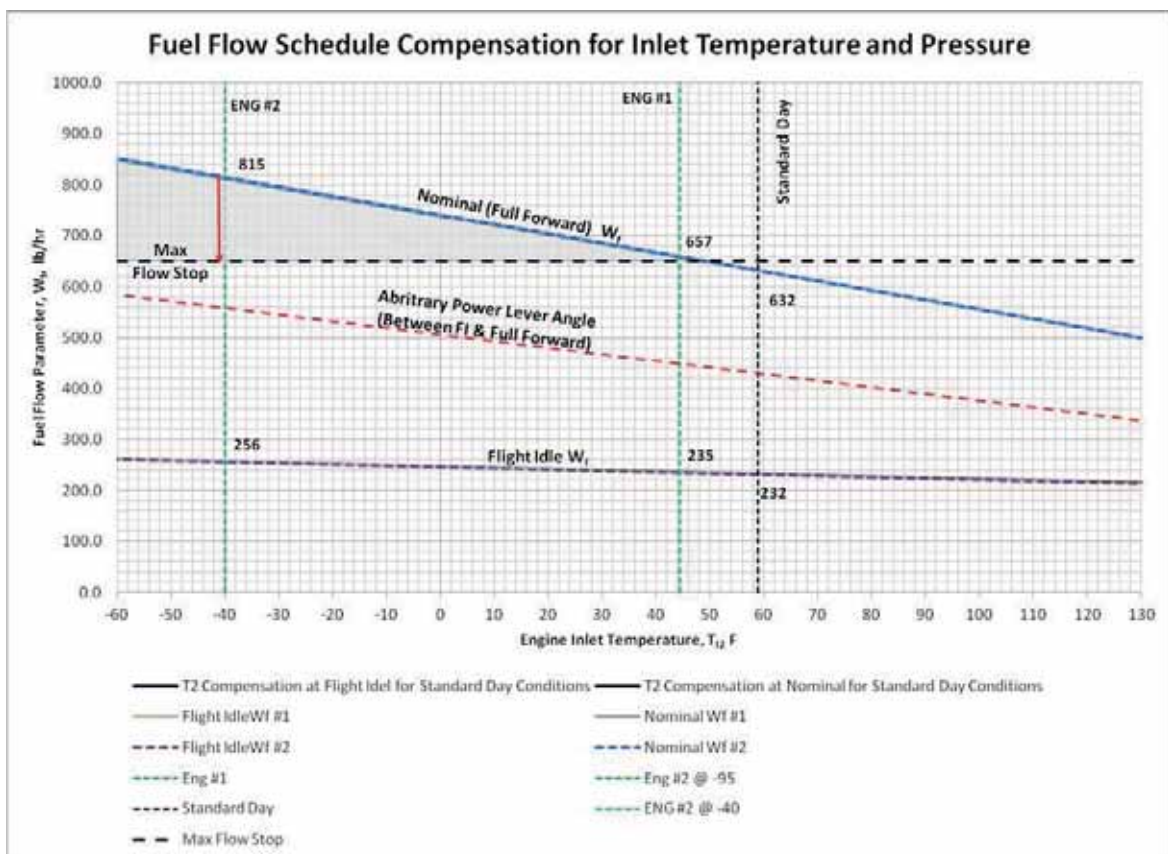
When the engine speeds are stabilised at approximately 97% RPM, and the power levers are advanced from Ground Idle towards high power, the fuel control transitions from the underspeed governor fuel schedule to the power lever schedule. The power lever schedule is compensated for inlet temperature (T_{T2}) in accordance with the characteristics shown in **Figure No. 2**. In this case the lower nearly horizontal line represents the fuel flow with the power lever at Flight Idle while the upper blue line is the fuel flow with the power lever fully forward. Power lever settings between Flight Idle and maximum power would be represented by similar lines between the two. The x-axis is the engine inlet temperature in degrees Fahrenheit ($^{\circ}F$). There is a maximum flow stop at 650 lb/hr which is represented by the dashed black line.

As the power lever is moved from Flight Idle to full forward, which is illustrated at an arbitrary power lever position by the dashed red line, there is a proportionally higher fuel flow to the No. 2 engine than to the No. 1 engine.

Figure No. 2: Fuel Flow Schedule Compensation (Source Honeywell)

Thus, as the power levers are advanced for take-off, the effect of a shortened bellows is to increase the fuel flow to the engine on the side with the shortened bellows, i.e. the No. 2 engine on EC-ITP.

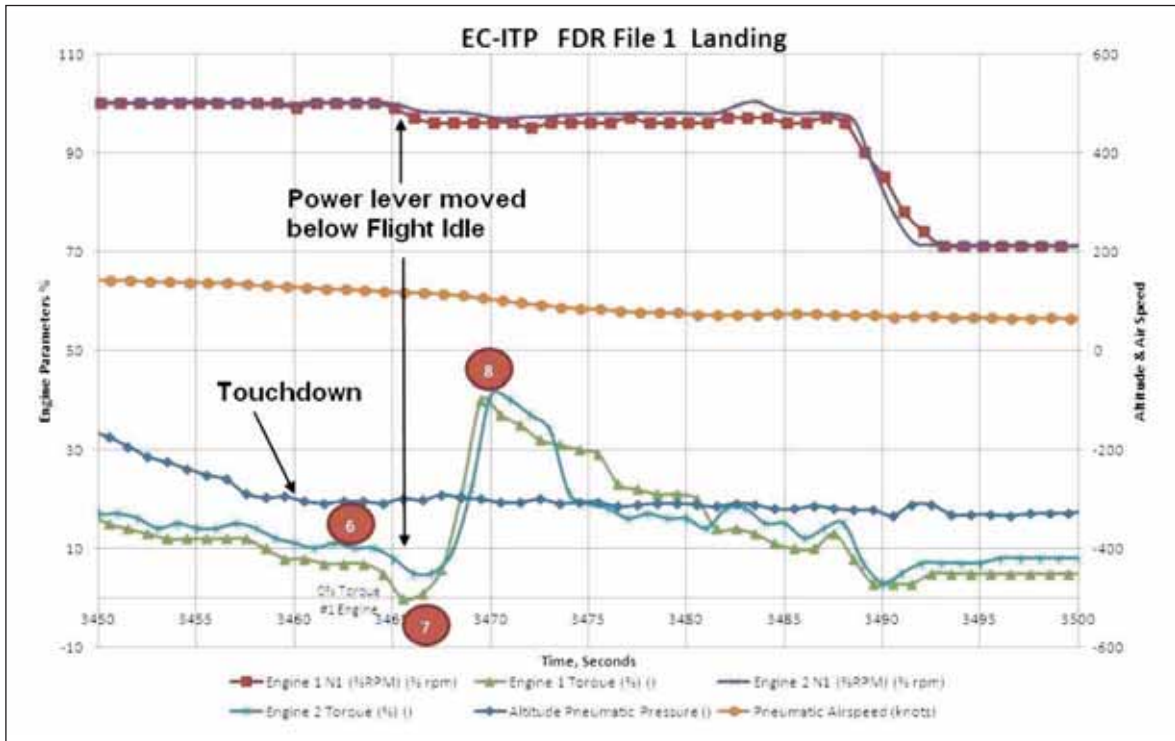
The Investigation looked at a landing which had been made by EC-ITP at a Spanish airport several weeks before the accident, and for which FDR data was available. **Figure No. 8** illustrates the FDR data for this landing in similar format to that shown for the accident. Time in seconds is shown on the x-axis while the various engine parameters along with altitude and airspeed are shown on the y-axis. The touchdown occurred at FDR time reference 3460.

Figure No. 8: FDR Data from Previous Landing

A similar analysis was carried out for this landing, and the manufacturer’s computer model was used to calculate the fuel flows at datapoints 6, 7 and 8 as shown in **Figure No. 8**. The data is shown for the No. 1 engine in **Table No. 6** and for No. 2 engine in **Table No. 7**.
