AIRCRAFT ACCIDENT REPORT 1/2016

**Report on the accident to
AS332 L2 Super Puma helicopter, G-WNSB
on approach to Sumburgh Airport
on 23 August 2013**

Air Accidents Investigation Branch

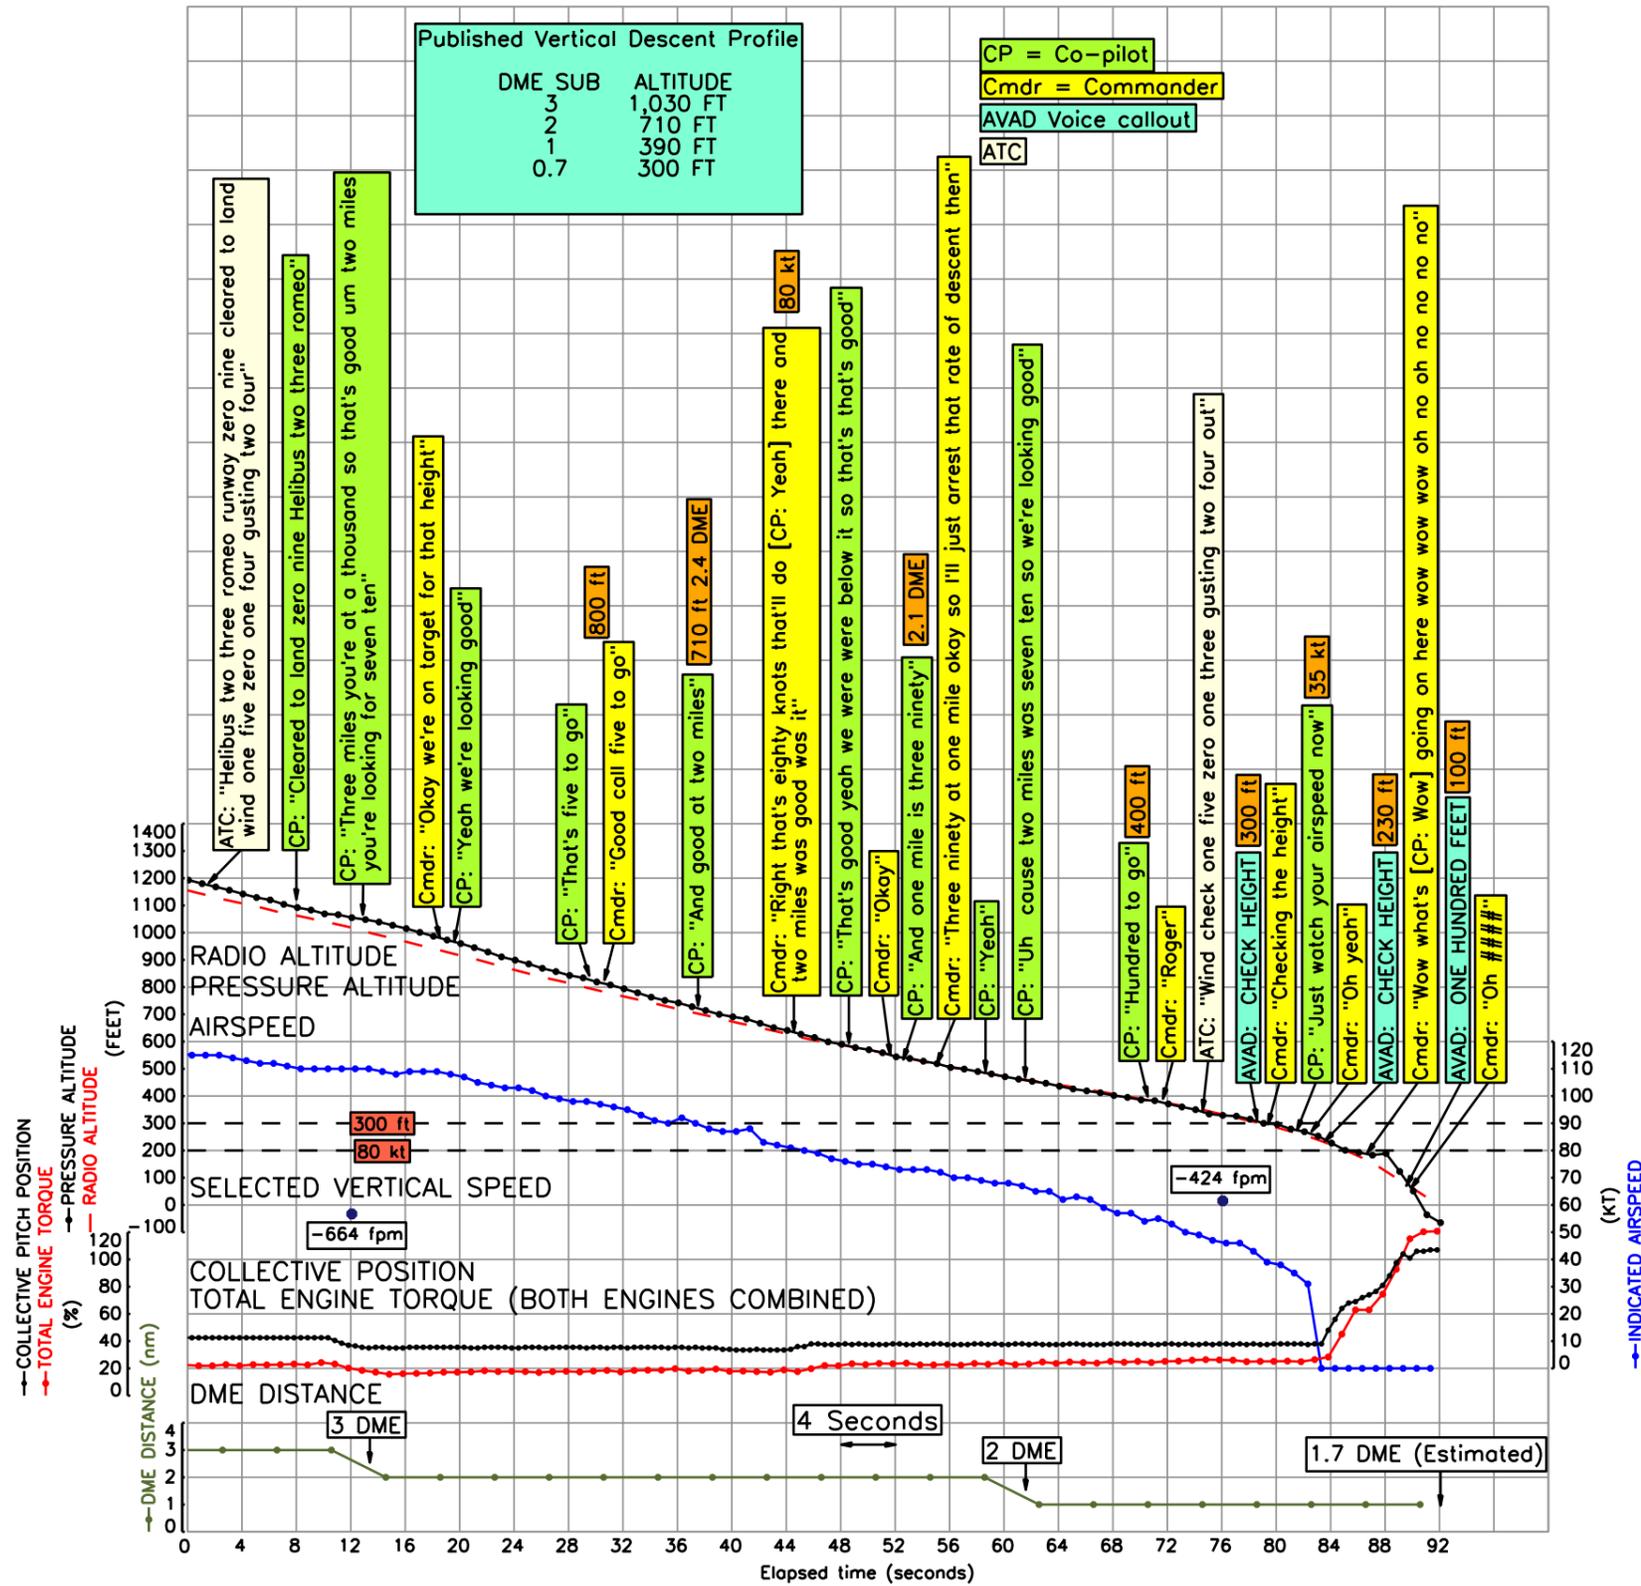
Figure 13
CVFDR record from 1,200 ft

As the helicopter descended to 100 ft, the AVAD 'ONE HUNDRED FEET' audio alert sounded. At the same time the cyclic stick was moved aft and the helicopter started to pitch up. The engine torque was now at a maximum of 120%. The helicopter impacted the surface of the sea approximately 1.7 nm from the threshold of Runway 09 (Figure 14), yawing to the right and rolling towards a level attitude from about 6° right bank and with the nose about 1.4° up. The time was 1717 hrs. The peak recorded normal acceleration at impact was about 5.5 g.

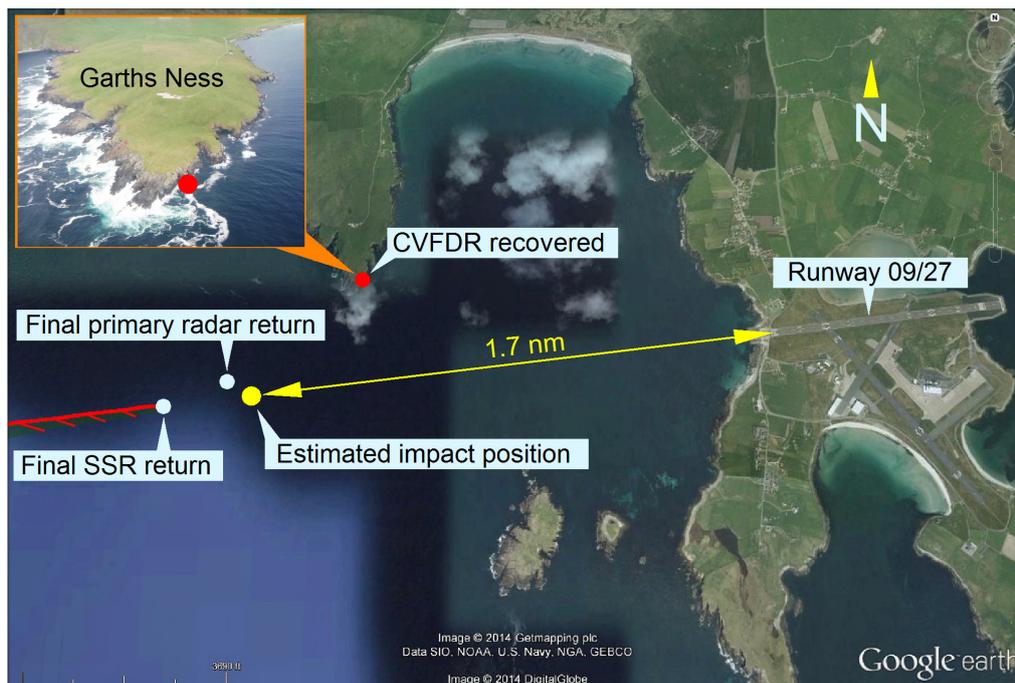
Figure 14

G-WNSB estimated impact position

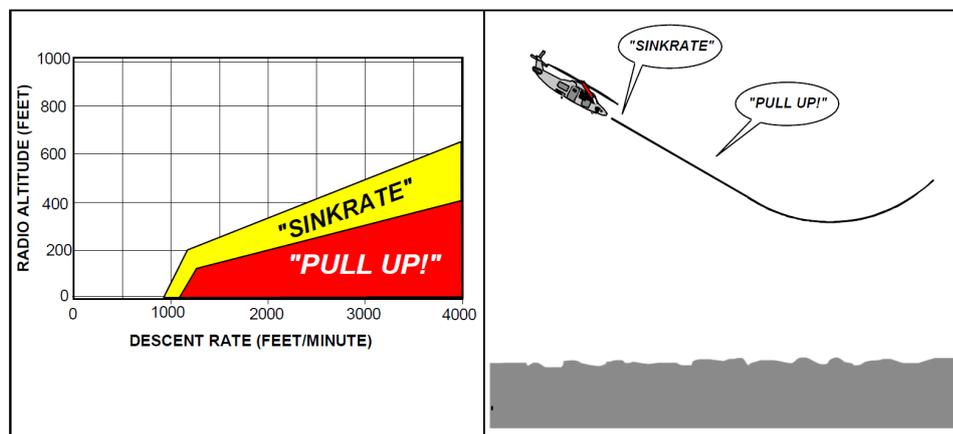
The results of the simulation were that: at a height of 179 ft, about 5.7 seconds before G-WNSB struck the surface of the sea, a Mode 1 'SINK RATE SINK RATE' audio alert would have been generated. Figure 17 provides details of the EGPWS Mode 1 envelope used to trigger the alert and Figure 18 is a time series plot of when the alert would have occurred relative to other alerts and impact with the sea.

EGPWS Mode 1 Alert envelope

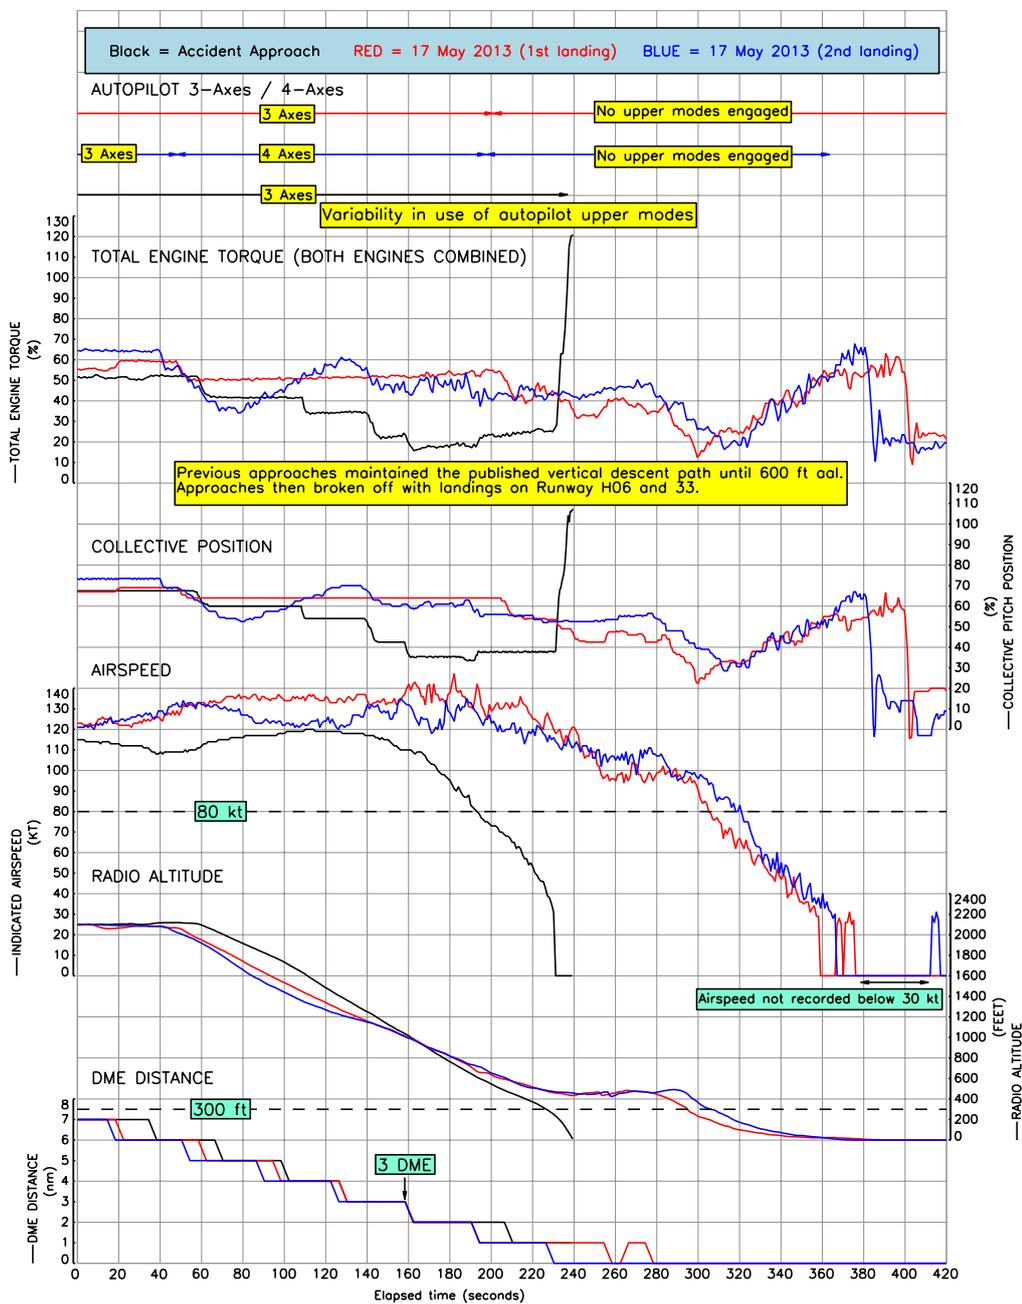
Figure 21 is a time series plot of flight data that shows variation in the use of the autopilot upper modes in 3-axes and 4-axes during two approaches to Runway 09 on 17 May 2013, compared with the accident approach. The first approach was similar to the accident approach, with the autopilot set to 4-axes for the intermediate descent and 3-axes during the approach. The second approach was with the autopilot in 4-axes. Both approaches maintained the vertical descent profile until about 600 ft aal, when the approaches were broken off to land on Runway H06 and Runway 33 respectively. The recorded cloud base and visibility at Sumburgh Airport during the period of the two approaches was about 900 ft and 7,000 m, respectively.

Previous approaches to Sumburgh Airport flown by commander

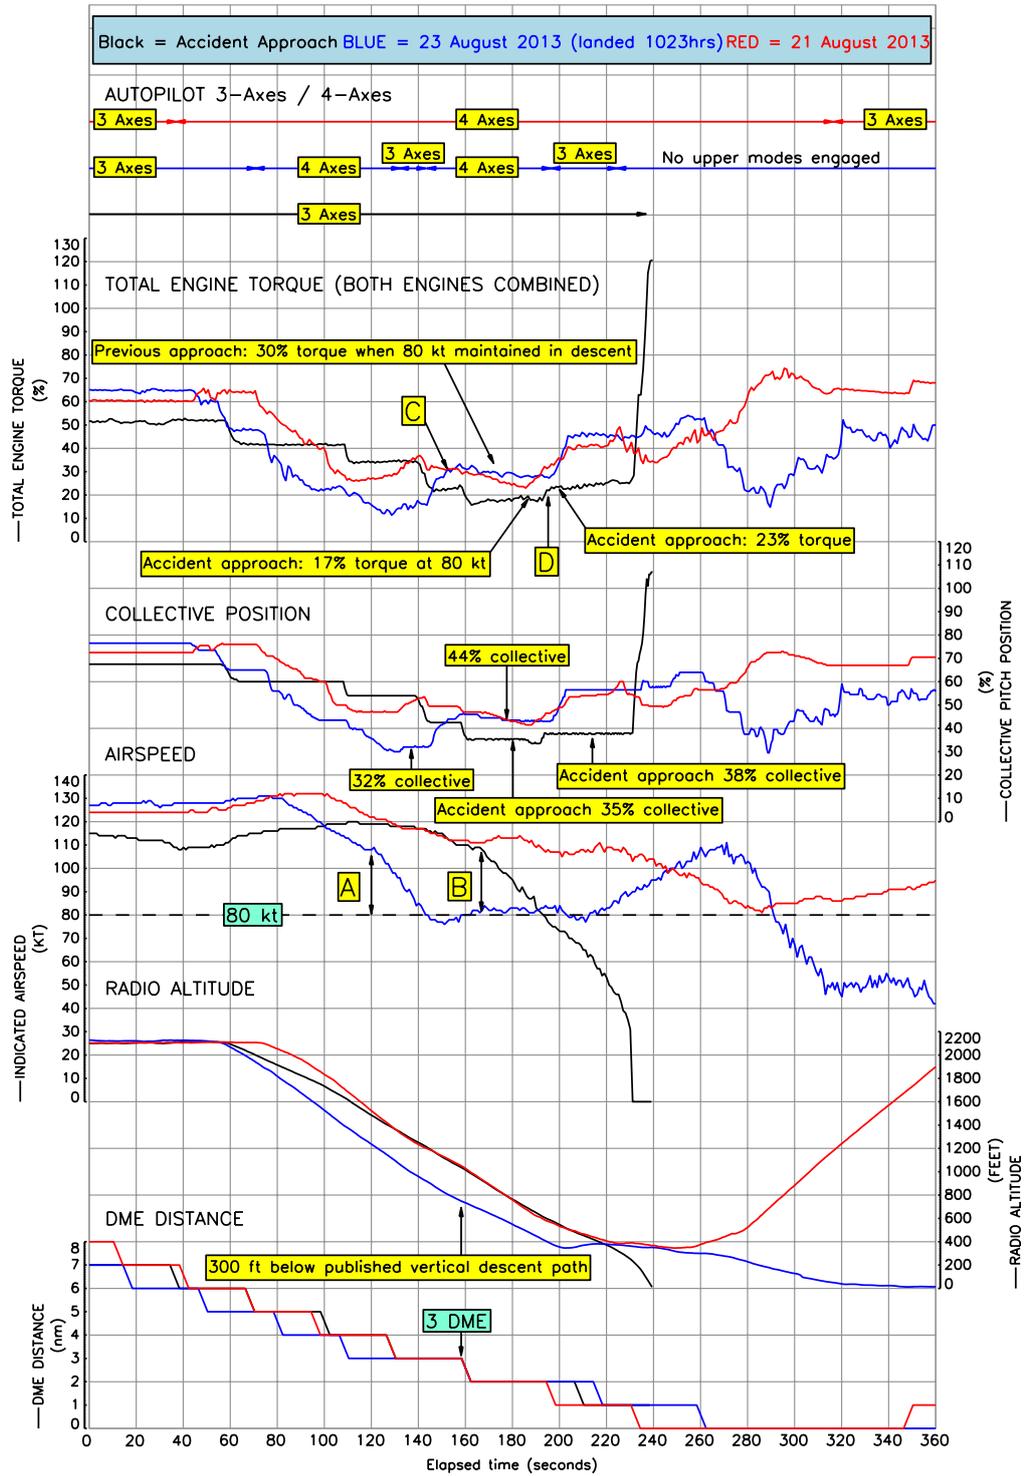
During the approach on the morning of 23 August 2013, the rate of reduction of airspeed between 109 kt and 80 kt was similar to that during the accident approach (1.2 kt per second, compared to 1 kt per second; Figure 22 Points A and B). The vertical descent rates during this period were also similar (about 700 fpm).

When the airspeed was stabilised at 80 kt during the earlier approach, a combined engine torque of 32% (collective pitch of 44%) was set. On the accident approach about 23% combined torque (collective pitch of 38%) was set but the airspeed continued to reduce below 80 kt (Figure 22 Points C and D).

Approaches to Sumburgh Airport Runway 09 by different crew

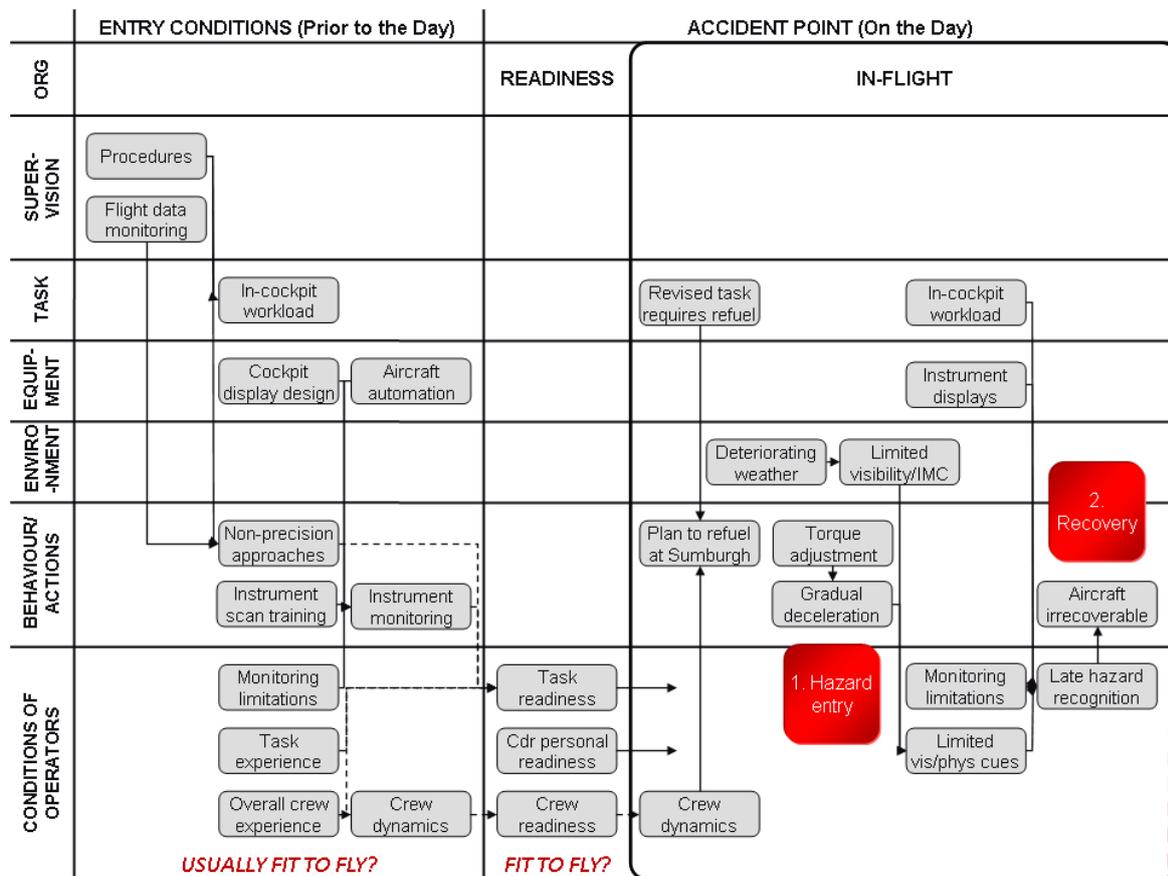
9. The evidence that was collected (as described in the previous section) was plotted against the ARM and the hazard management process. The ARM for the G-WNSB accident is presented in Figure 2: Accident Route Matrix (ARM) for Super Puma G-WNSB on 23 Aug 2013. The remainder of this section presents evidence related to the HF considerations identified in the ARM. The section begins by describing the entry conditions on the left of the ARM – that is those factors present before the day of the accident that influenced readiness and hazard management. The section then describes the factors on the right hand side of the ARM – that is the factors that were specific to the day of the incident and the hazard management process itself.

Figure 2: Accident Route Matrix (ARM) for Super Puma G-WNSB on 23 Aug 2013
