# CAPTAIN FIRED AFTER NOSE-WHEEL LANDING

The Captain of a Boeing 737-700 landed hard at LaGuardia Airport, collapsing the nose gear. But it's actually what happened leading up to the hard landing that makes this particular case interesting. The final report has not been released; however various public documents, including the Chariman's factual reports, are now available on the NTSB site:

Southwest Airlines flight 345 on 22 July 2013 was a scheduled passenger service from Nashville International Airport in Tennessee to LaGuardia Airport in New York carrying 145 passengers and 5 crew. The Captain started her sequence of trips on the 21st of July and the First Officer began his on the 19th. They met up on the morning of the 22nd at Los Angeles International. They had not previously flown together. They flew into Nashville International Airport, arriving at noon, and changed aircraft to the Boeing 737-700. The Captain invited the First Officer to do the next leg as the Pilot Flying and the Captain would take the role of Pilot Monitoring. An American Airlines pilot was in the jumpseat of the cockpit for the trip to New York.

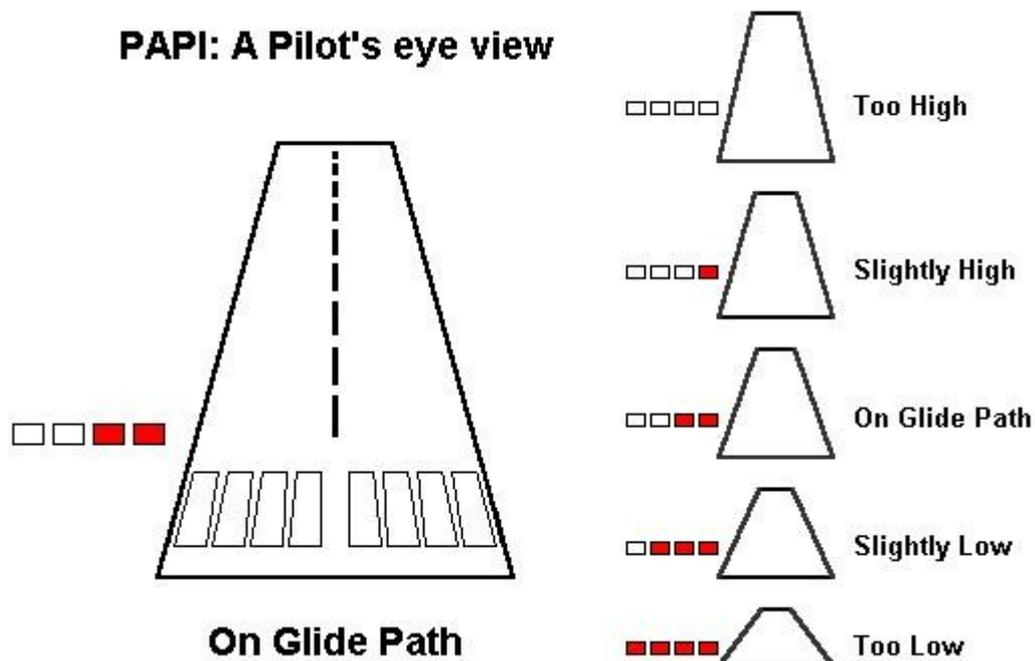
The Precision Approach Path Indicator (PAPI) is a visual display which provides vertical guidance for the approach path. In a normal approach, the PAPI would show two whites and two reds. More whites means that the angle of the approach is too high. More reds than white means that the angle of the approach is too low.

At around 500 feet, the First Officer disconnected the autopilot and autothrottles. The PAPI indicated two whites and two reds and he was satisfied with his airspeed and crosswind corrections. As far as he was concerned, everything was fine.
